FORMOSA PLASTICS CORPORATION, TEXAS

Traffic Pellet/Powder & Misc.
Observations

Gate 2 Road, Railcar Repair Shop
Area, PE2/PP2 Railcar Loading
& Inland Traffic

Conducted: March 11, 2016

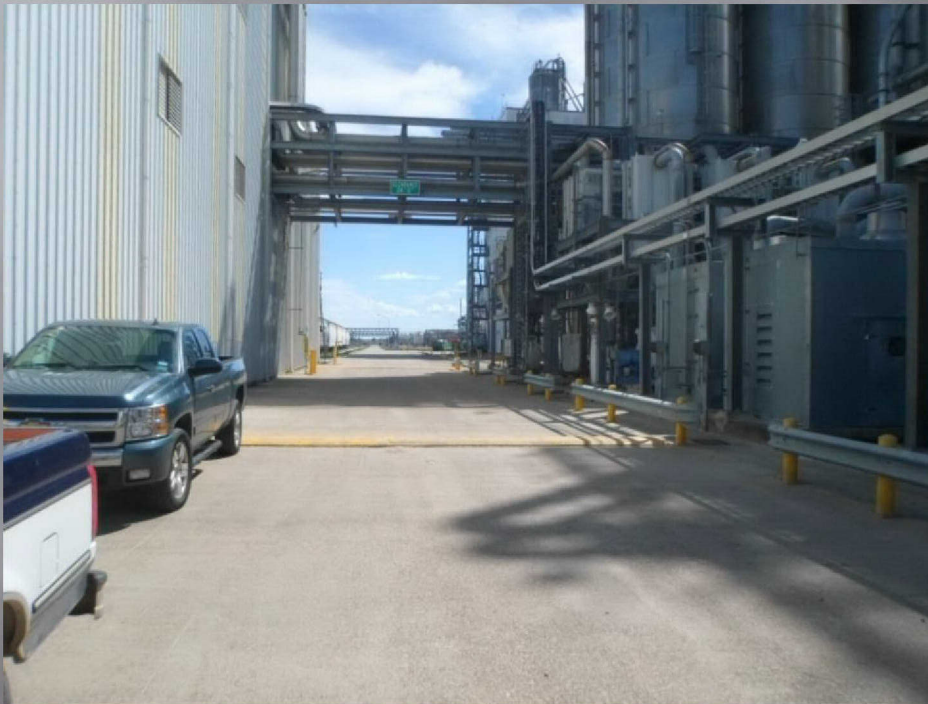
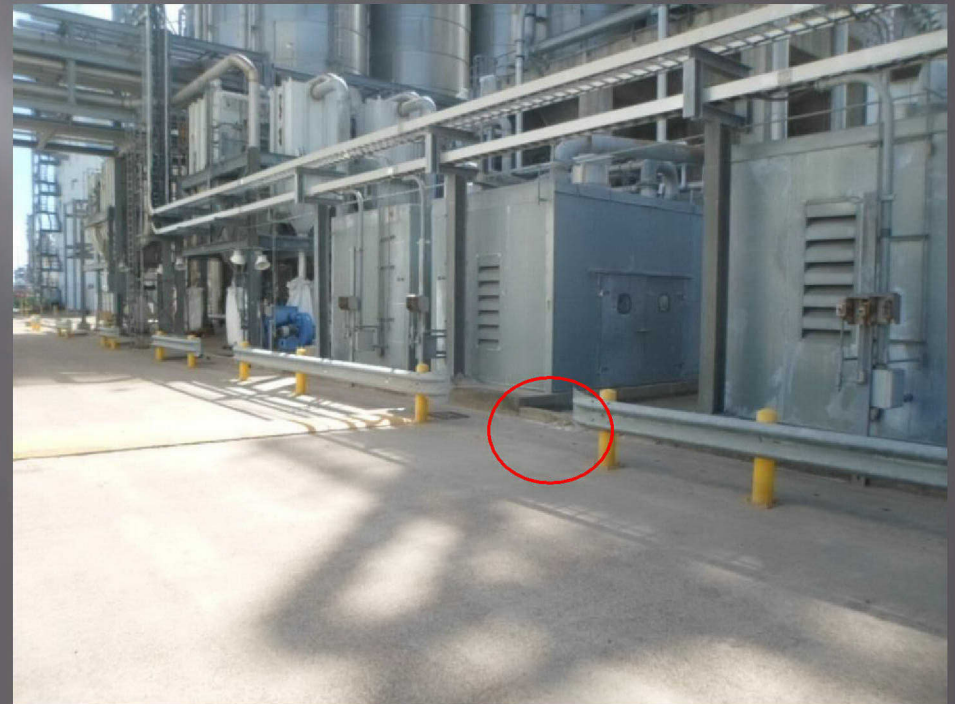
PE2/PP2 RAIL LOADING AREA

PELLETS AND POWDER ARE VISIBLE ALONG THE LEFT SIDE OF THE STREET. NEXT PHOTO GIVE A CLEARER IMAGE.

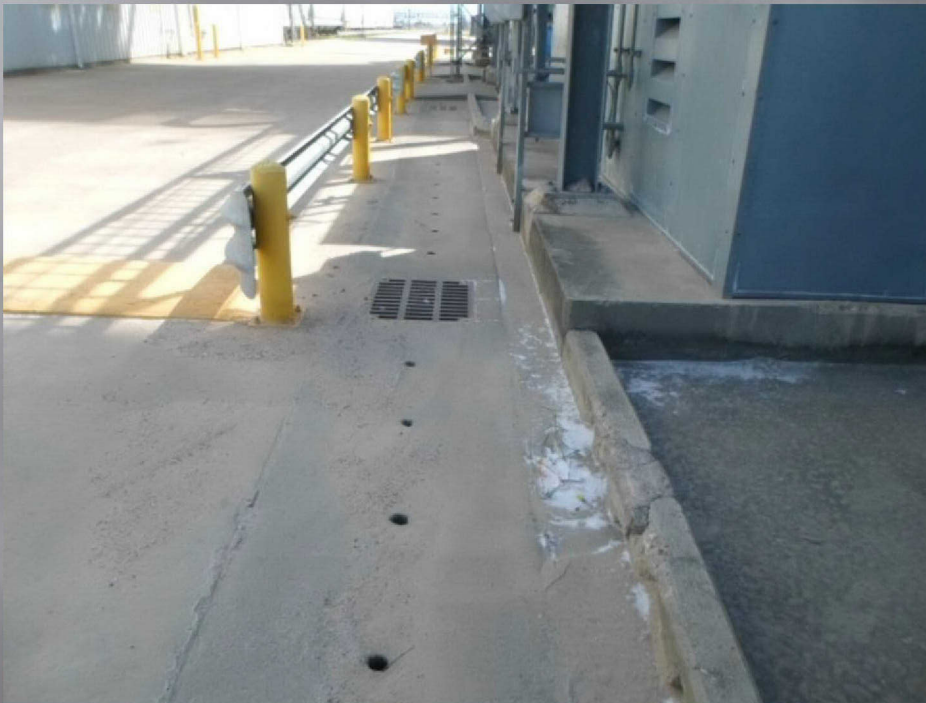
PE2/PP2 RAIL LOADING AREA

CLOSER IMAGE. NOTE THAT HOLES ON PAVEMENT DRAIN TO THE INTERNAL DITCH FOR PROCESS AREA. WATER FROM THIS DITCH IS DISCHARGE D INTO OUTFALL 009.

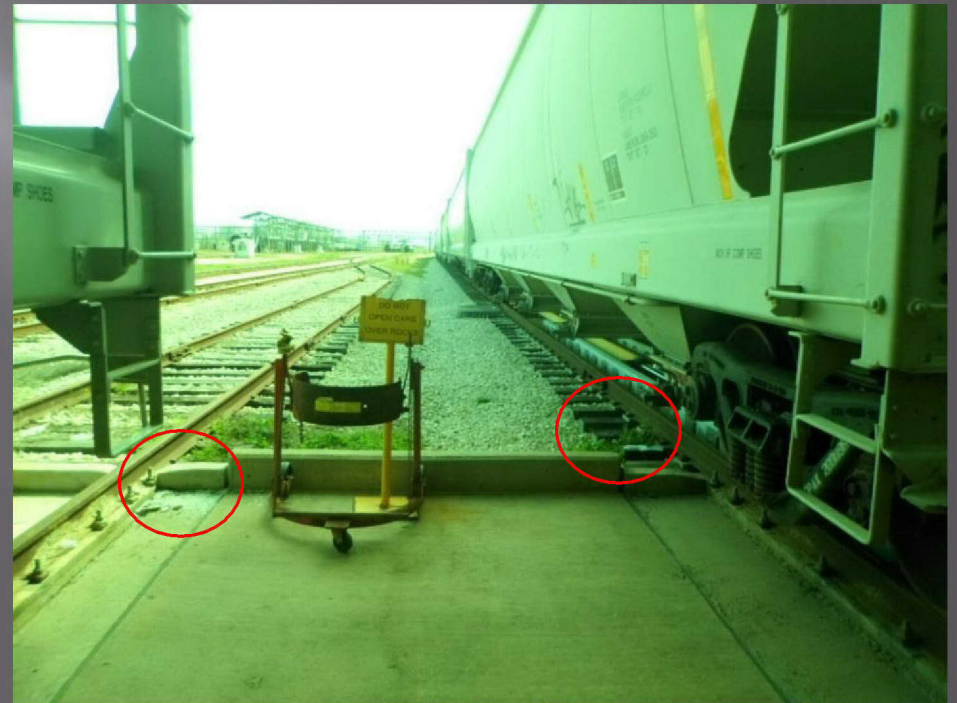
PELLETS ARE OBSERVED IN THIS AREA (SOUTH END OF RAILCAR LOADING AREA) BY AN OUTLET OF THE RAILCAR AND ALSO AT THE CORNER OF THE PAVEMENT. NEXT PHOTOS PROVIDE CLOSER IMAGE.

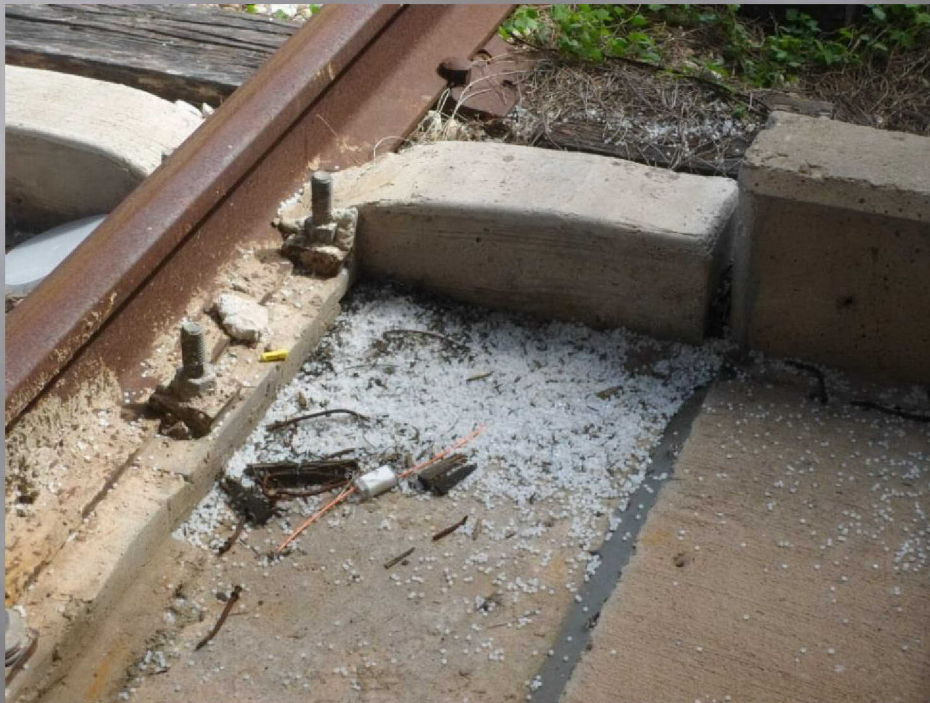
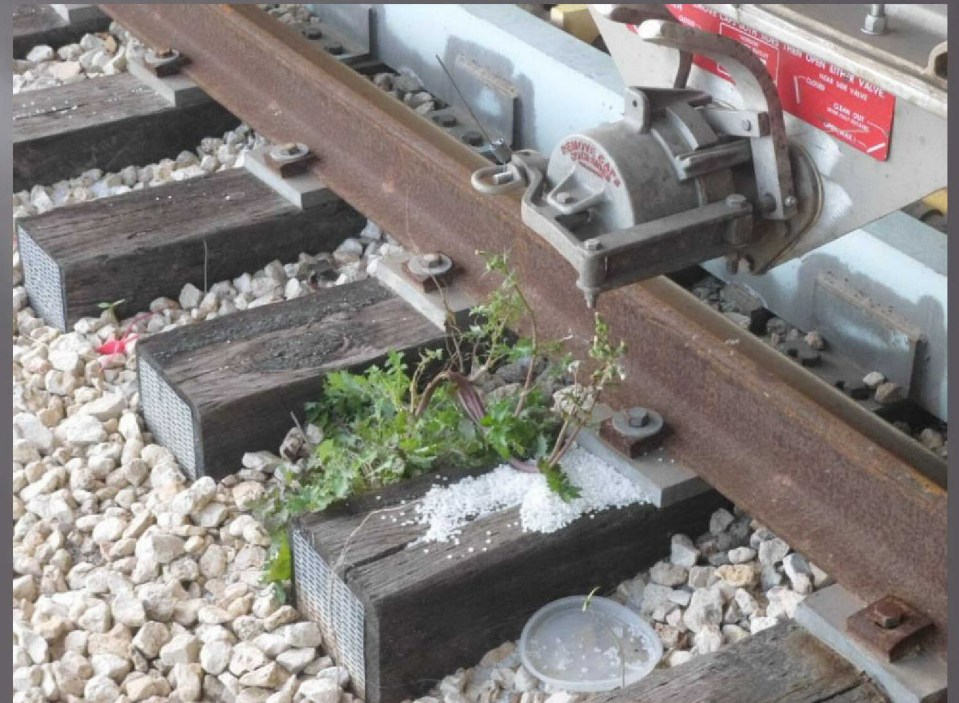
PE2/PP2 RAIL LOADING AREA

CLOSER IMAGES FROM PREVIOUS PHOTO.

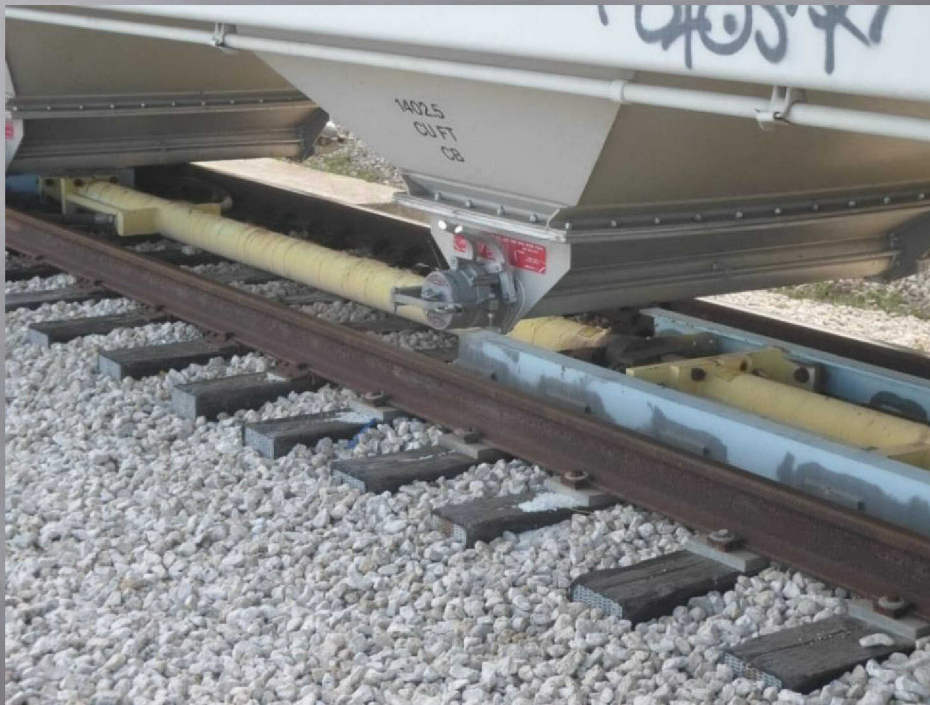
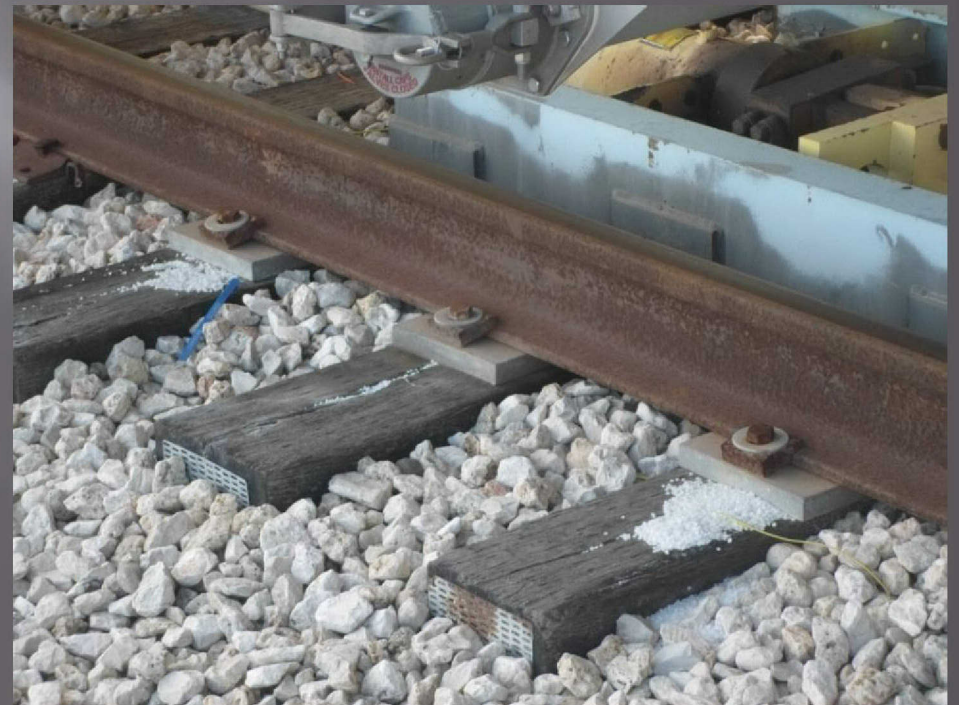
PE2/PP2 RAIL LOADING AREA

PRIOR TO THIS RAILCAR ENTERING THE LOADING AREA, PELLETS ARE OBSERVED ON ROAD

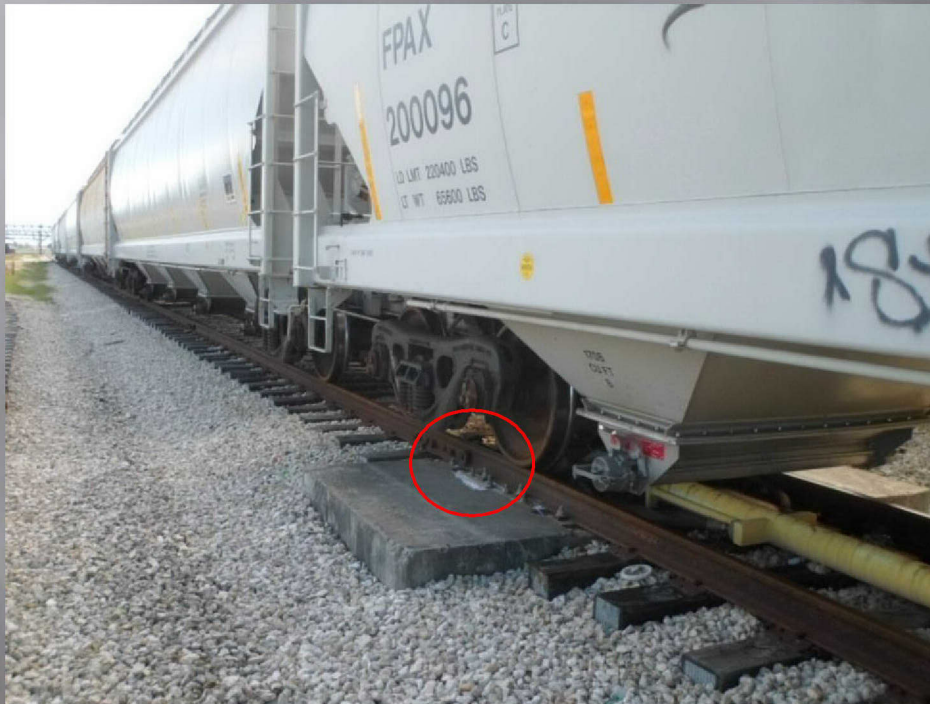
PE2/PP2 RAIL LOADING AREA

PELLETS OBSERVED JUST PAST THE OUTLET OF THE RAILCAR ON SOUTH END OF THE LOADING AREA.

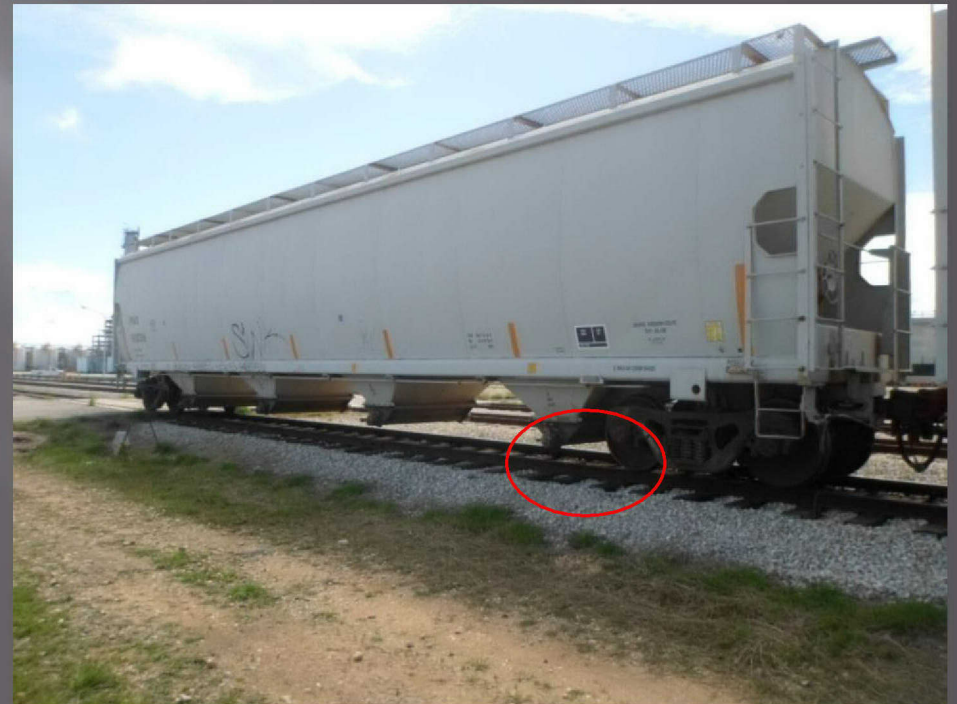
PELLETS OBSERVED ON GROUND BY OUTLET PRIOR. THIS CAR WAS NORTH OF INLAND TRAFFIC CHEMICALS AREA. NEXT PHOTOS PROVIDE CLOSER IMAGE.

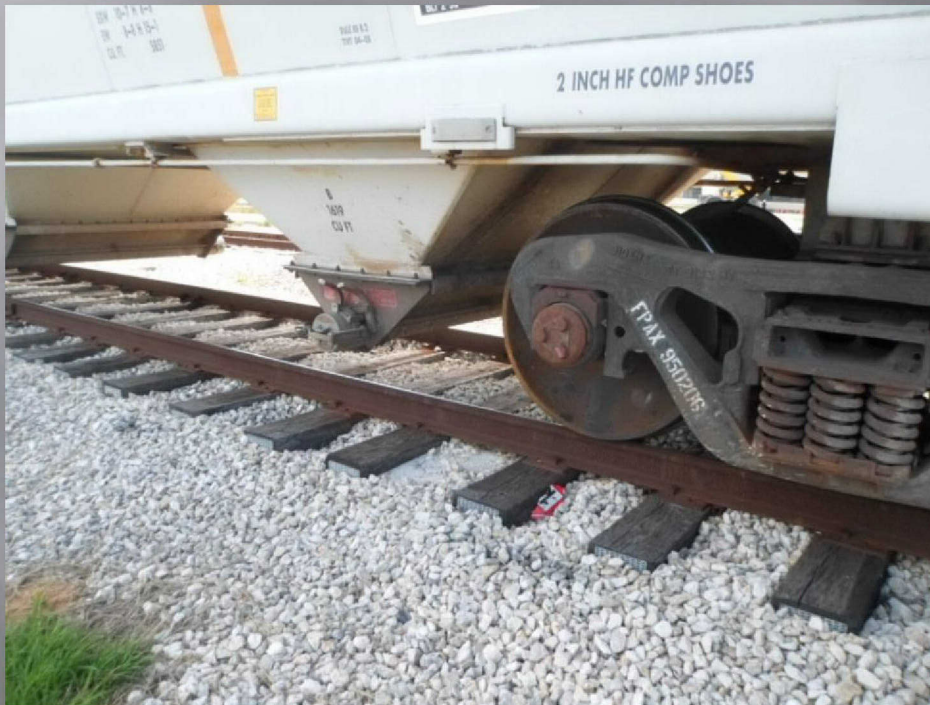
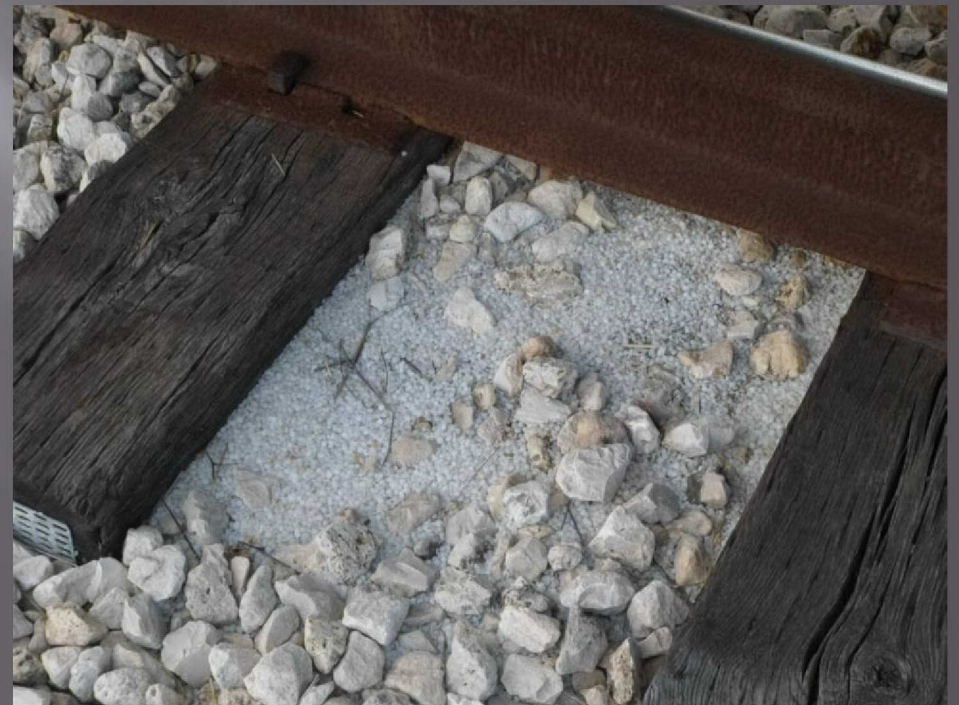
PE2/PP2 RAIL LOADING AREA

CLOSER IMAGE OF PELLETS.

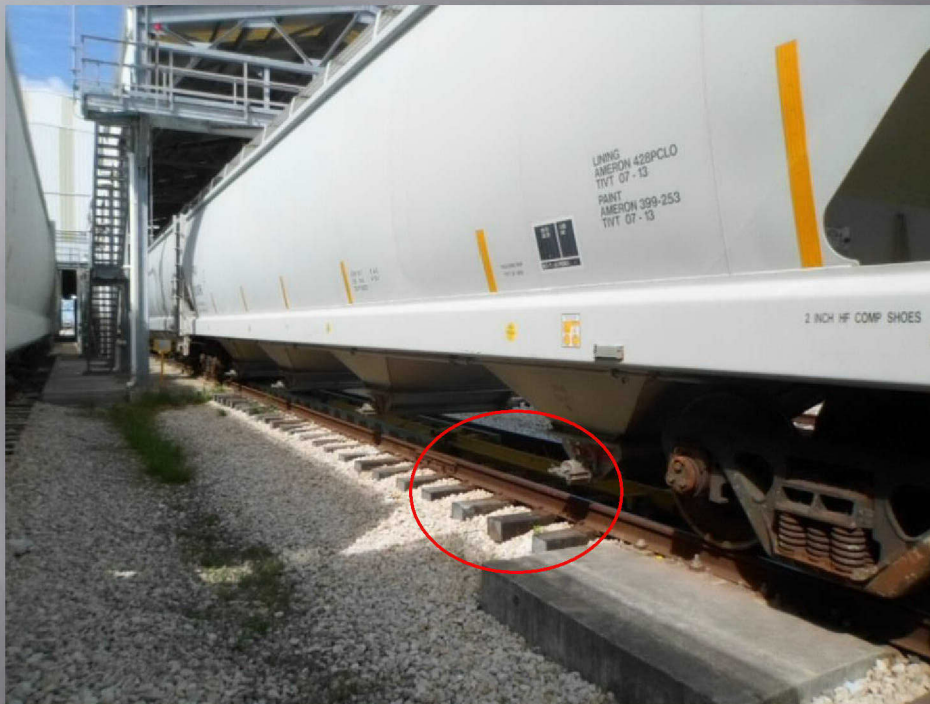
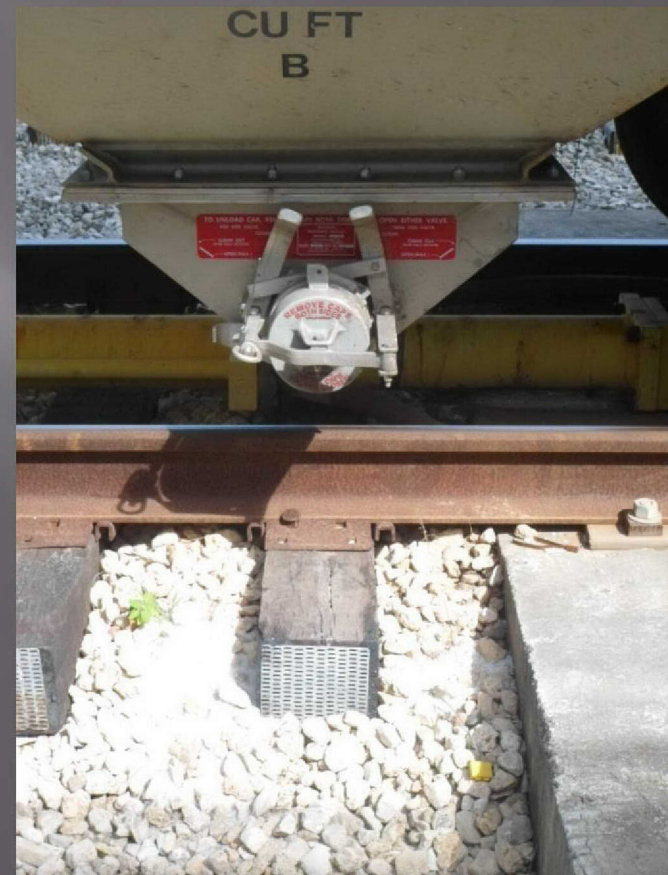
PE2/PP2 RAIL LOADING AREA

BELOW THE HATCH, PELLETS ARE VISIBLE ON THE WHITE ROCK. NEXT PHOTO PROVIDES CLOSER IMAGE.

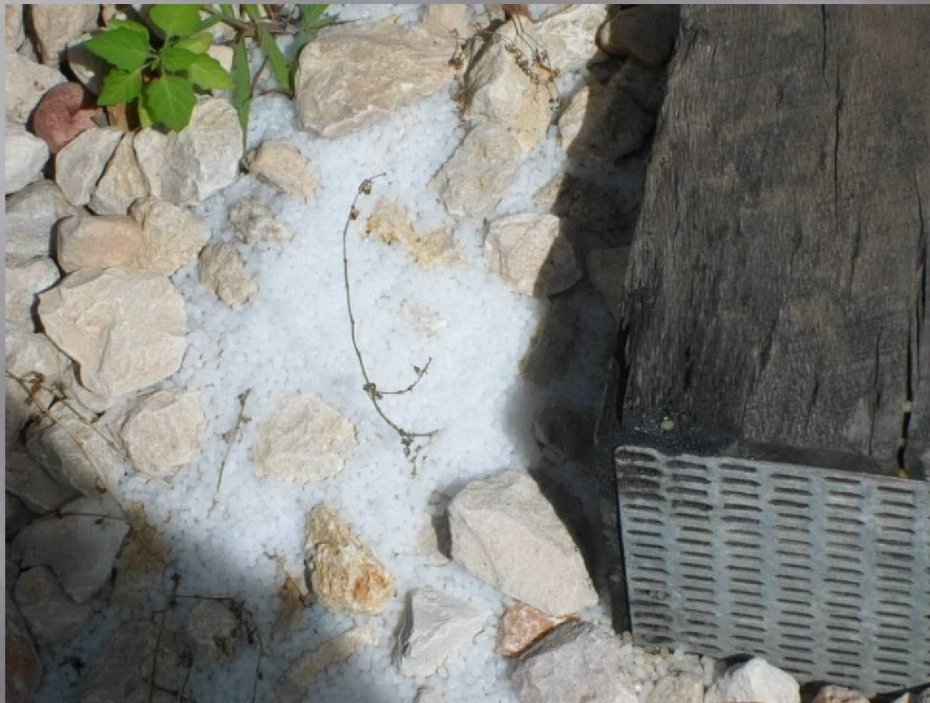
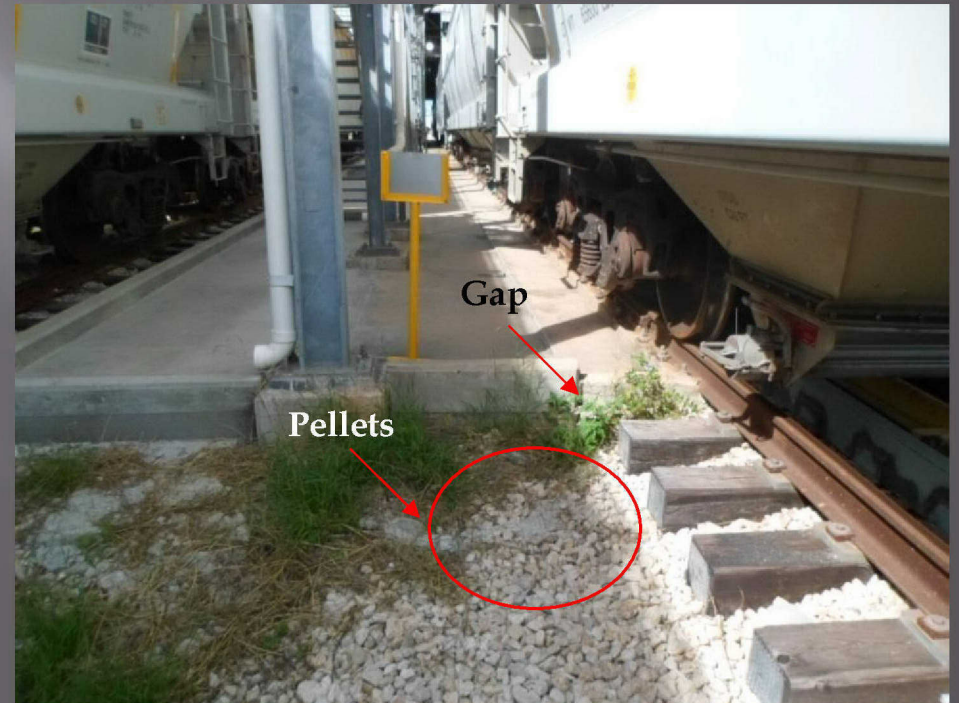
PE2/PP2 RAIL LOADING AREA

CLOSER IMAGE OF PREVIOUS PHOTO.

IMMEDIATELY SOUTH OF THE PAVEMENT, PELLETS ARE OBSERVED IN THE WHITE ROCK. FURTHER OBSERVATIONS PROVIDES THAT THERE IS A GAP IN THE CONTAINMENT WALL.

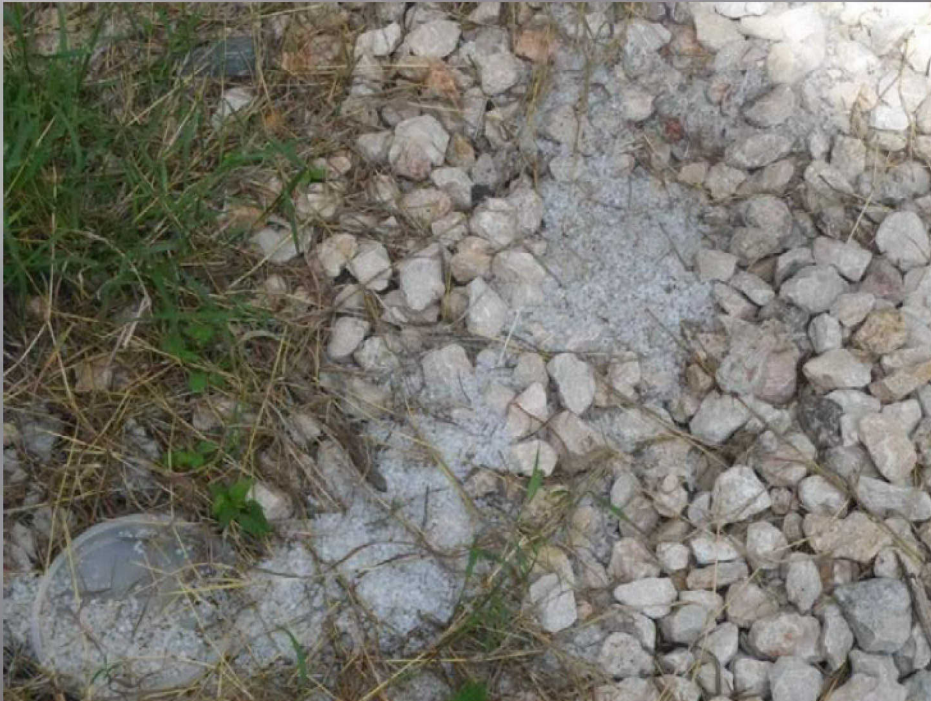
PE2/PP2 RAIL LOADING AREA

CLOSER IMAGE OF PELLETS SOUTH OF PAVEMENT.

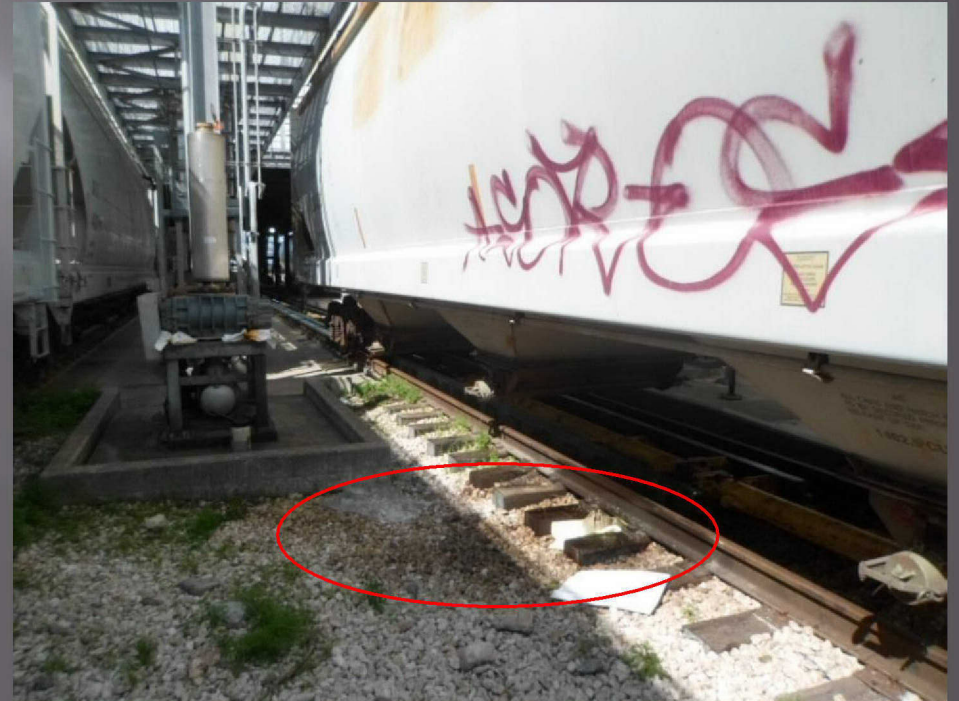
THIS AREA OF THE RAIL LINE HAS OIL THAT IS VISIBLE ON TRACKS ON BALLAST. CLEANUP EFFORTS HAVE BEGUN BUT NOT COMPLETED.

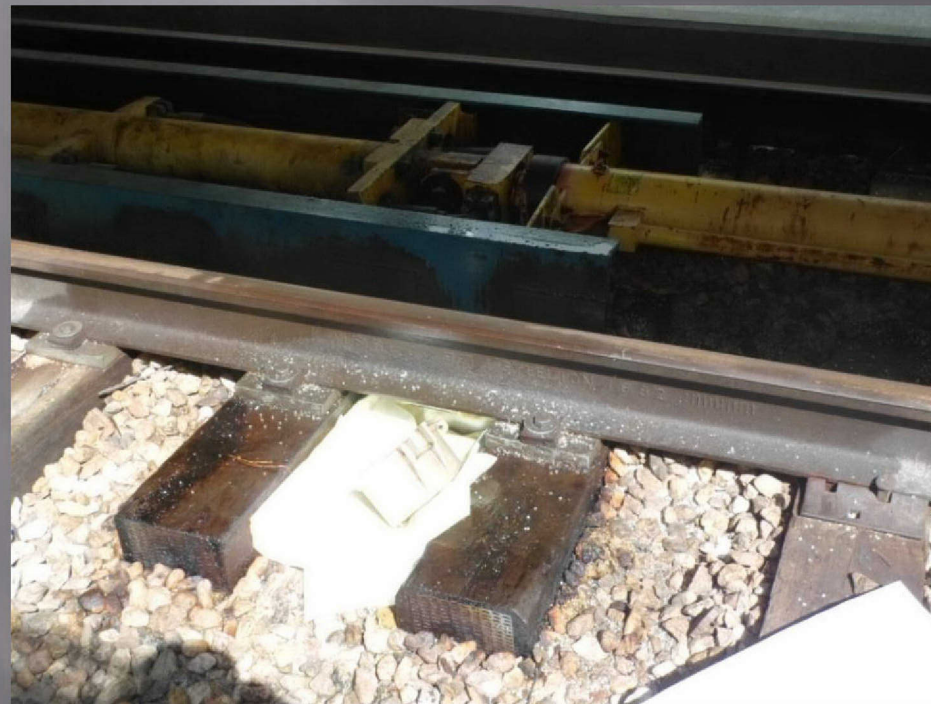
PE2/PP2 RAIL LOADING AREA

CLOSER IMAGE OF LEAK.

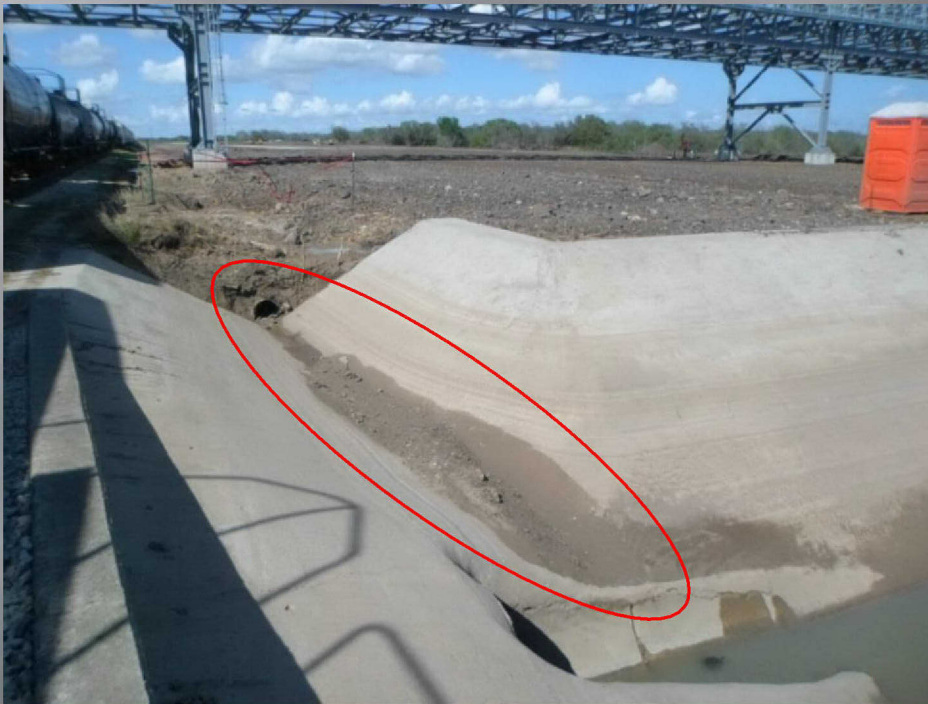
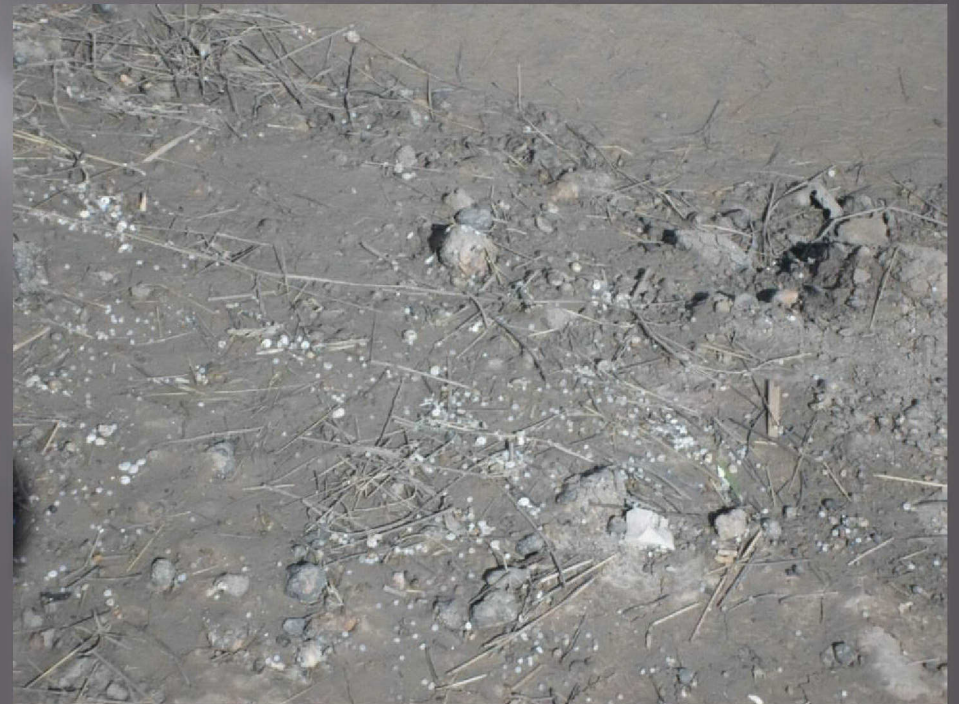
STORM WATER OUTFALL 009

UPSTREAM OF OUTFALL 009, PELLETS ARE OBSERVED IMMEDIATELY PASTE A CULVERT. THE SECOND PHOTO PROVIDES CLOSER IMAGE OF PELLETS.

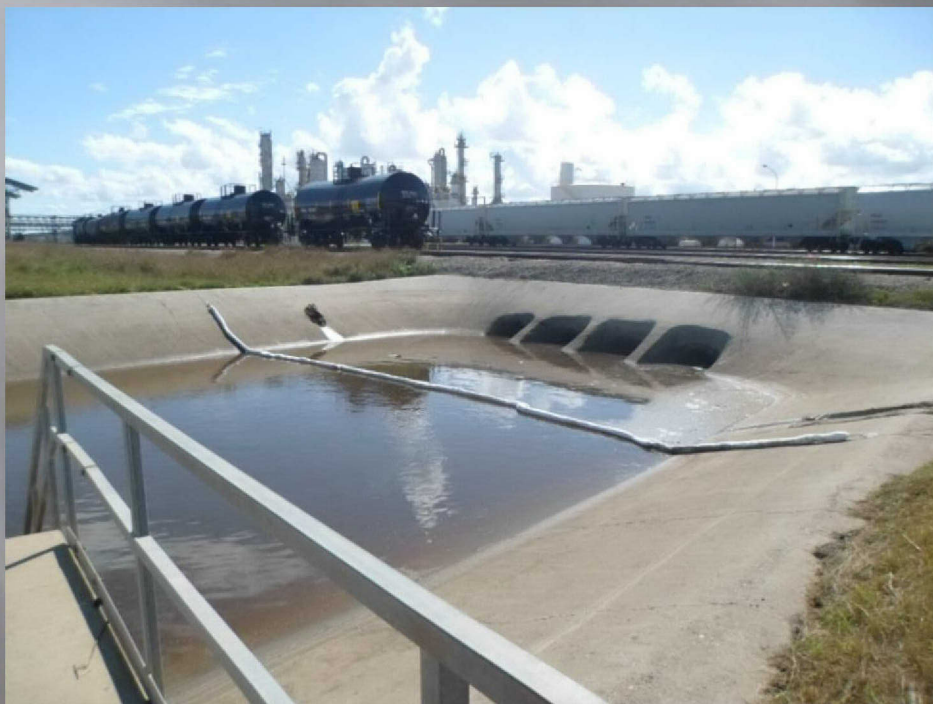
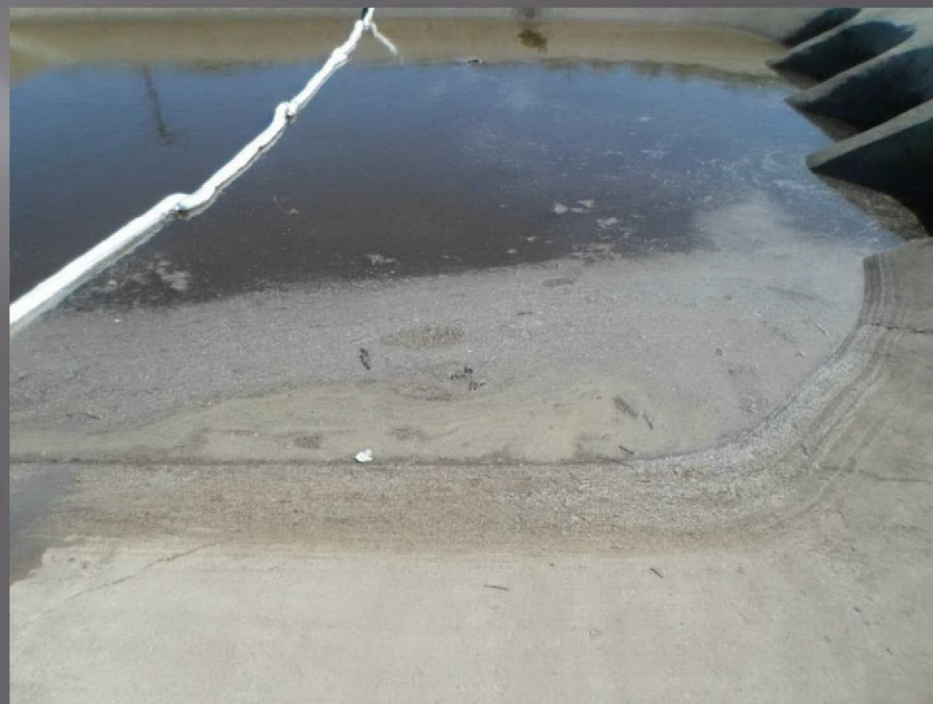
STORMWATER OUTFALL 008

UPSTREAM OF THE CONTAINMENT BOOM PELLETS HAVE ACCUMULATED . SECOND PHOTO PROVIDES CLOSER IMAGE OF PELLETS.

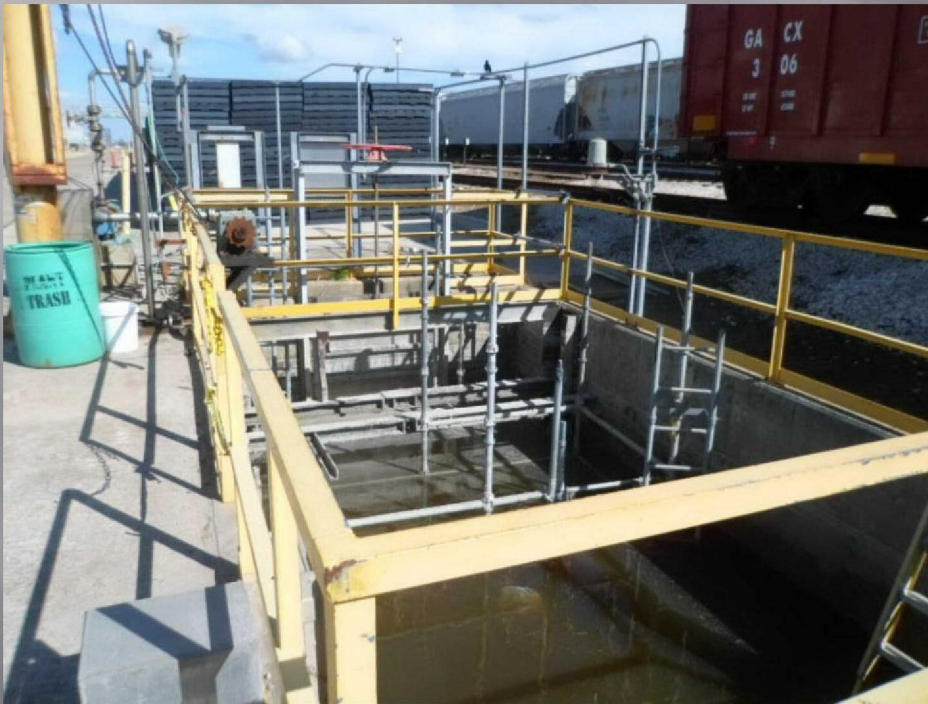
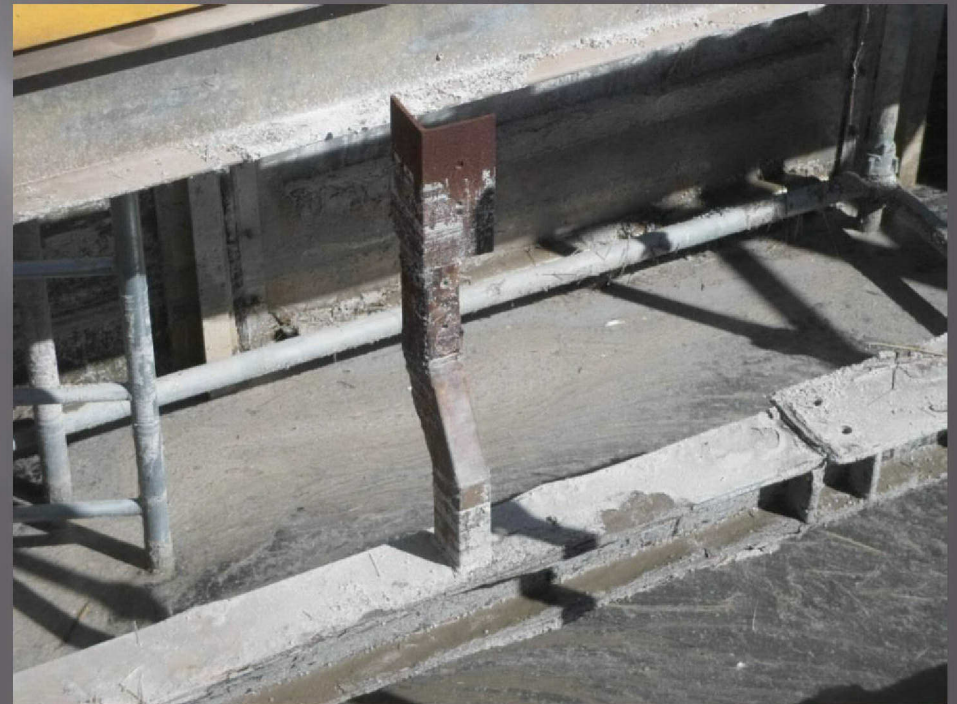
PET/PP1 BAGGING SHIPPING AREA

PELLETS AND POWDER HAVE ACCUMULATED IN THE SUMP WHERE THE WEIR WAS. NO WORK IS BEING CONDUCTED IN THIS AREA. THE NEXT PHOTO SHOWS POWDER AND PELLETS THAT HAVE STUCK TO STRUCTURE.

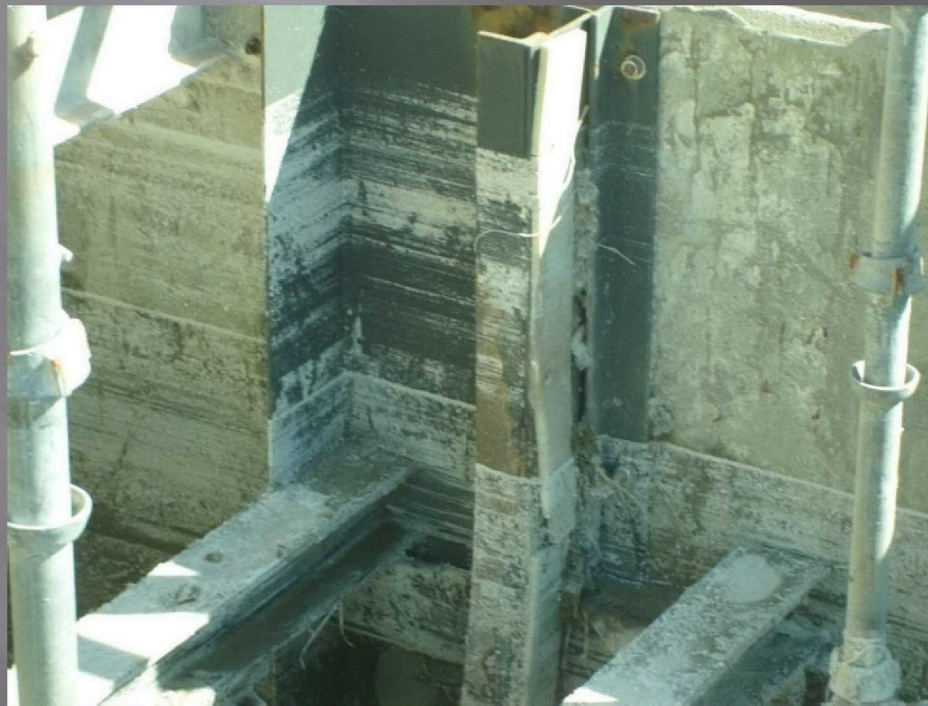
PET/PP1 BAGGING SHIPPING AREA

IMAGE OF POWDER AND PELLETS ON STRUCTURE.

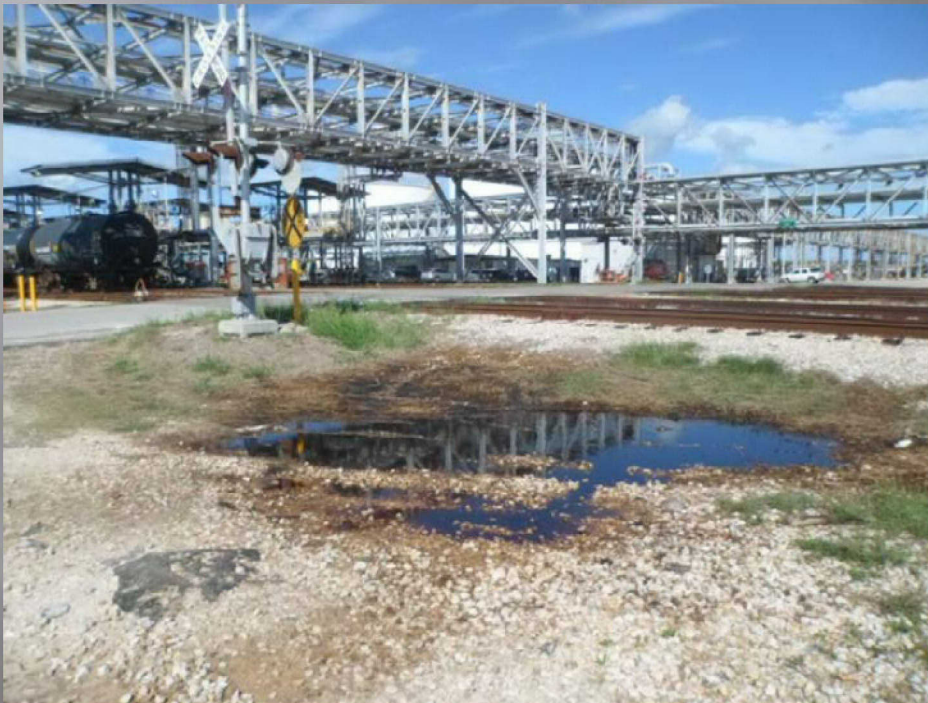
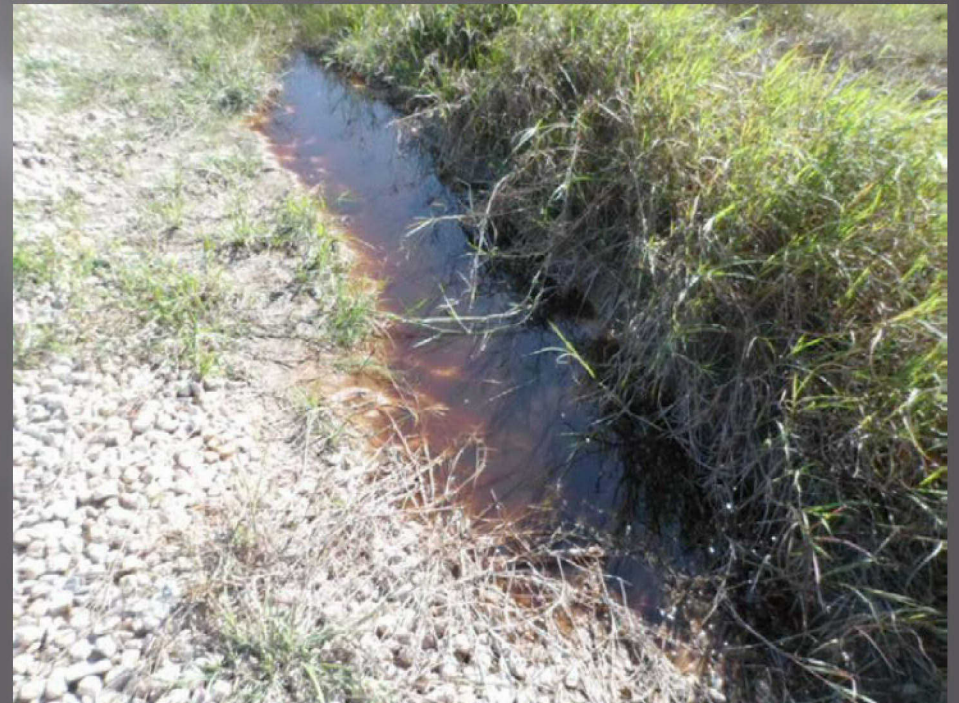
INLAND TRAFFIC

CAUSTIC IS VISIBLE IN THE WHITE ROCK WEST OF THE TRACKS AT INLAND TRAFFIC. PER DISCUSSION WITH TRAFFIC PERSONNEL A CLEAN UP EFFORTS WILL BEGIN SOON.
