FORMOSA PLASTICS CORPORATION, TEXAS

Traffic Pellet/Powder Observations

Gate 2 Road, Railcar Repair Shop
Area, PE2/PP2 Railcar Loading

Conducted: February 26, 2016

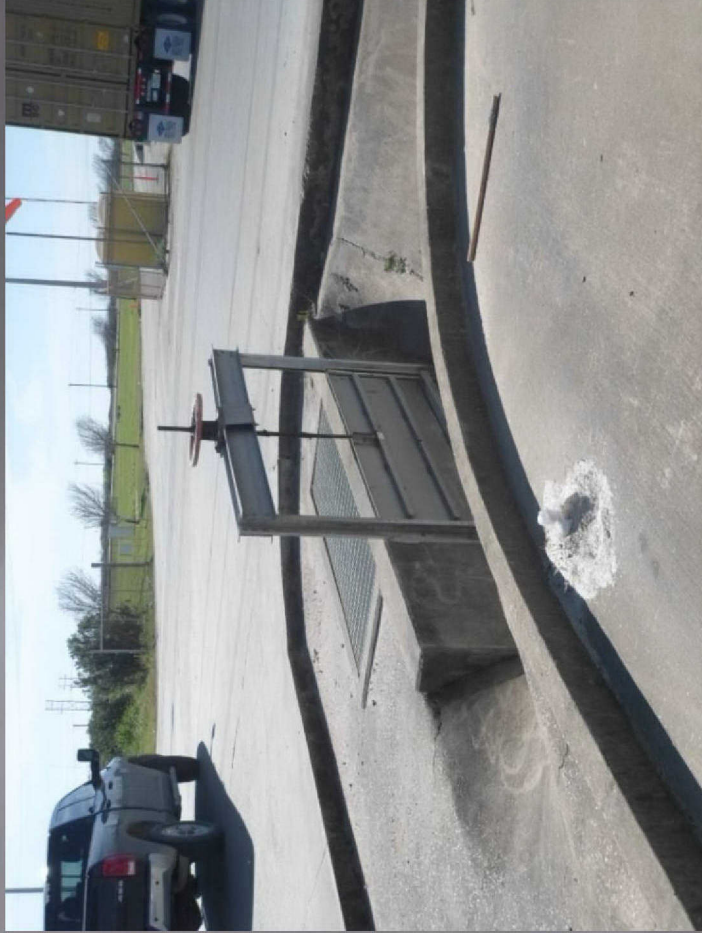
LLDPE WAREHOUSE

SOUTHWEST CORNER OF LLDPE WAREHOUSE, A PILE OF PELLETS IS VISIBLE ON THE PAVEMENT. THIS WAS ALSO OBSERVED ON 2.22.16 AUDIT.

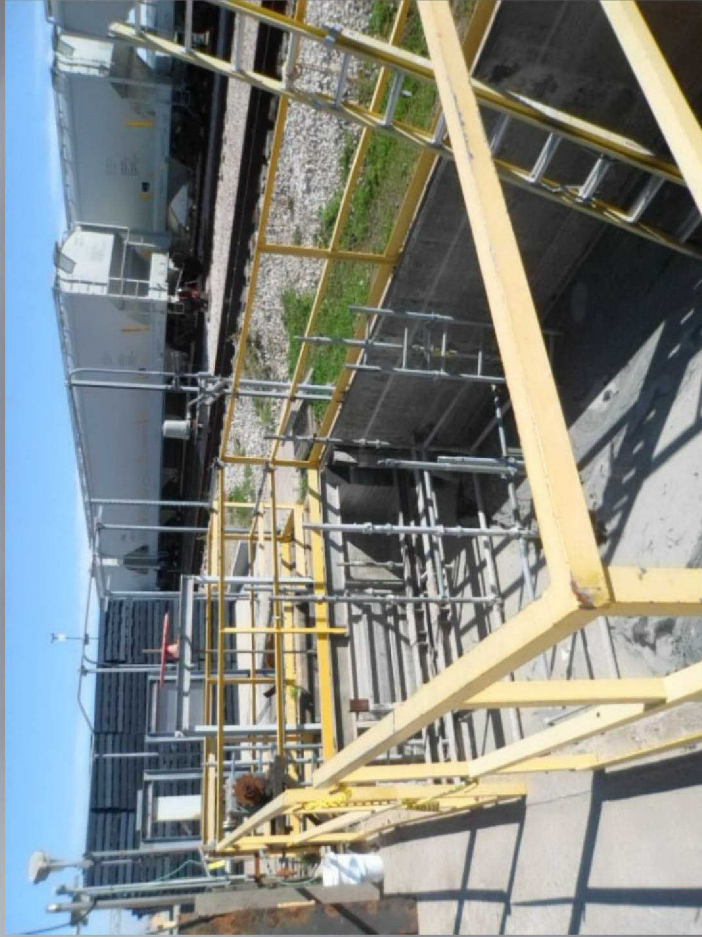
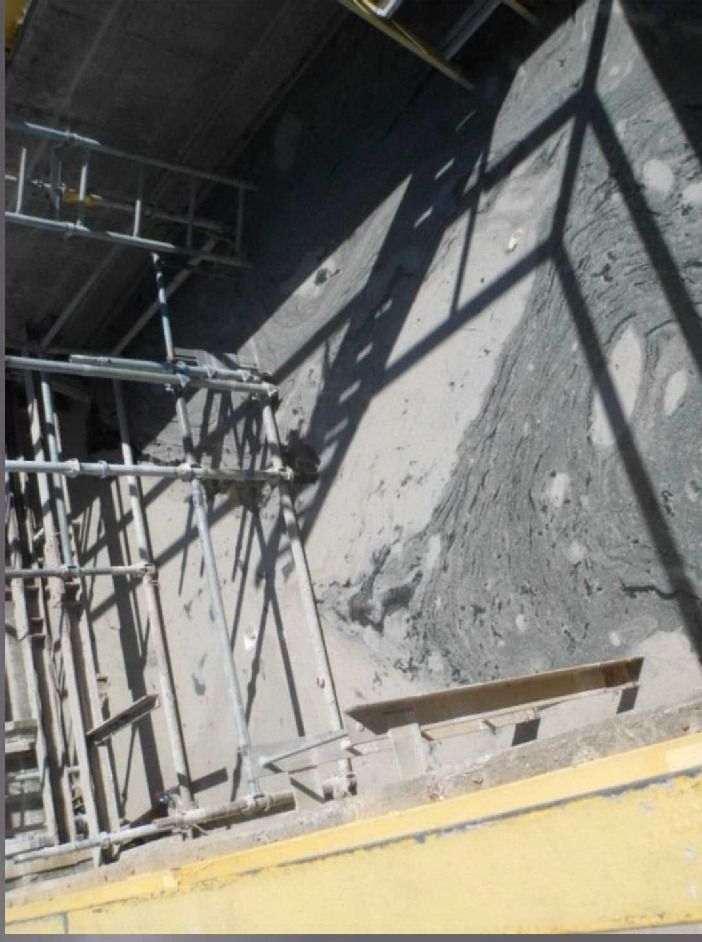
PEI/PP1 BAGGING SHIPPING AREA

WORK STILL CONTINUES ON THE WEIR. PELLETS ARE VISIBLE FLOATING ON THE WATER AS WELL AS OTHER DEBRIS.

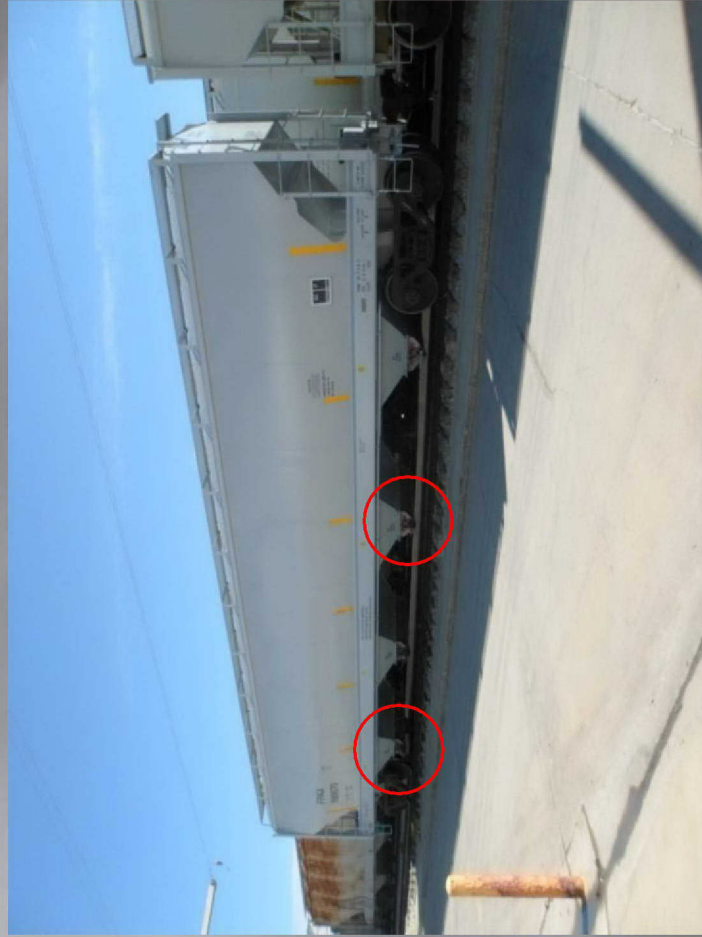
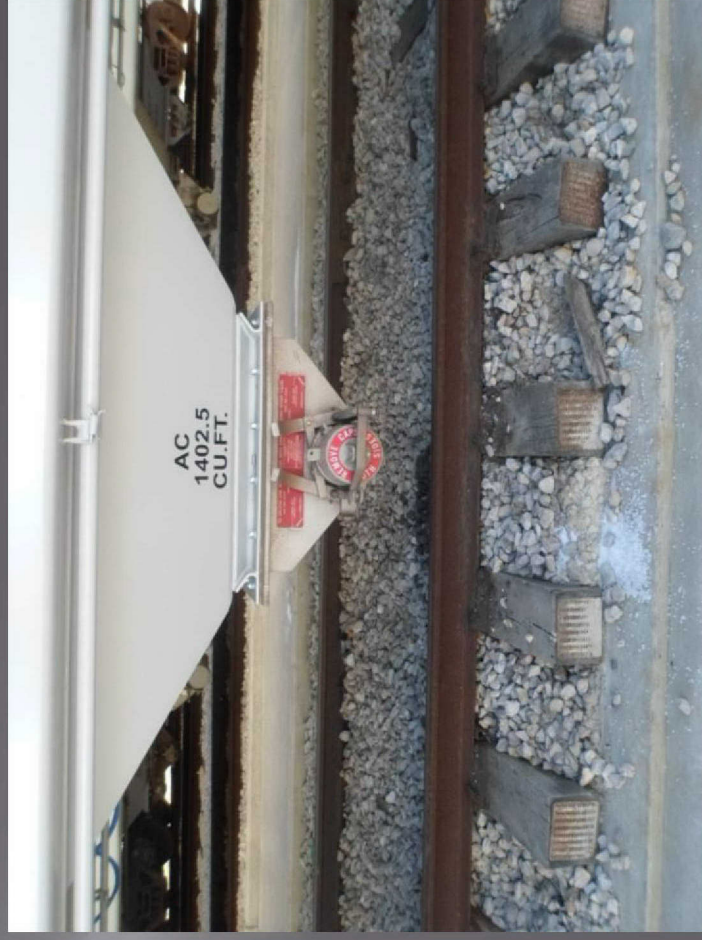
RAILCAR UNLOADING

PELLETS ARE OBSERVED ON THE GROUND JUST UNDERNEATH THE OUTLETS OF THE RAILCAR.

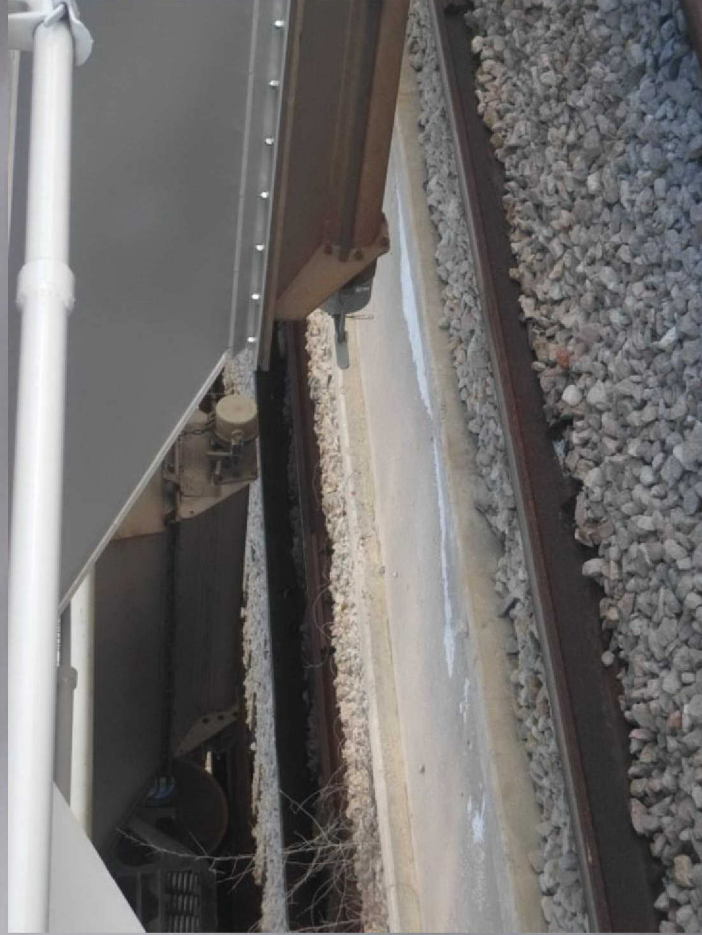
RAILCAR UNLOADING

BACKSIDE OF THE RAILCAR, PELLETS ARE OBSERVED ON THE PAVEMENT.

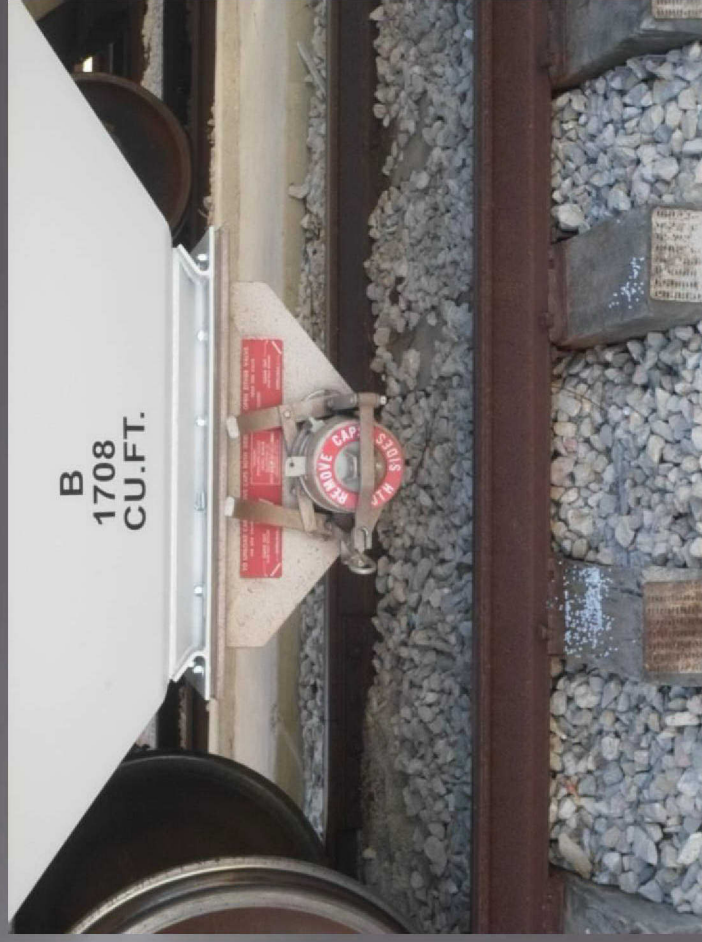
SIMILAR TO THE OTHER OUTLET FROM PREVIOUS SLIDE, PELLETS ARE OBSERVED ON THE GROUND.

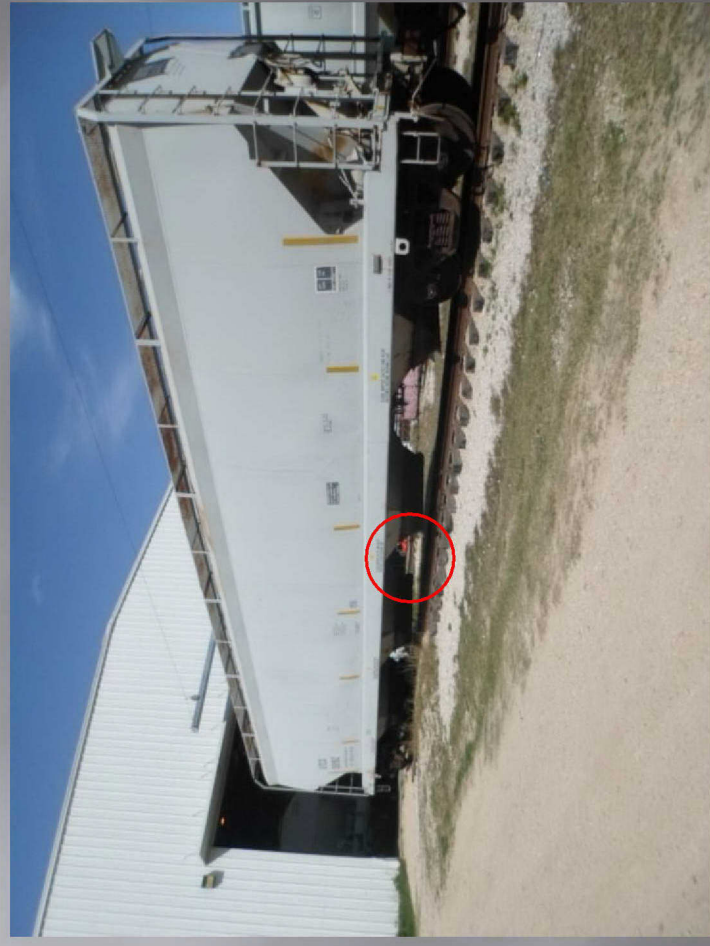
RAILCAR REPAIR SHOP

CLOSER IMAGE OF PELLETS ON THE GROUND. NEXT PHOTO SHOWS CLOSER IMAGE OF PELLETS ON WHITE ROCK.

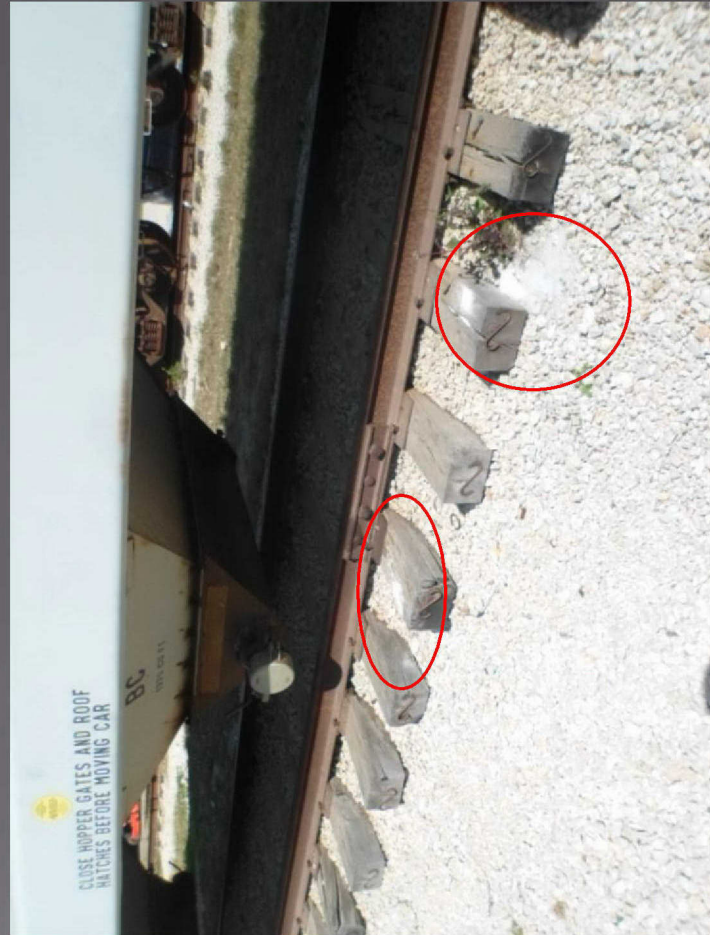
RAILCAR JUST SOUTH OF THE RAILCAR REPAIR SHOP, PELLETS ARE OBSERVED ALONG THE TRACKS.

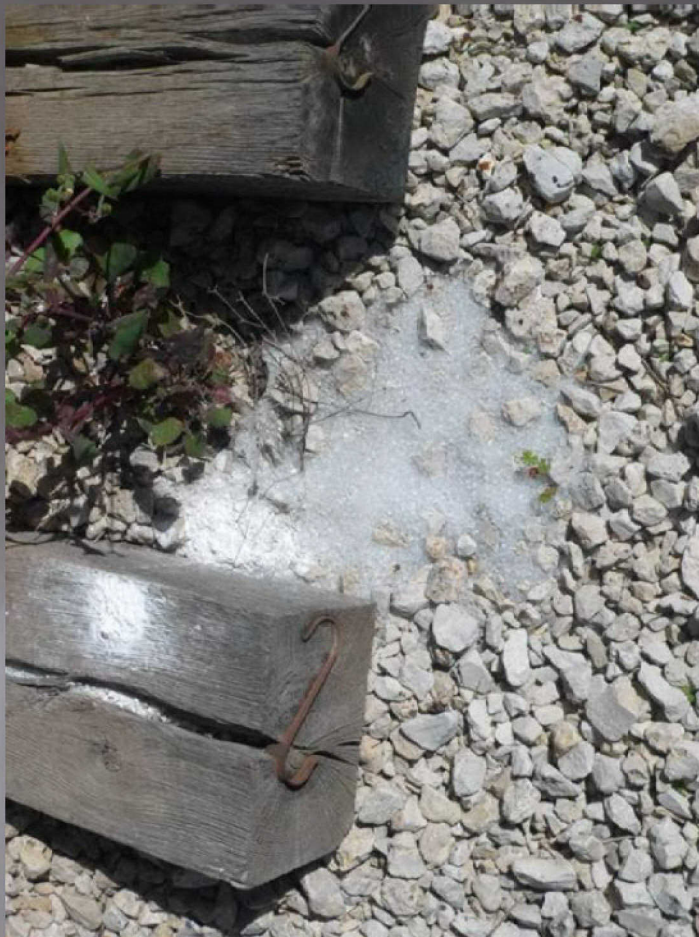
RAILCAR REPAIR SHOP

CLOSER IMAGE OF PELLETS.

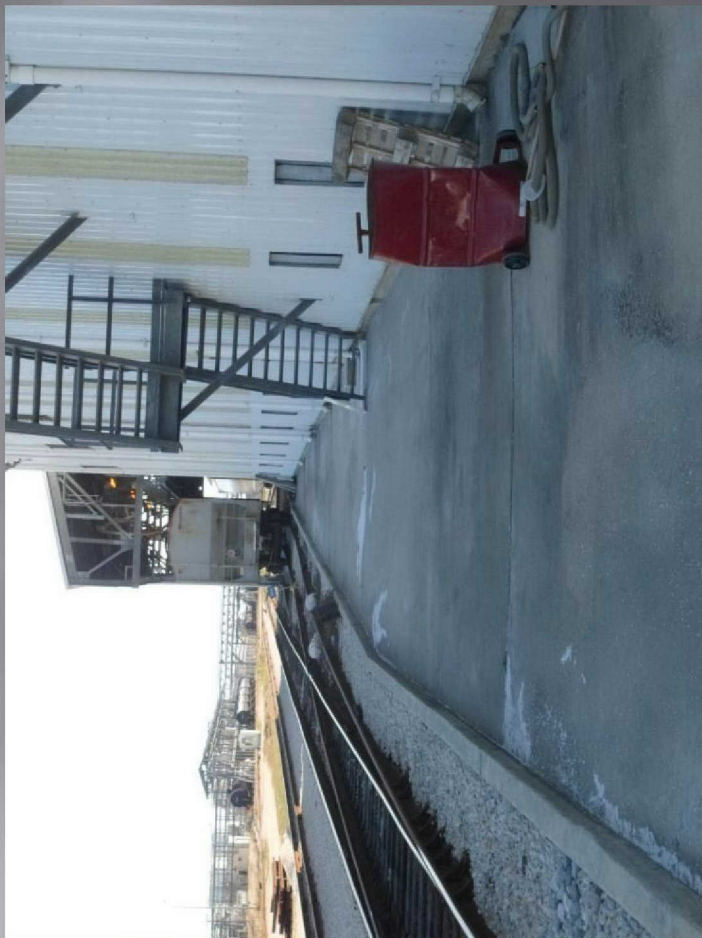
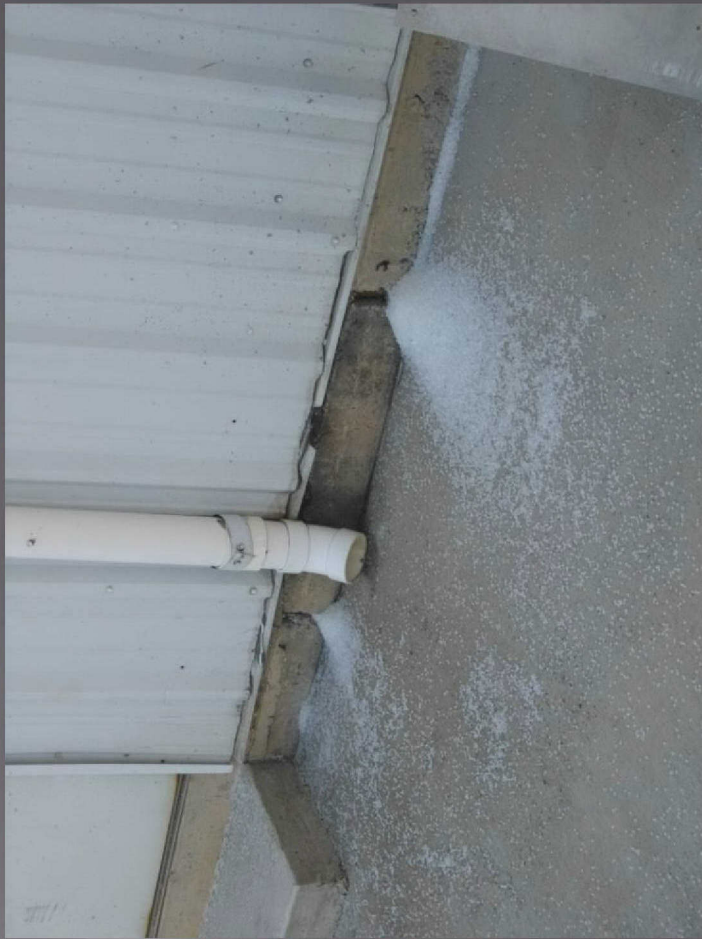
PE2/PP2 RAILCAR LOADING

EAST SIDE OF THE RAILCAR LOADING AREA, PELLETS ARE VISIBLE ALL OVER THE PAVEMENT. PELLETS ARE ALSO LEAKING THRU THE CRACKS OF THE CONCRETE FROM THE LOADING AREA.

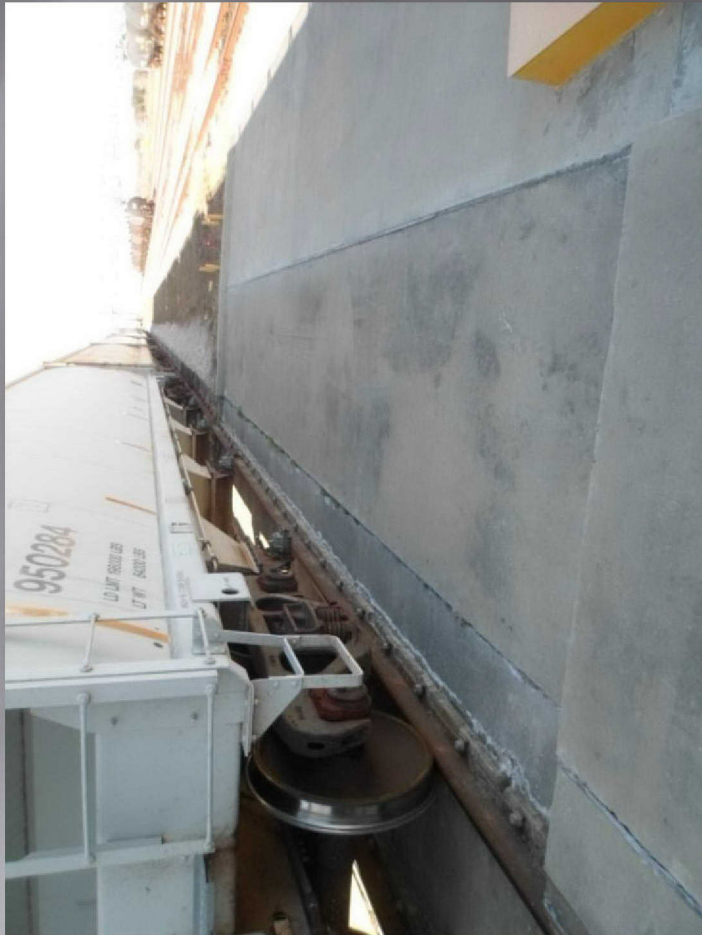
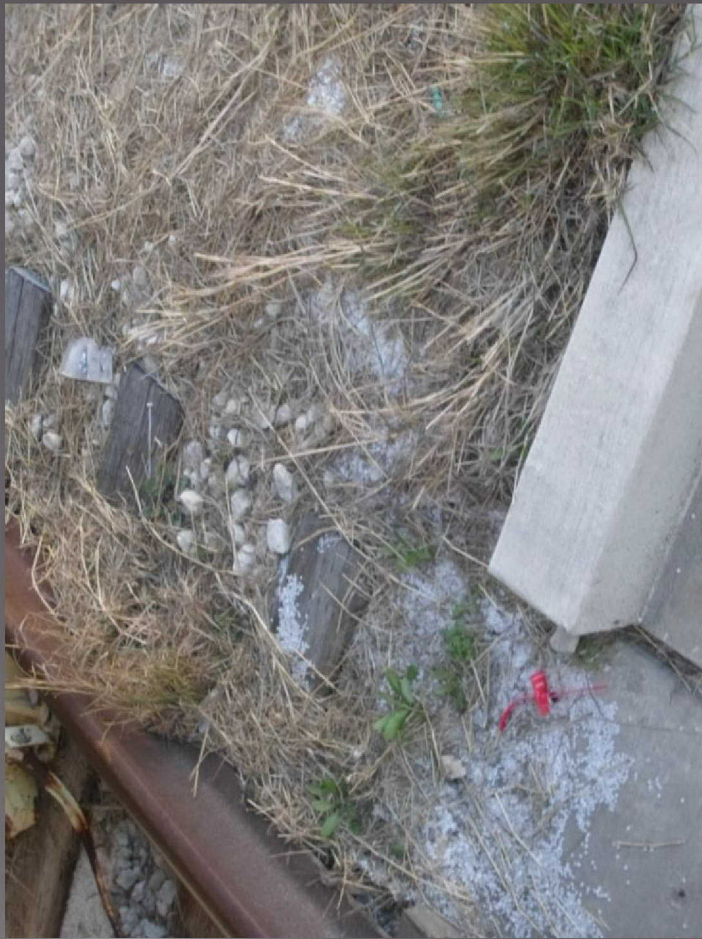
PE2/PP2 RAILCAR LOADING

PELLETS ARE VISIBLE ALONG THE RAIL LINE, ULTIMATELY PELLETS ARE VISIBLE JUST PAST THE PAVEMENT ON THE GROUND.

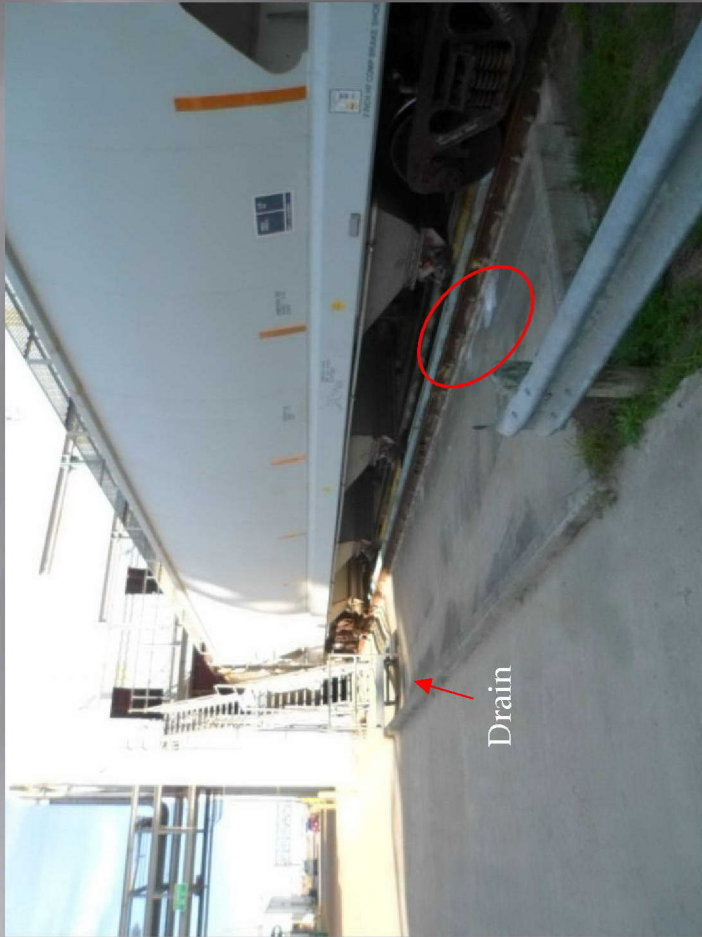
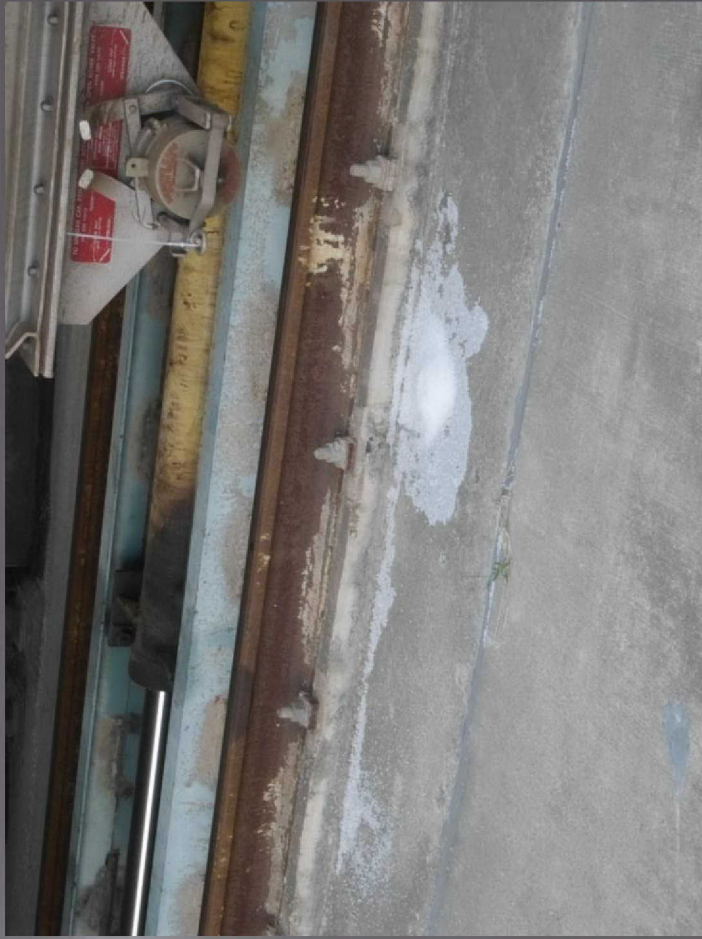
PE2/PP2 RAILCAR LOADING

SOUTH OF THE RAILCAR LOADING AREA, PELLETS ARE VISIBLE ON THE PAVEMENT. THERE IS A SCREEN WHICH PROTECTS THE DRAIN, HOWEVER CLEANING EFFORTS IN THIS AREA HAVE NOT BEEN PERFORMED.

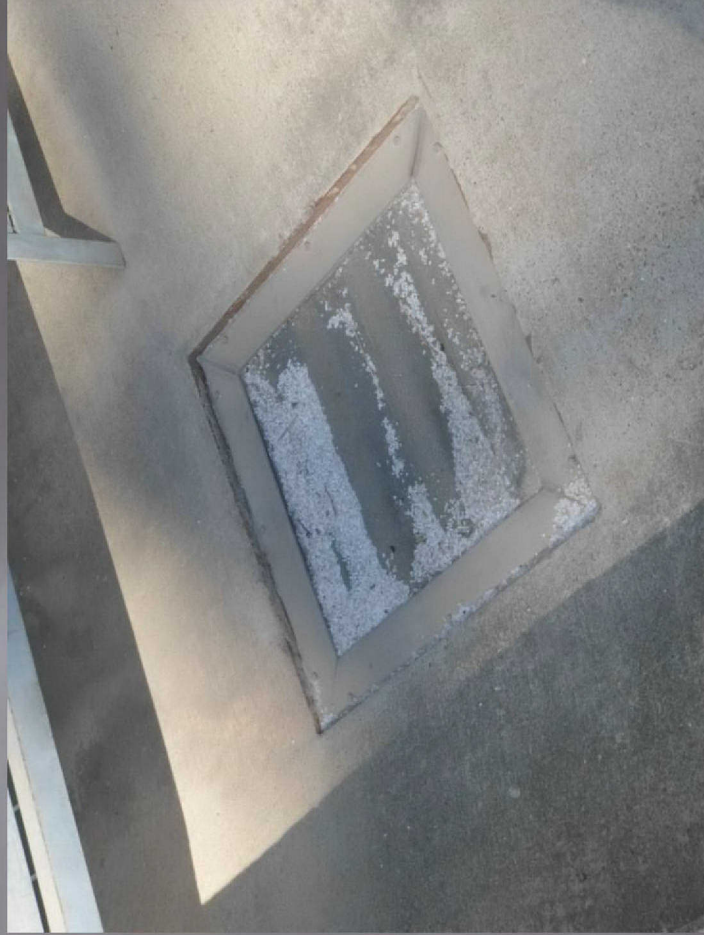
PE2/PP2 RAILCAR LOADING

CLOSER IMAGE OF DRAIN.

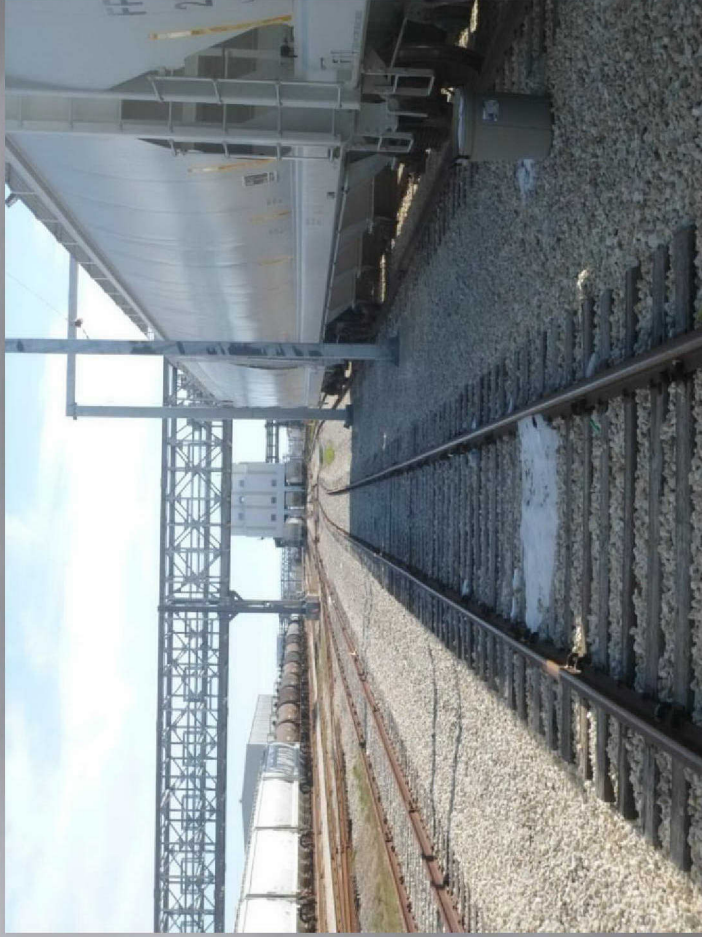
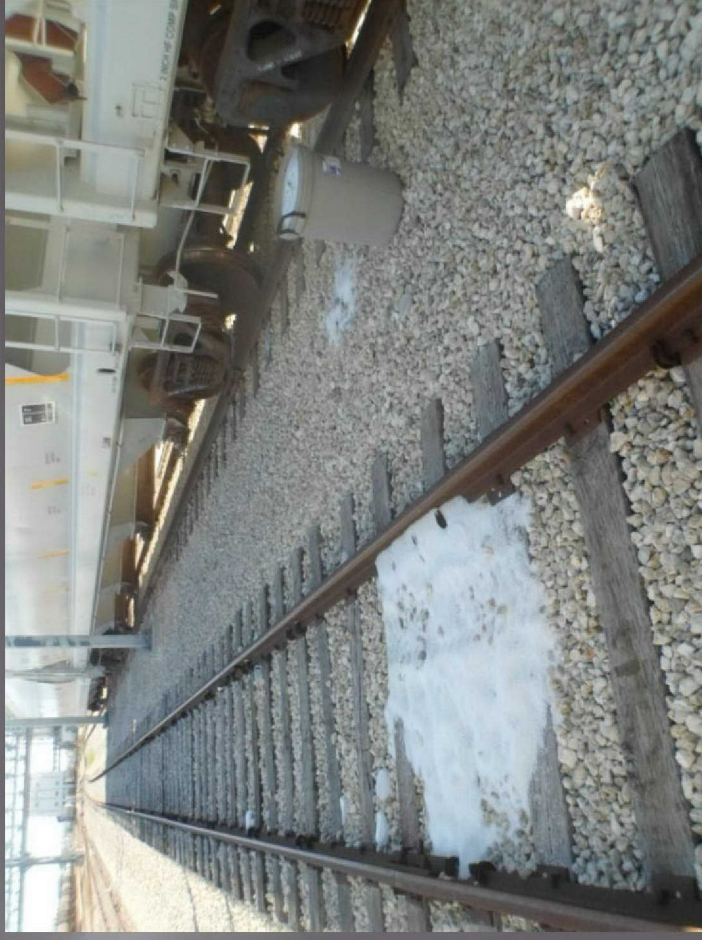
RAIL LINE

PELLETS ARE OBSERVED ON THE TRACKS AND ALSO ALONG THE RAIL CARS.

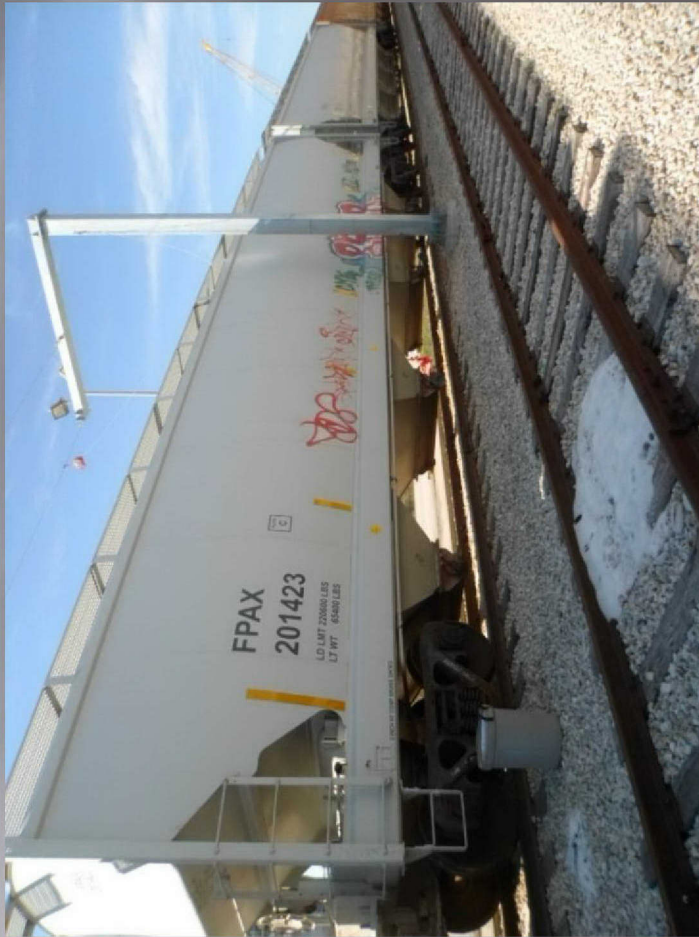
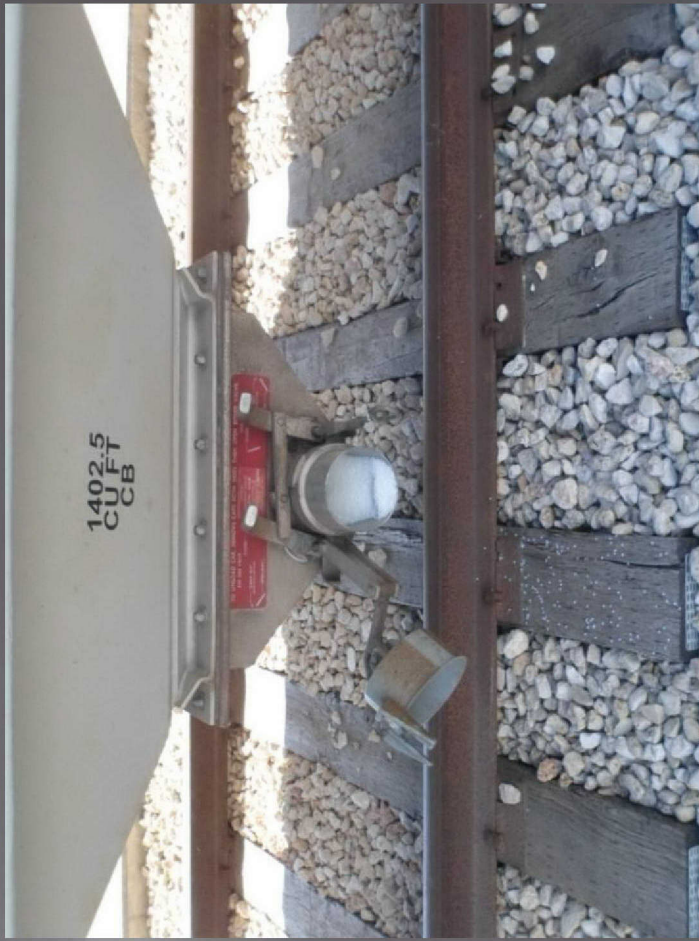
RAIL LINE

OUTLETS ON THIS RAILCAR ARE ALL OPEN, THERE ARE TWO OUTLETS WHERE PELLETS ARE VISIBLE, PELLETS HAVE SPILLED ONTO THE GROUND.

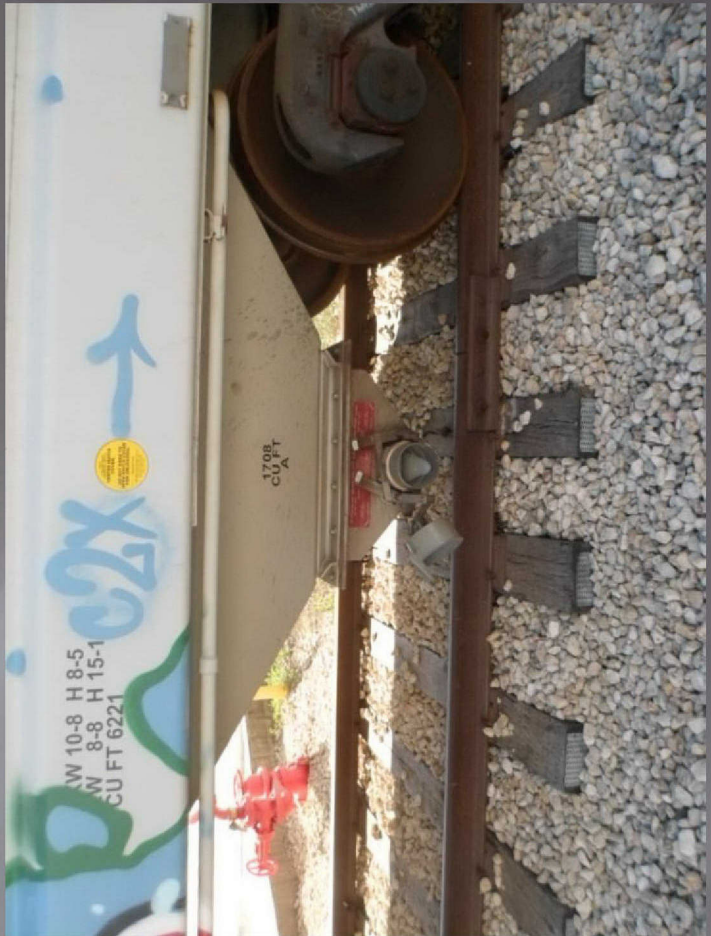
RAIL LINE

OUTLET IS OPEN, PELLETS ARE VISIBLE.
