FORMOSA PLASTICS CORPORATION, TEXAS

Traffic Pellet/Powder Observations
Gate 2 Road

Conducted: January 29, 2016

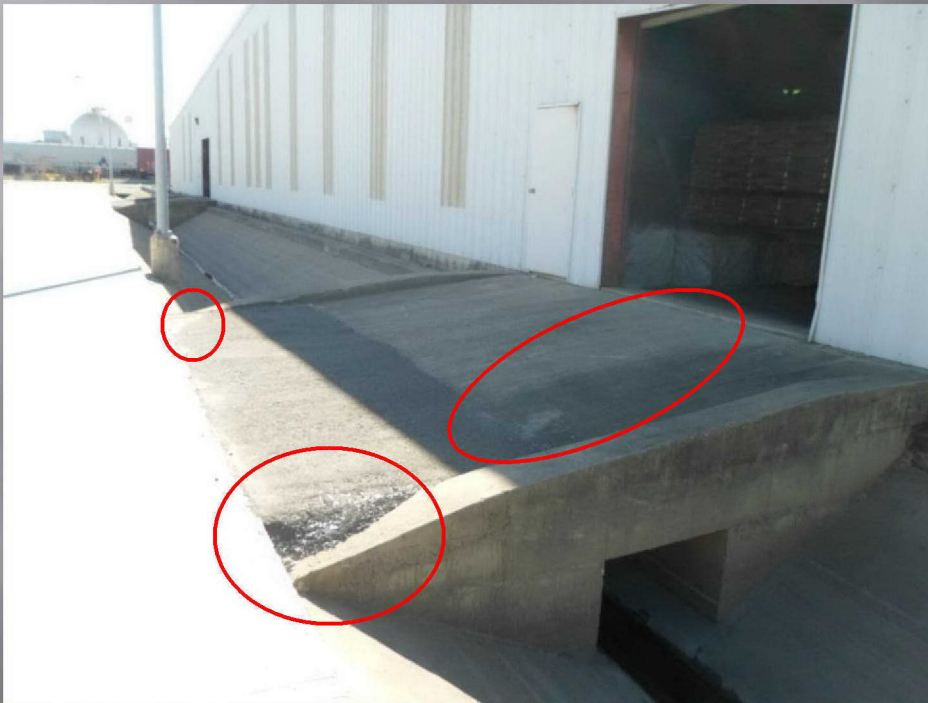
PE1/PP1 Bagging Area

FIRST ENTRANCE ON THE EAST SIDE OF BUILDING, PELLETS ARE VISIBLE ON THE PAVEMENT. CORNERS OF THIS ENTRANCE HAVE THE MOST AMOUNT OF PELLETS THAT HAVE ACCUMULATED IN THE CRACKS OF PAVEMENT.

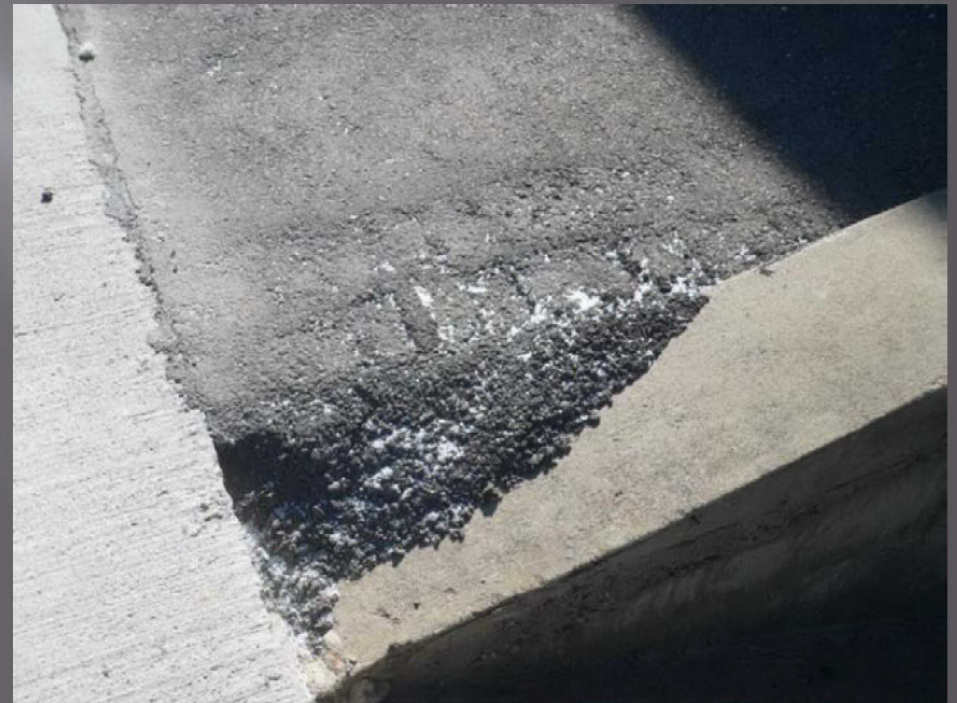
CLOSER IMAGE OF THE CORNER OF THE ENTRANCE.

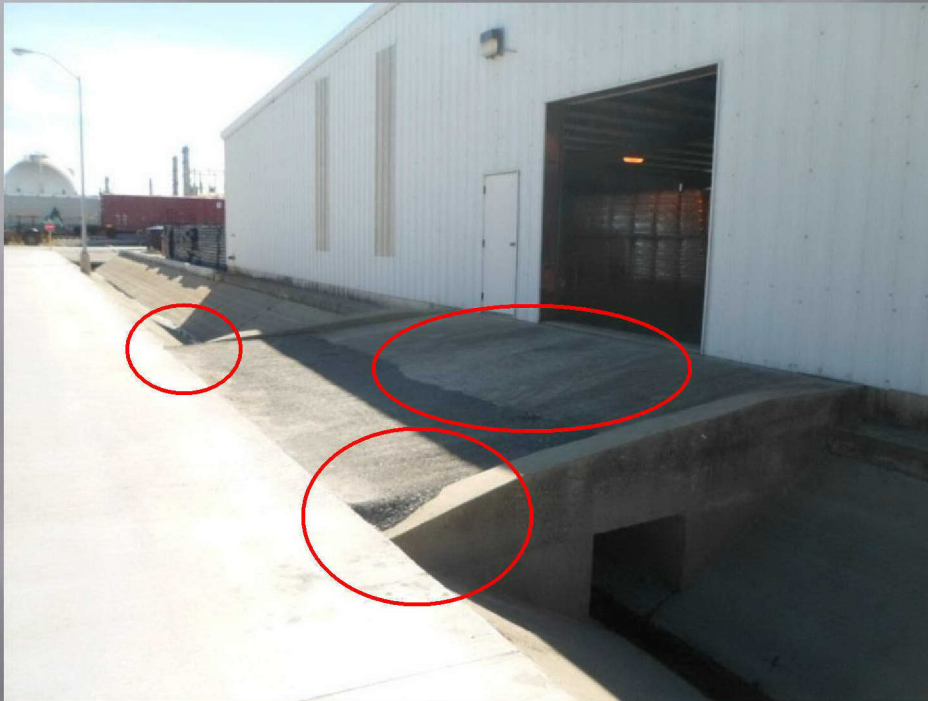
PE1/PP1 Bagging Area

SECOND ENTRANCE ON THE EAST SIDE, IS THE SAME AS THE FIRST ENTRANCE. PELLETS ARE OBSERVED ON THE PAVEMENT.

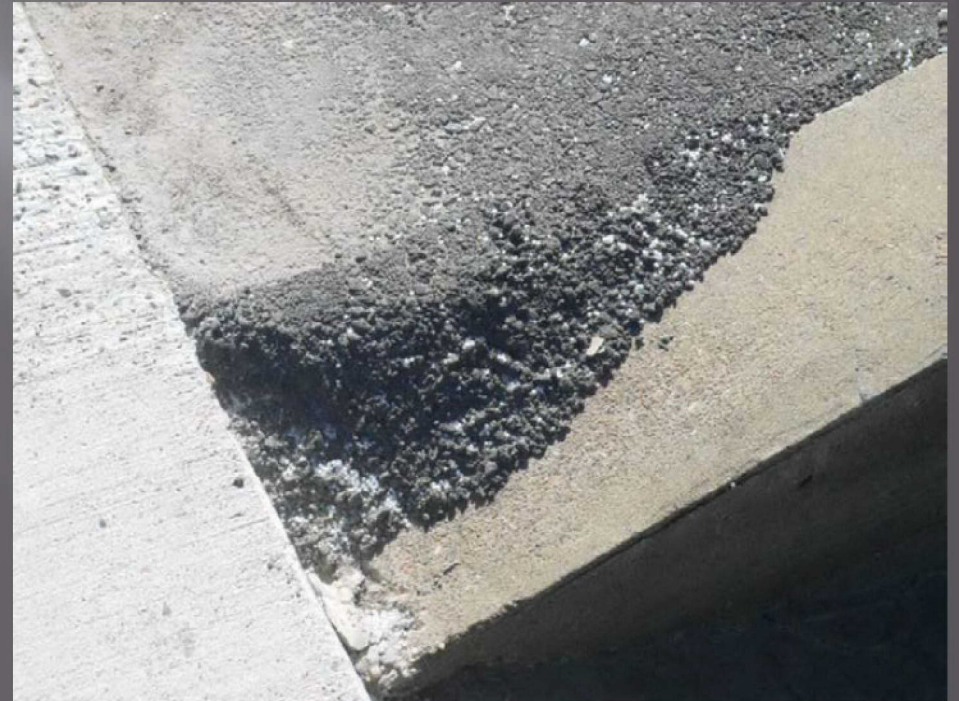
CLOSER IMAGE OF THE PAVEMENT.

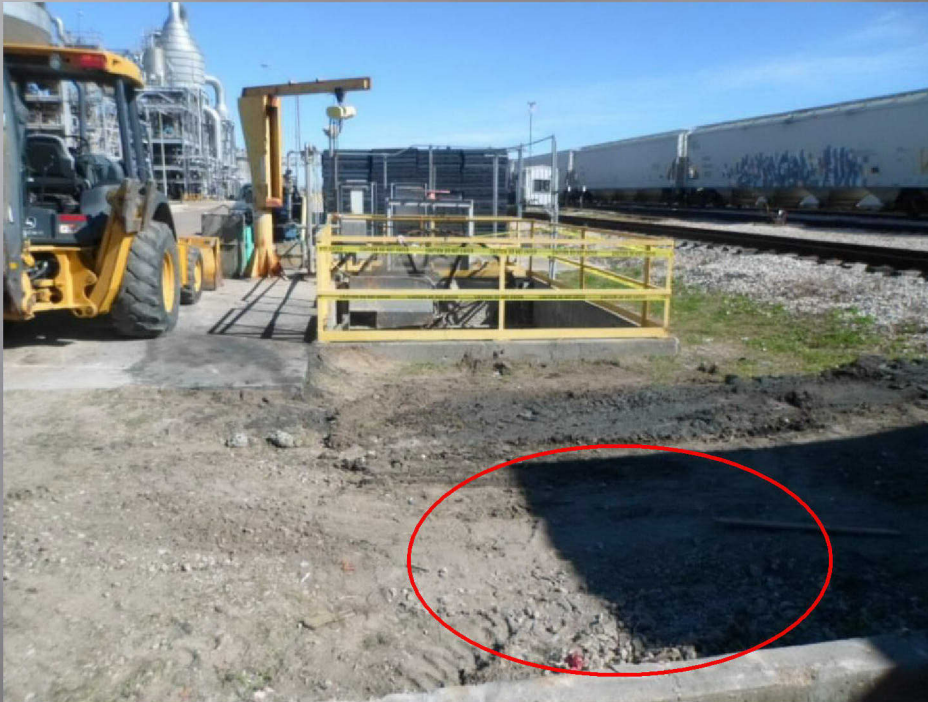
PE1/PP1 Bagging Area

IN THE ARE IN FRONT OF THE WEIR, PELLETS ARE OBSERVED IN A PILE OF ROCKS. NEXT PHOTOS SHOW CLOSER IMAGES.

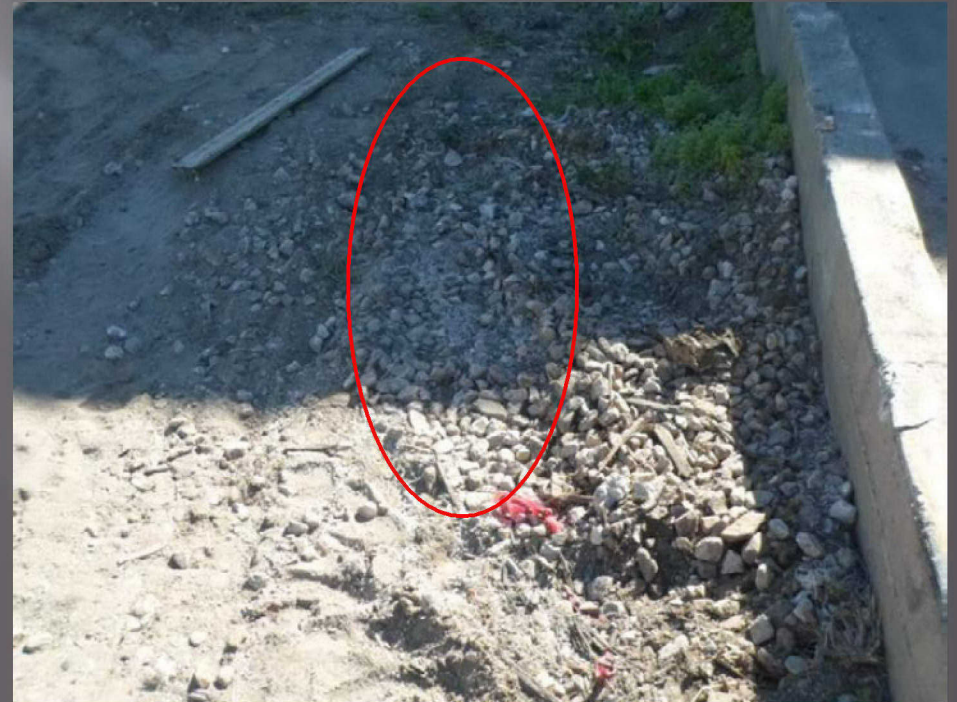
VIEW OF PELLETS AND ROCKS.

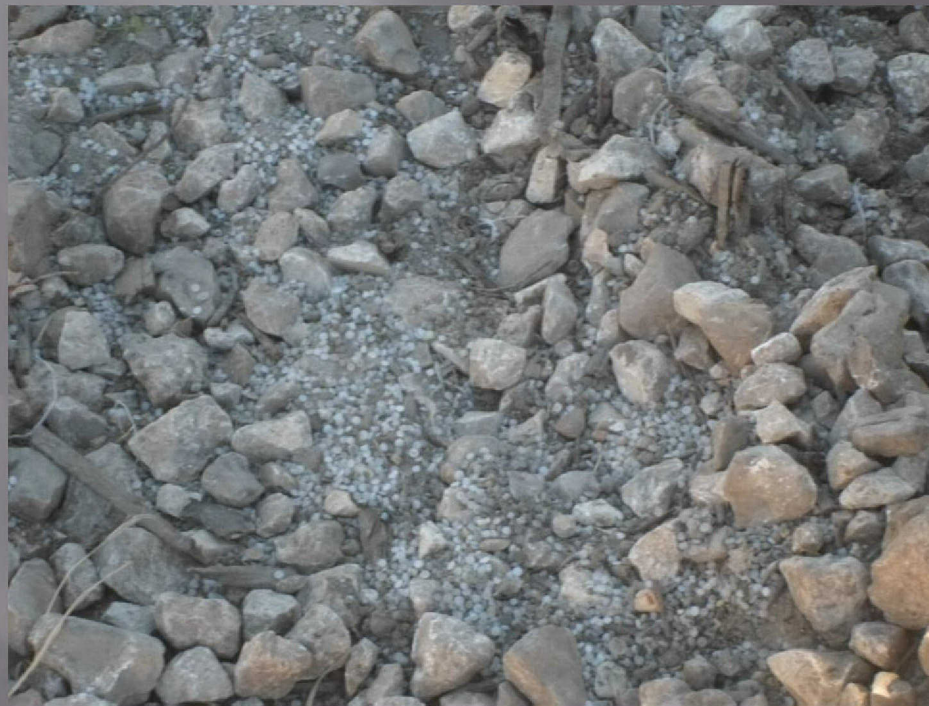
PE1/PP1 Bagging Area

CLOSER IMAGE OF PELLETS.

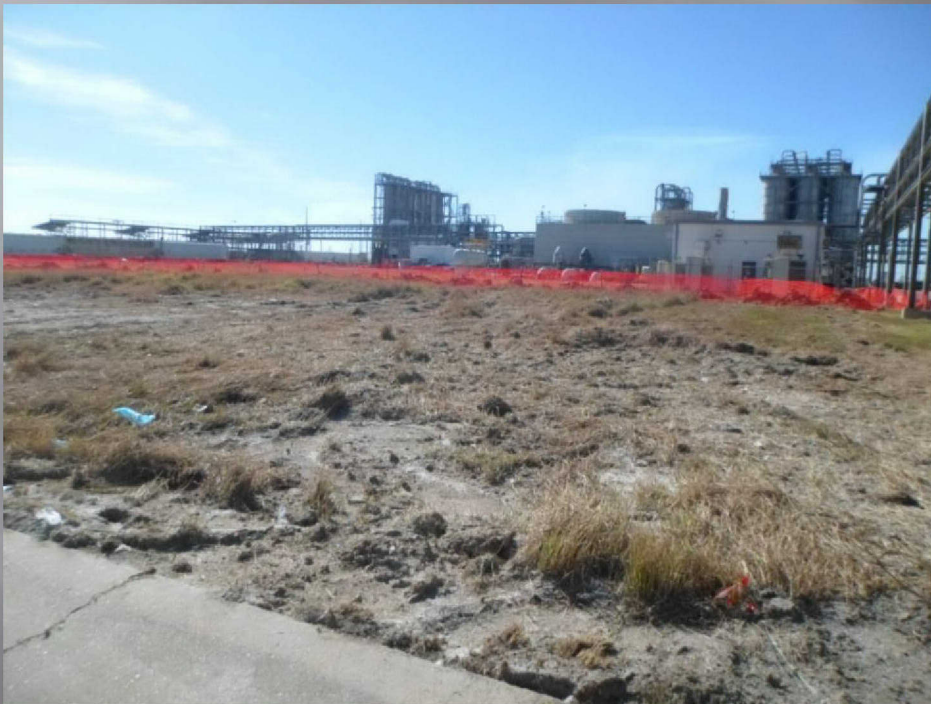
PP 2

PELLETS ARE SCATTERED THROUGHOUT THIS AREA.
NEXT IMAGES SHOW A FEW AREAS CLOSE TO THE
CONCRETE DITCH.

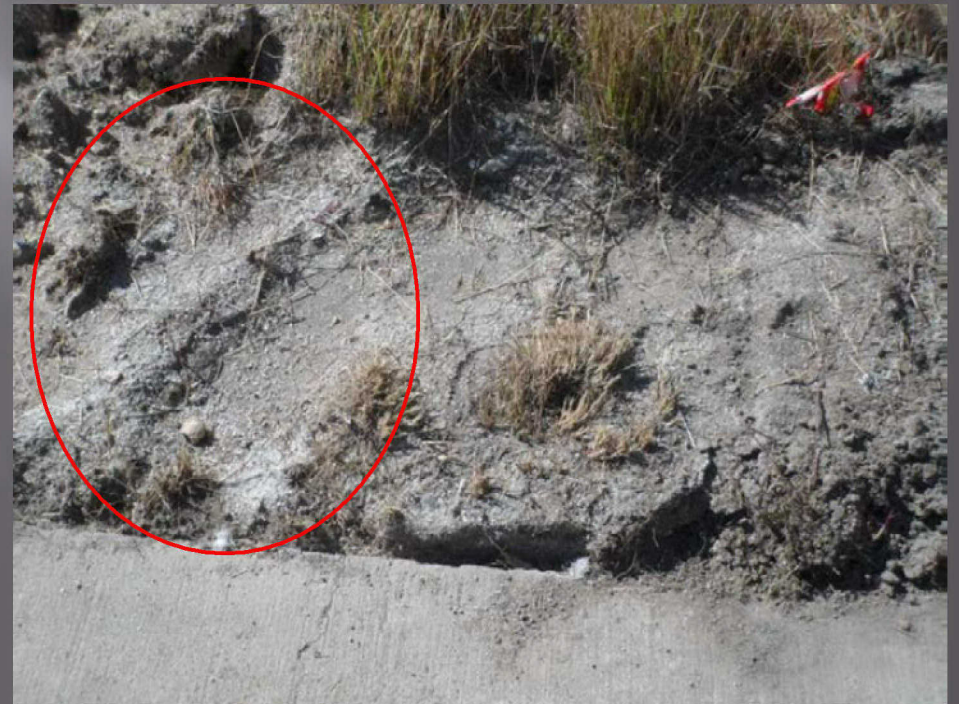
CLOSER IMAGE OF PELLETS.

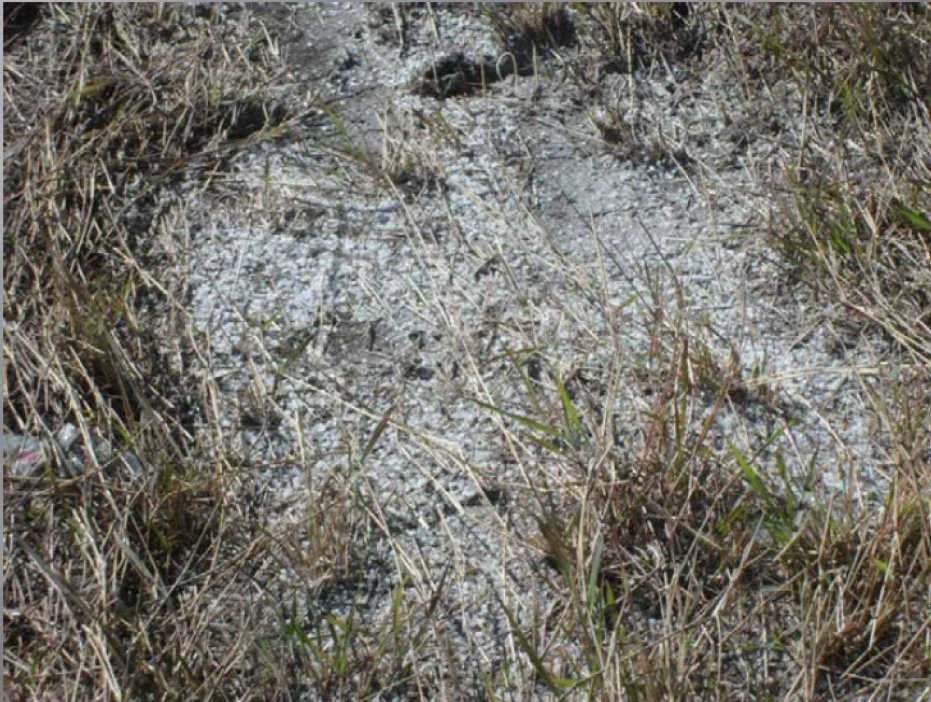
PP 2

PELLETS OBSERVED IN GRASS AREA.

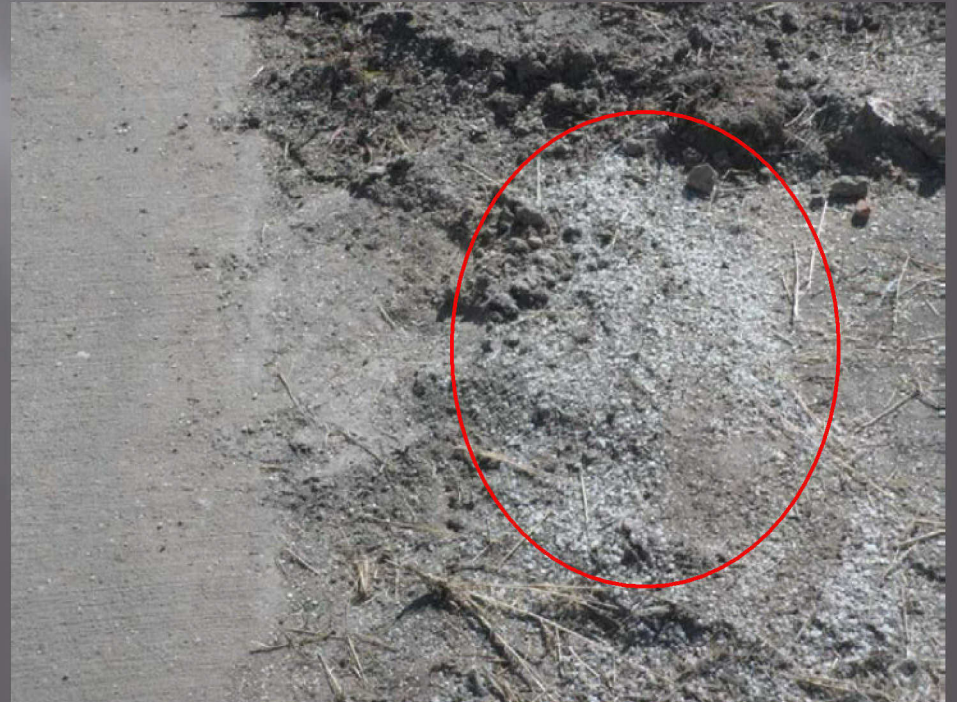
CLOSER IMAGE OF PELLETS.

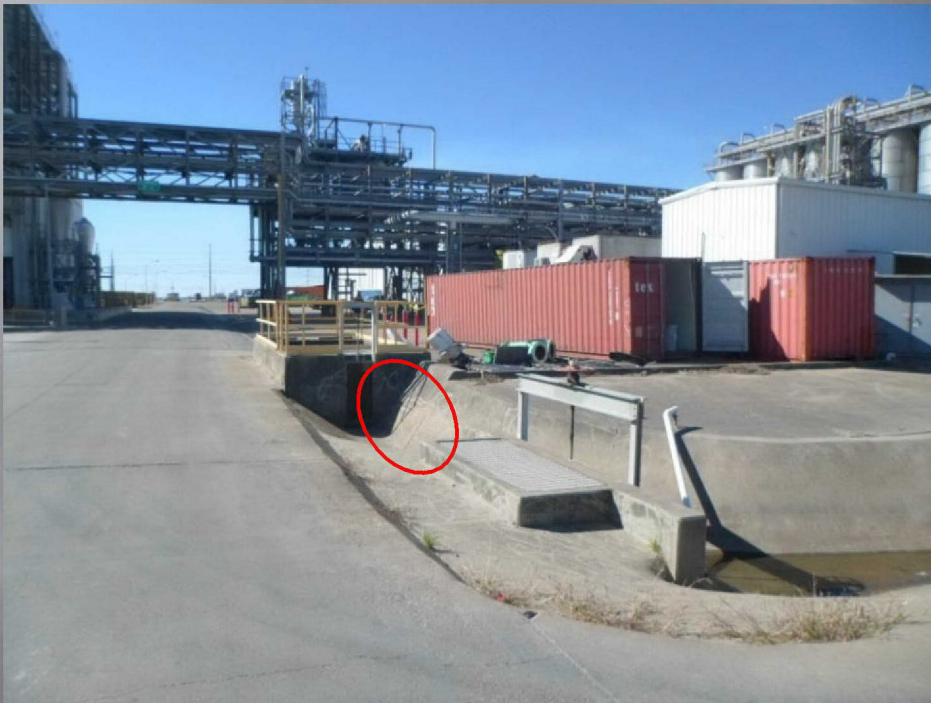
LLDPE

SMALL AMOUNTS OF PELLETS ARE OBSERVED IN THE DITCH JUST DOWNSTREAM OF THE GATE. NEXT TWO PHOTOS SHOW CLOSER IMAGES.

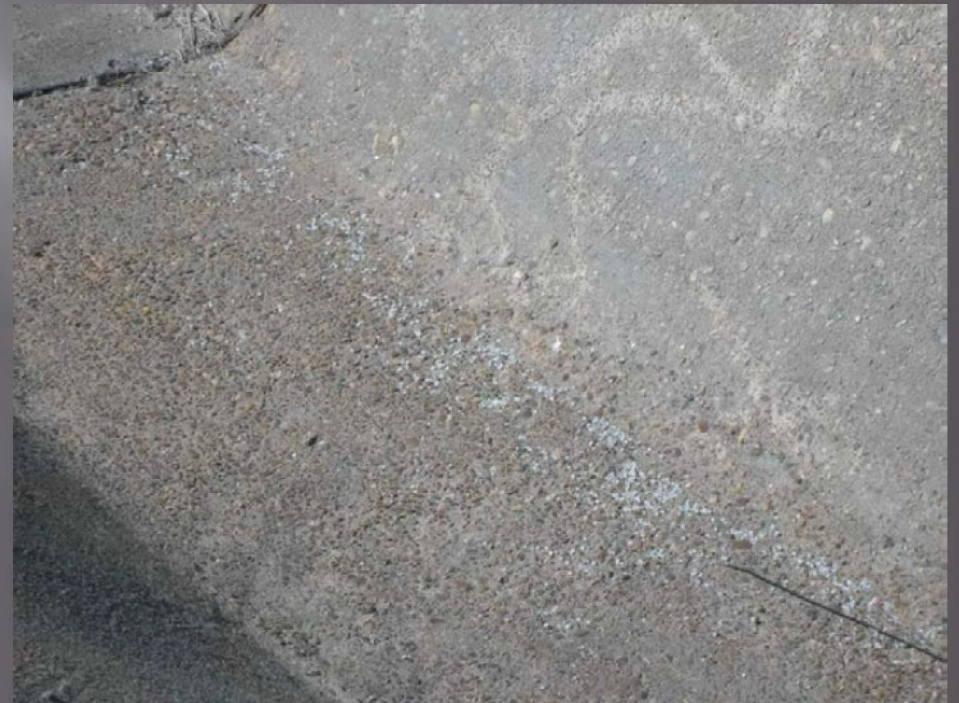
PELLETS ARE OBSERVED ON PAVEMENT. NOTE THAT PAVEMENT HAS CRACKS AND CHIPS, MOST THE PELLETS ARE OBSERVED IN THESE AREAS.

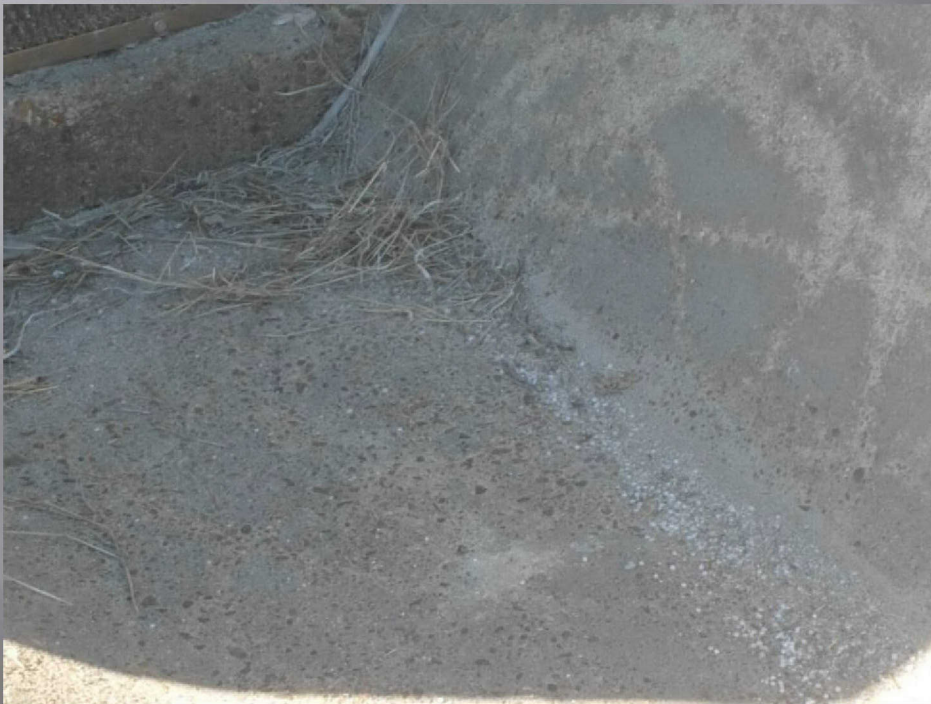
LLDPE

ADDITIONAL PHOTO WHICH SHOWS PELLETS.

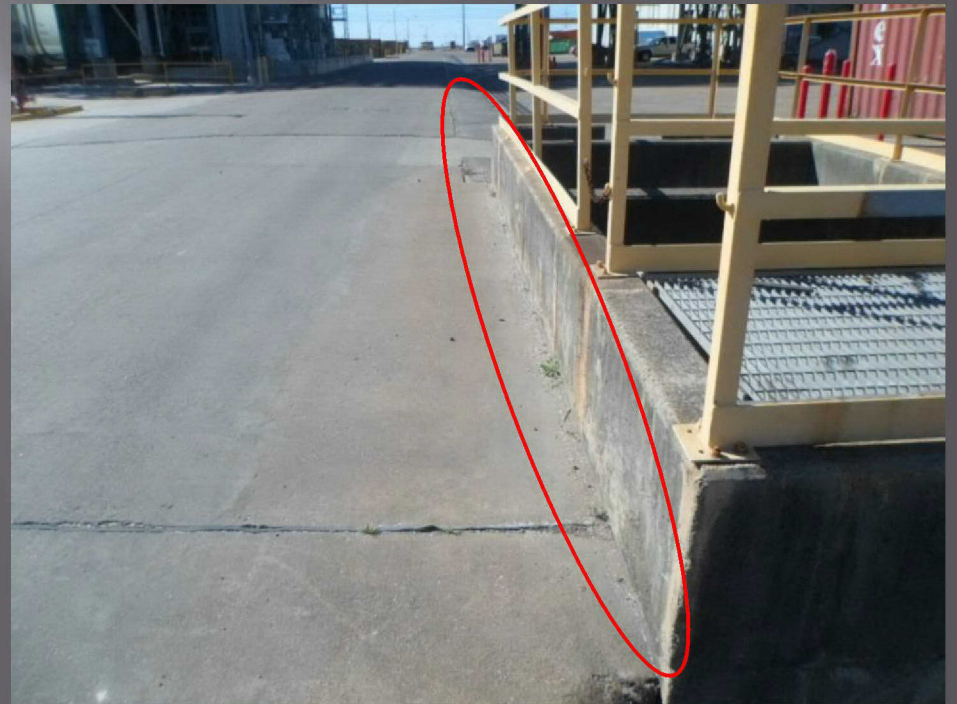
ALONG THIS WALL ON THE STREET, PELLETS ARE OBSERVED, AGAIN PELLETS ARE ABLE TO BE SEEN IN CRACKS ON THE STREET IN THIS AREA.

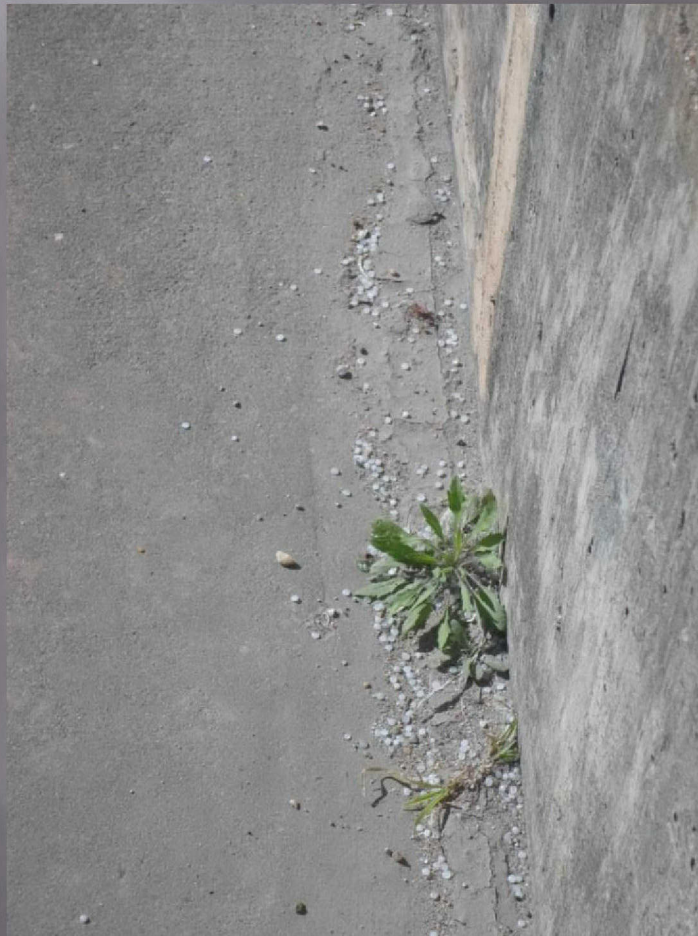
LLDPE

CLOSER IMAGE FROM PREVIOUS PHOTO.

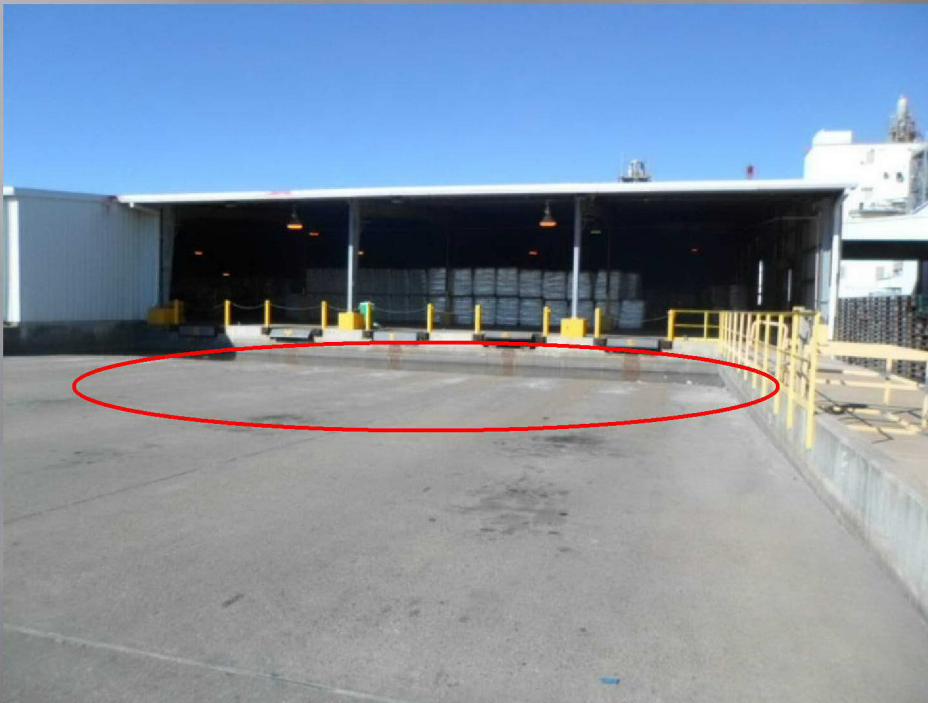
LLDPE WAREHOUSE

TRUCK LOADING AREA, PELLETS ARE OBSERVED ON PAVEMENT. THERE IS GRATING UP AGAINST THE WALL OF THE LOADING AREA, SEEMS THERE IS ALSO DRAINAGE ISSUES, POSSIBLY WITH GRATING BEING OBSTRUCTED WITH DEBRIS.

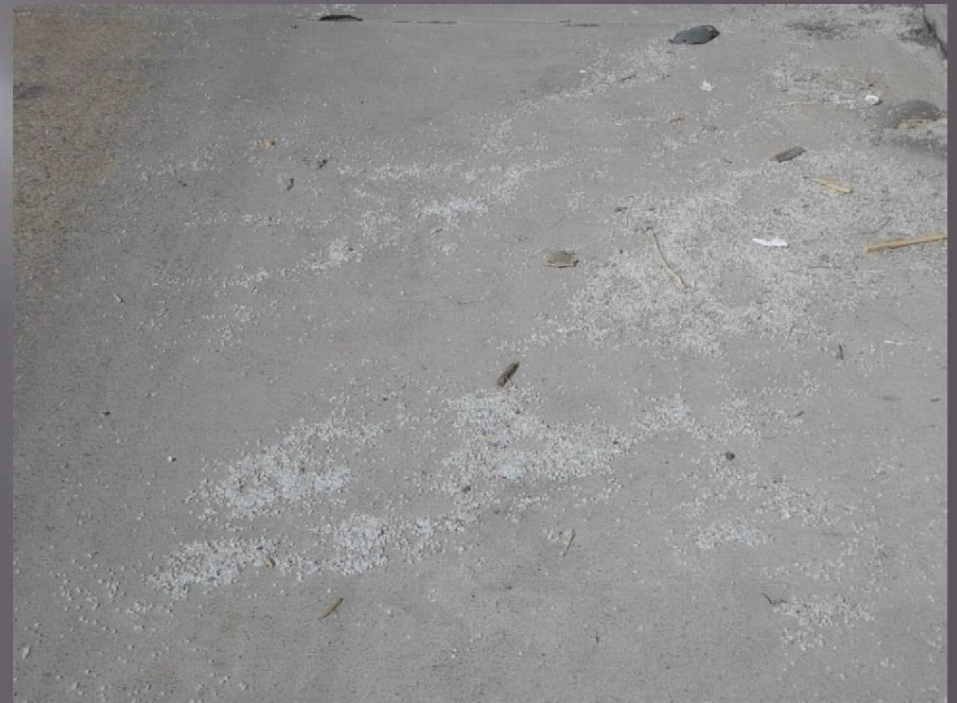
CLOSER IMAGE OF PELLETS IN LOADING AREA.

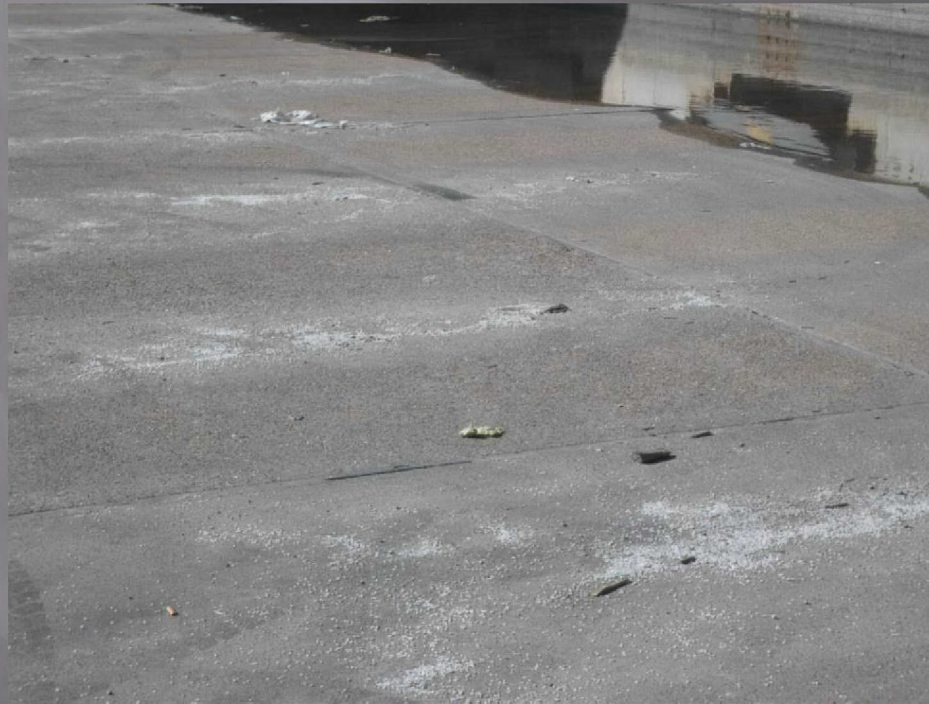
LLDPE WAREHOUSE

ADDITIONAL PHOTO OF PELLETS ON PAVEMENT.
