# FORMOSA PLASTICS CORPORATION, TEXAS

Traffic Pellet/Powder & Misc.  
Observations

Gate 2 Road

Conducted: January 5, 2017

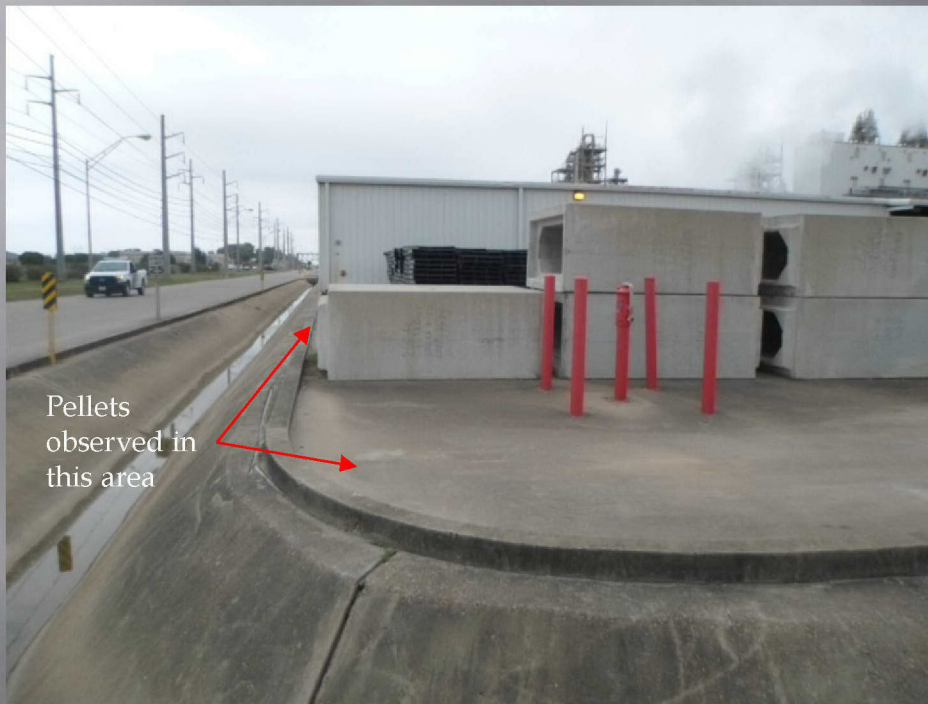
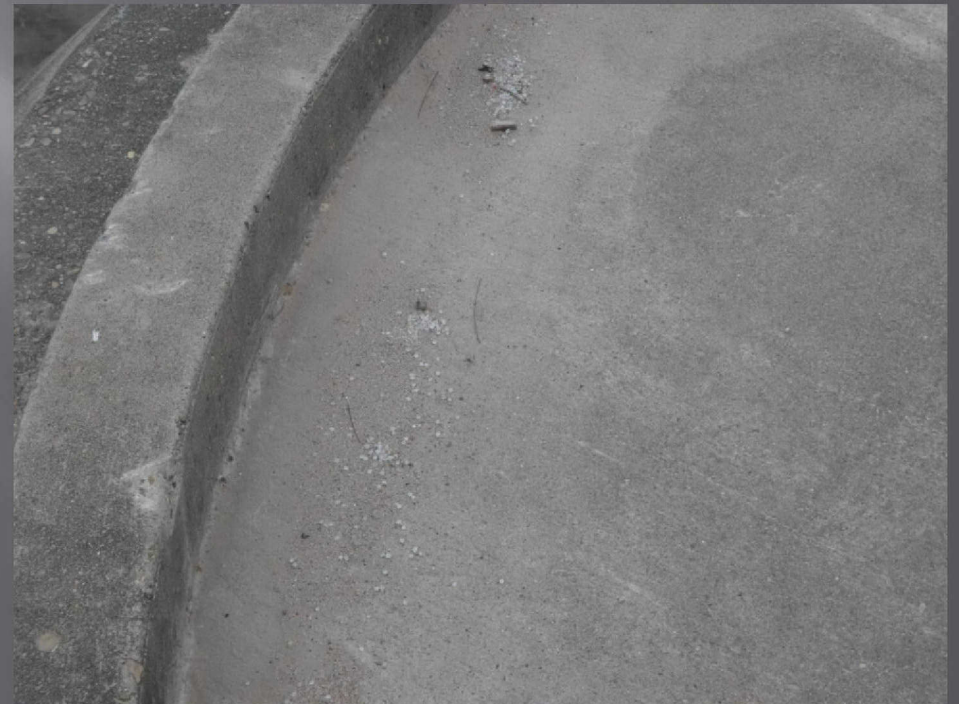
# LLDPE Warehouse

AT THE SOUTHWEST CORNER OF THE WAREHOUSE, PELLETS WERE OBSERVED UP AGAINST THE CONCRETE CURB AS WELL AS NORTH OF THE CONCRETE CULVERTS.

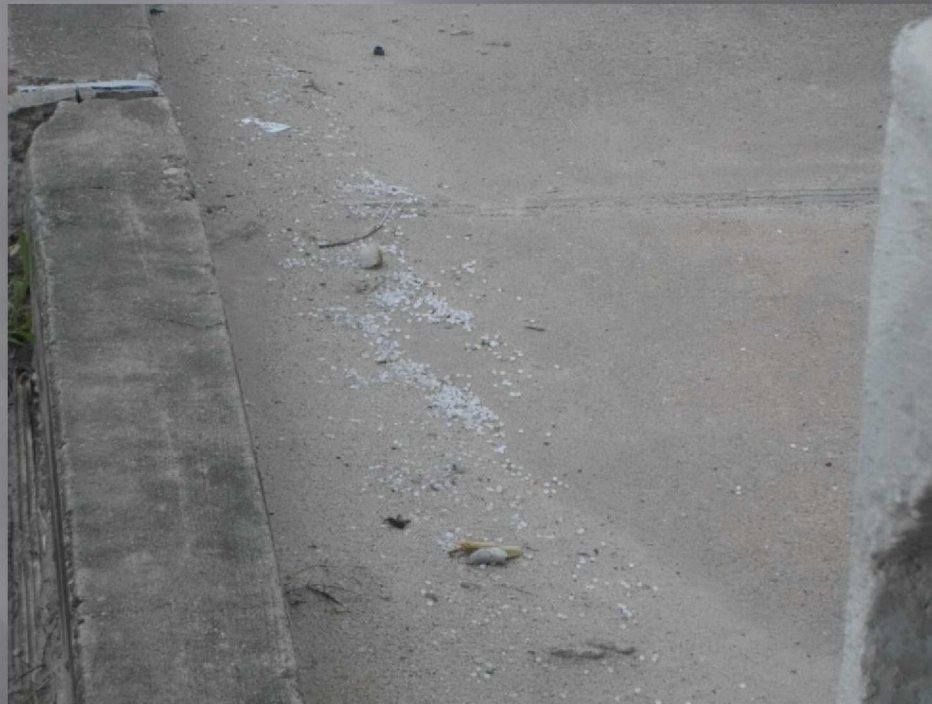
# LLDPE Warehouse

CLOSER IMAGE OF PELLETS NORTH OF CULVERTS.

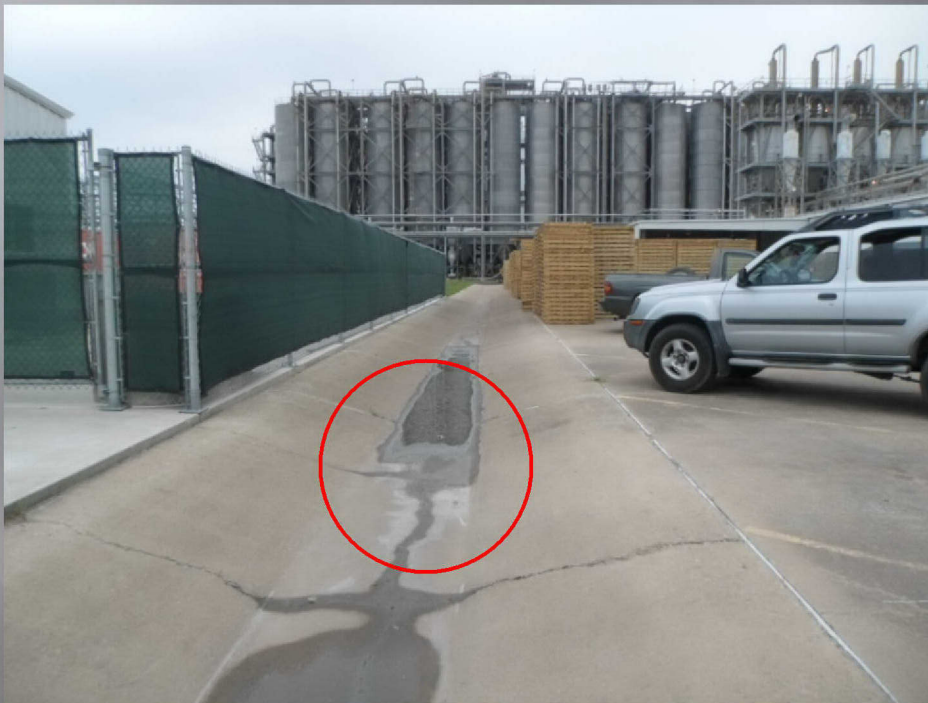
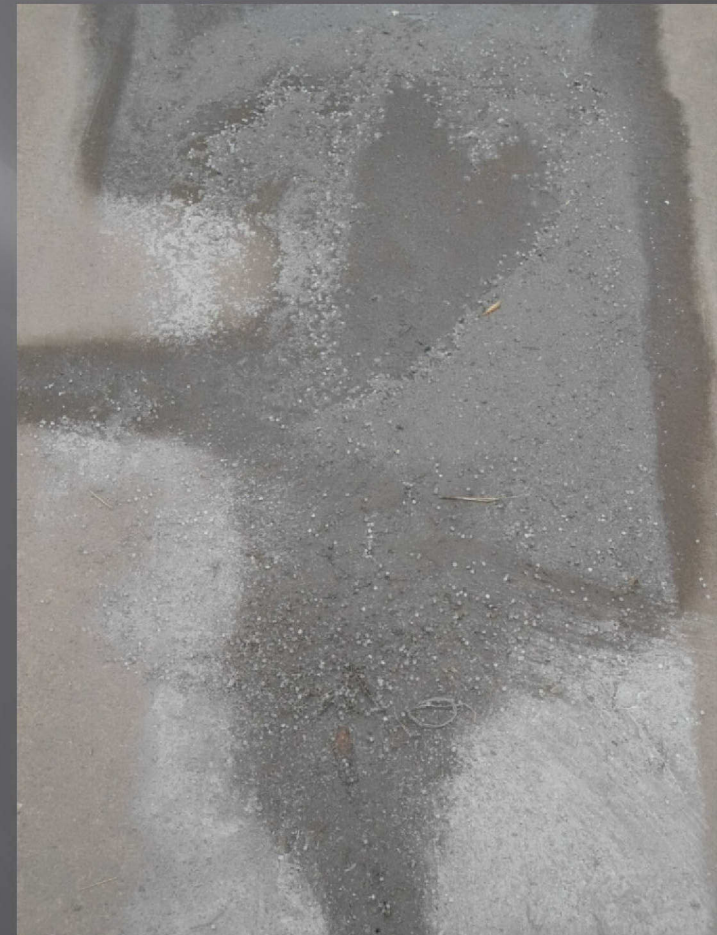
# PE1/PP1 Bagging/Shipping

WEST OF THE BAGGING/SHIPPING BUILDING, PELLETS WERE OBSERVED IN A SECTION OF THE DITCH. UPON CLOSER INSPECTION, OBSERVATION WAS MADE THAT PELLETS HAD BEEN SWEEPED UP INTO A PILE BUT NOT YET PICKED UP.

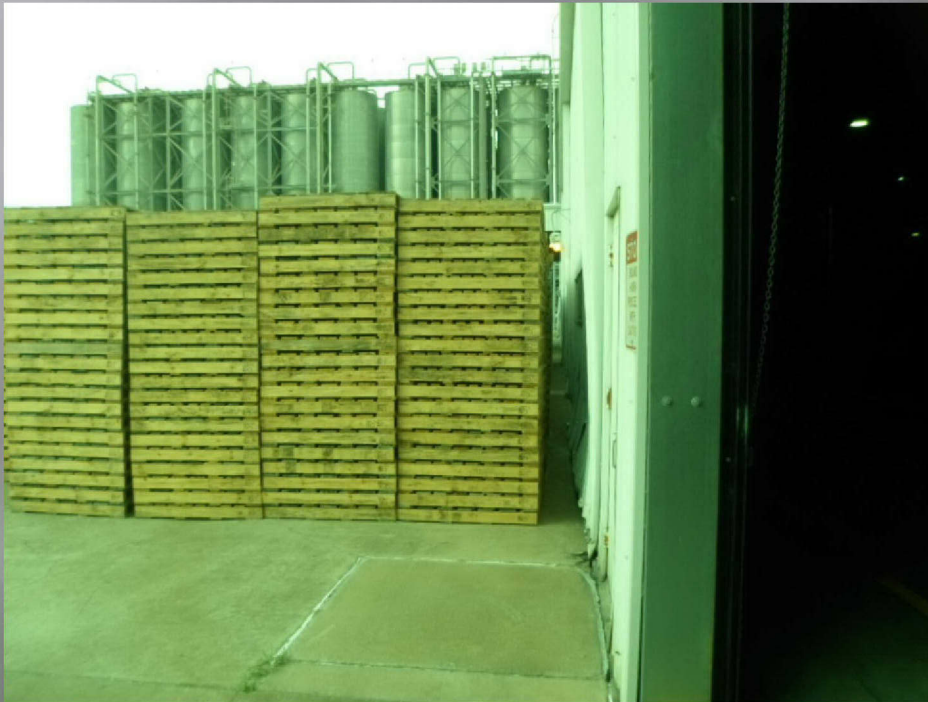
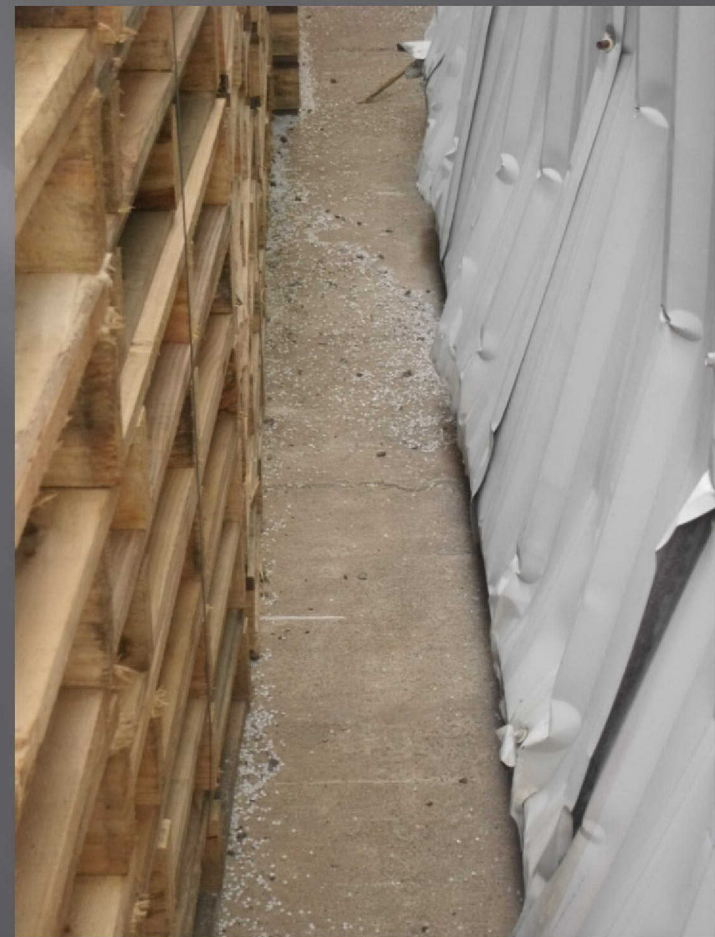
# PE1/PP1 Bagging/Shipping

WEST OF THE BUILDING BEHIND THE PALLETS, PELLETS WERE OBSERVED COMING FROM INSIDE THE BUILDING THRU CRACKS IN THE OUTER WALL.

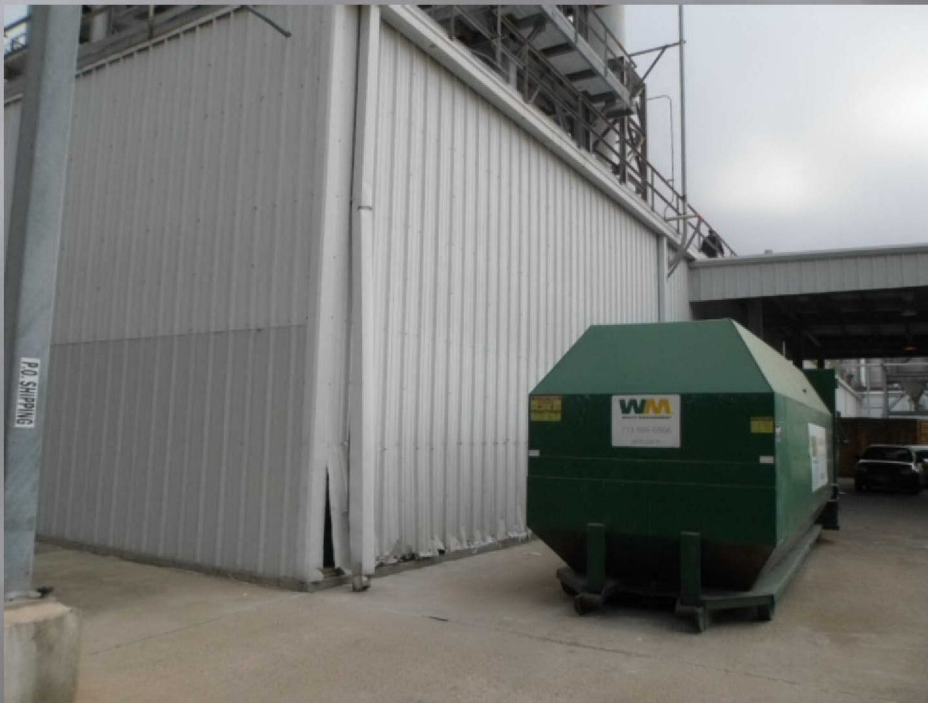
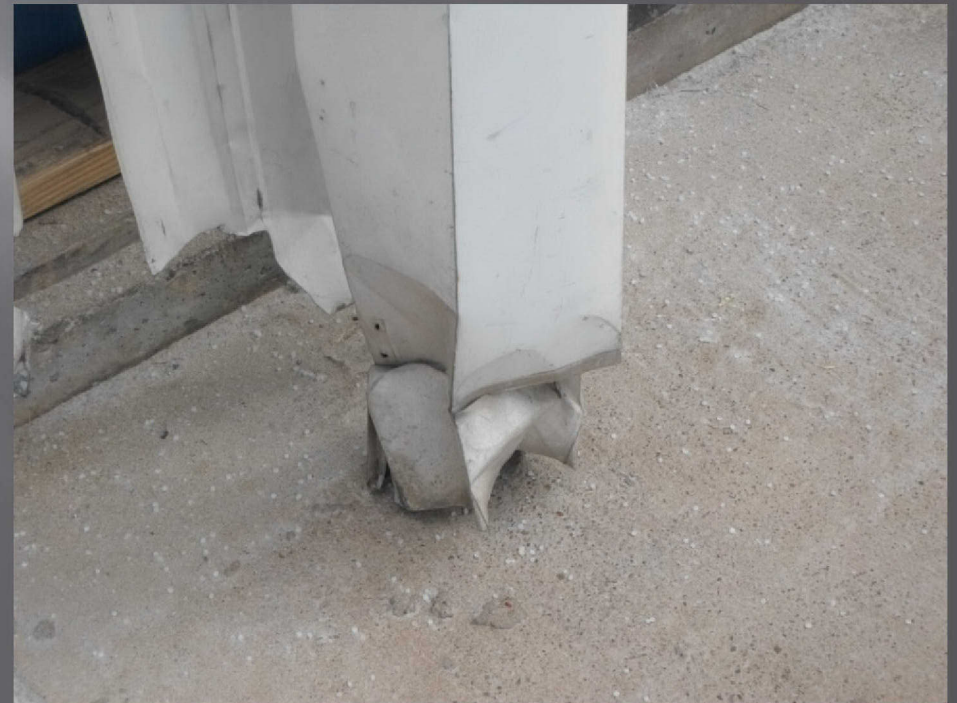
# PE1/PP1 Bagging/Shipping

SIMILAR TO THE PREVIOUS SLIDE JUST FURTHER NORTH OF THE PALLETS, PELLETS WERE OBSERVED AROUND A CRACK IN THE OUTER WALL.

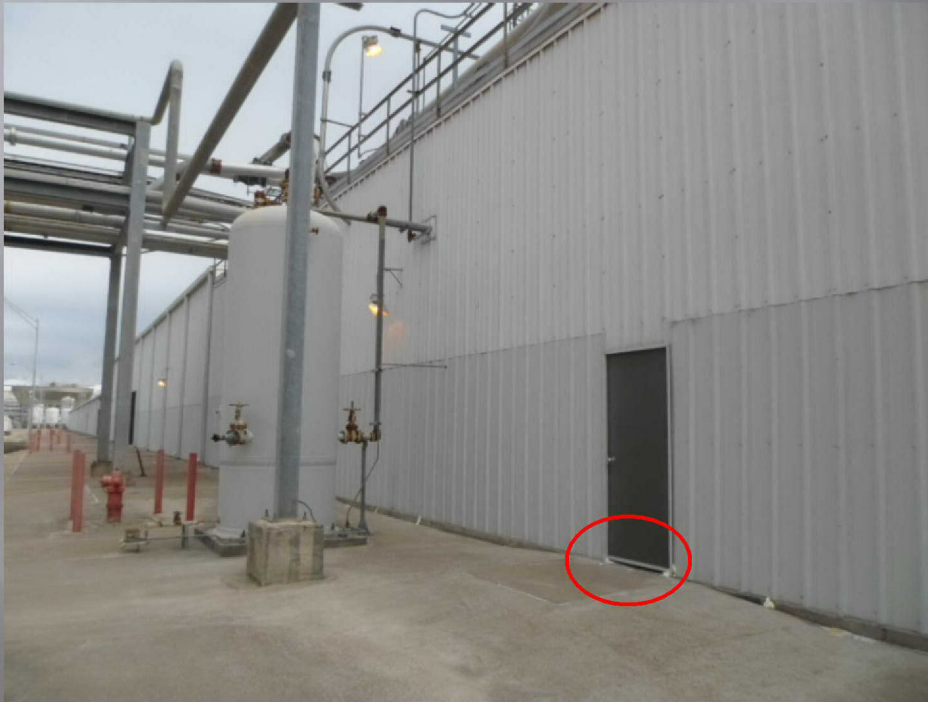
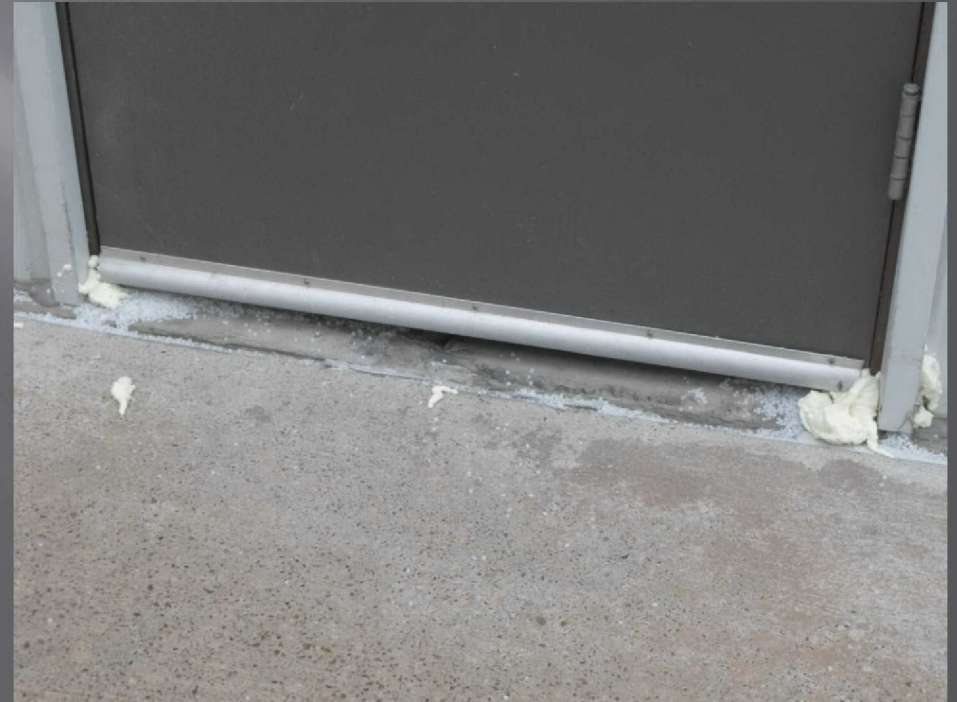
# PE1/PP1 Bagging/Shipping

ON THE NORTH SIDE OF THE BUILDING AT THE DOOR. ATTEMPTS TO STOP THE PELLETS FROM TRAVELING OUT OF THE BUILDING HAVE BEEN MADE FROM INSIDE. HOWEVER THERE SEEMS TO BE A SMALL SPACE WHICH PELLETS ARE ABLE TO GET OUT FROM.

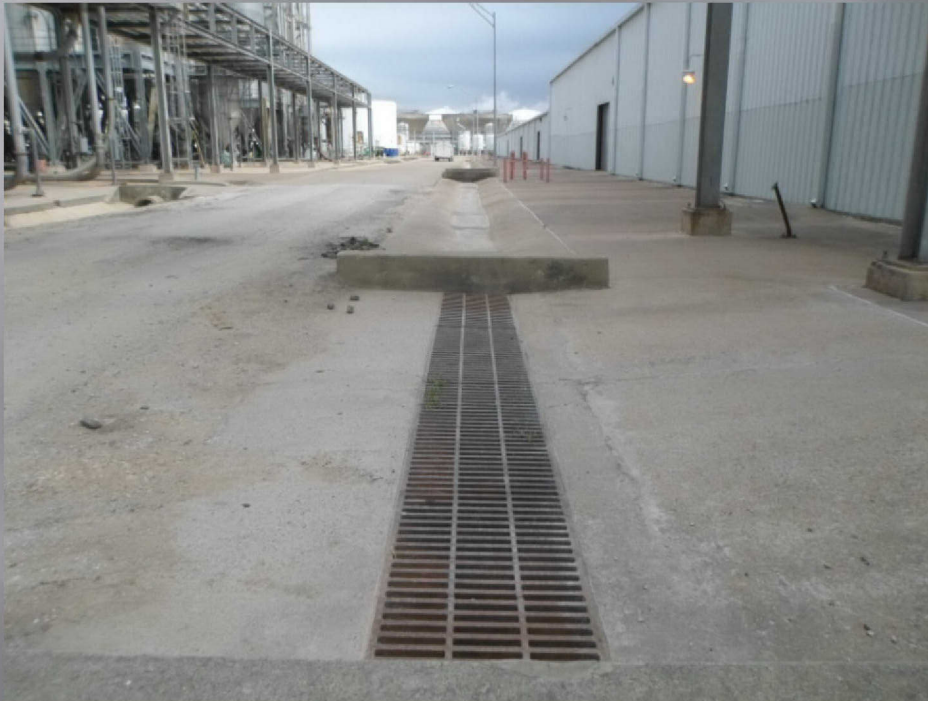
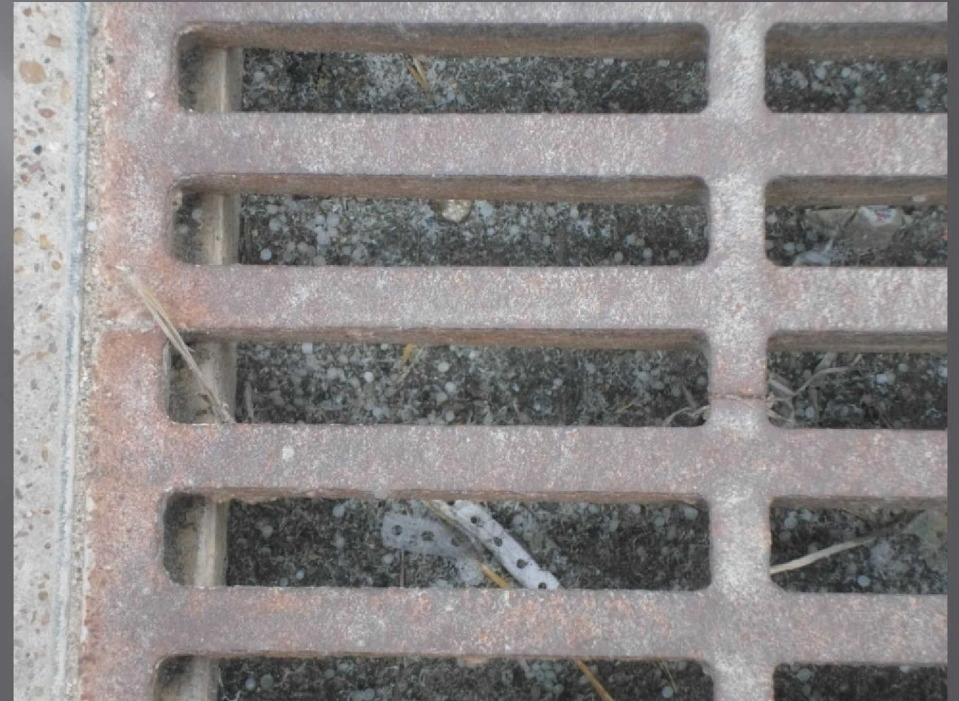
# PE1/PP1 Bagging/Shipping

ON THE NORTH SIDE OF THE BUILDING (BETWEEN PP1 SILOS AND BAGGING/SHIPPING BUILDING, UNDER THE GRATING PELLETS AND POWDER WERE OBSERVED. FURTHER INVESTIGATION UPSTREAM AND DOWN STREAM INDICATES THE CONCRETE DITCHES HAVE BEEN SWEEPED, HOWEVER DEBRIS STILL LIES UNDER THE GRATING.

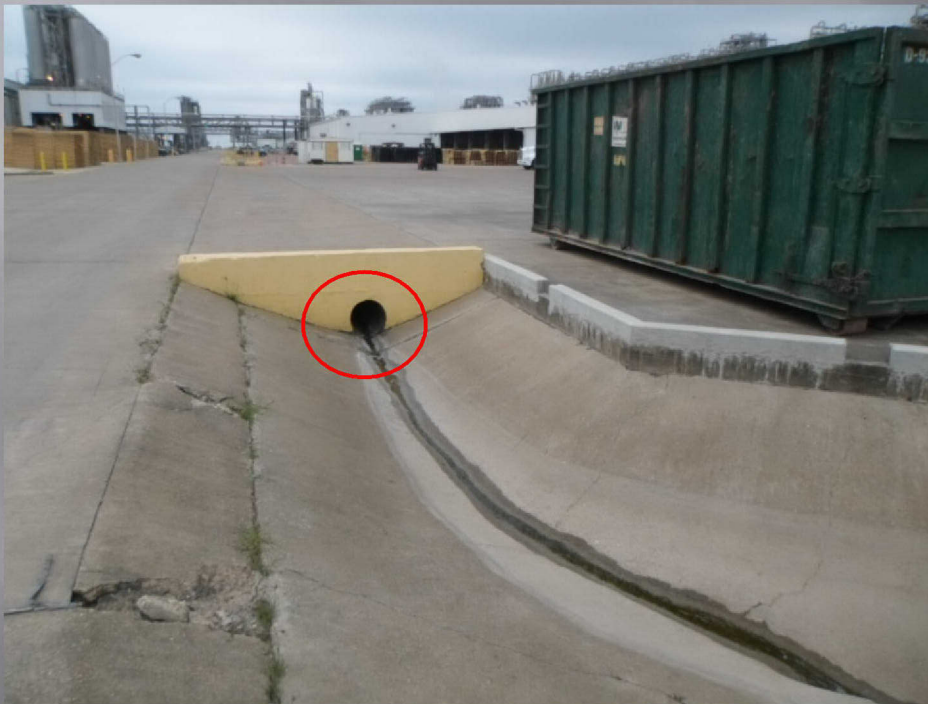
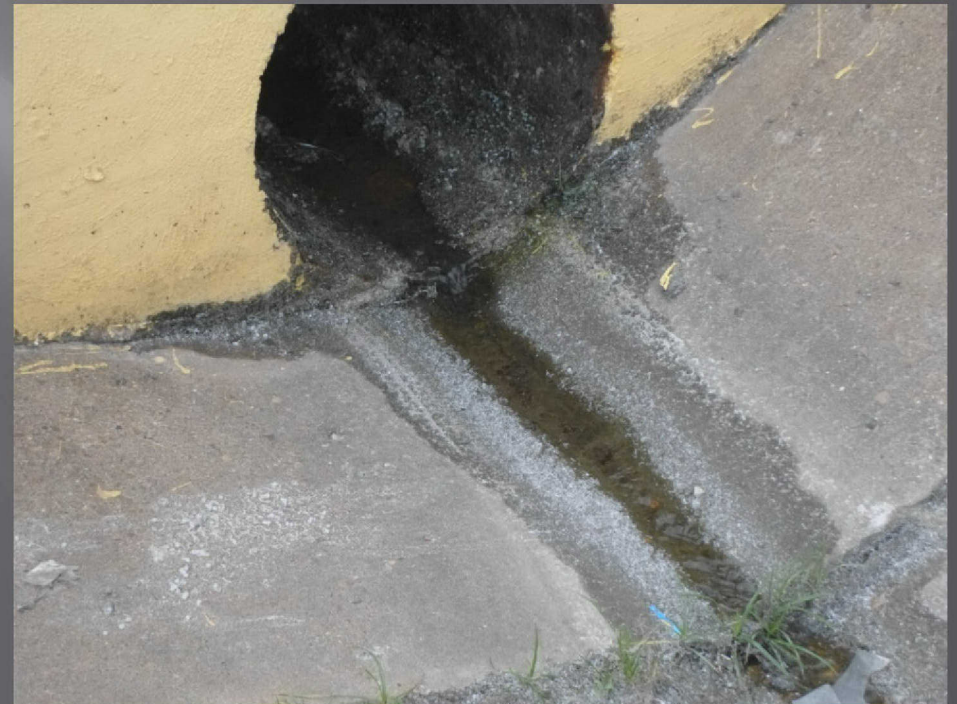
# PE1/PP1 Bagging/Shipping

AT THE SOUTHEAST CORNER, PELLETS AND POWDER WERE OBSERVED JUST OUTSIDE THE CULVERT AREA.

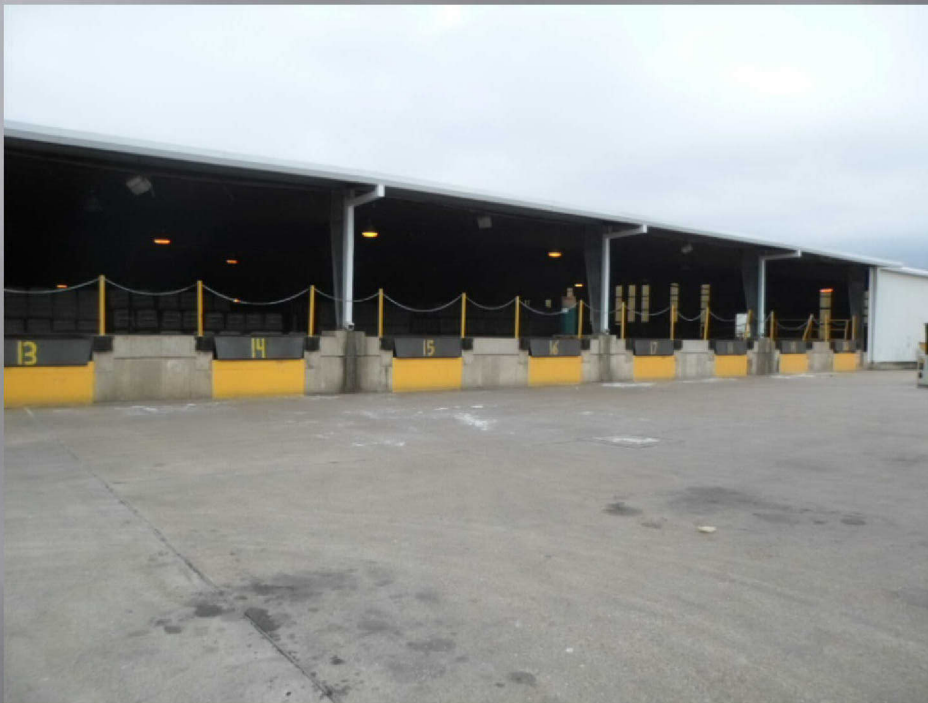
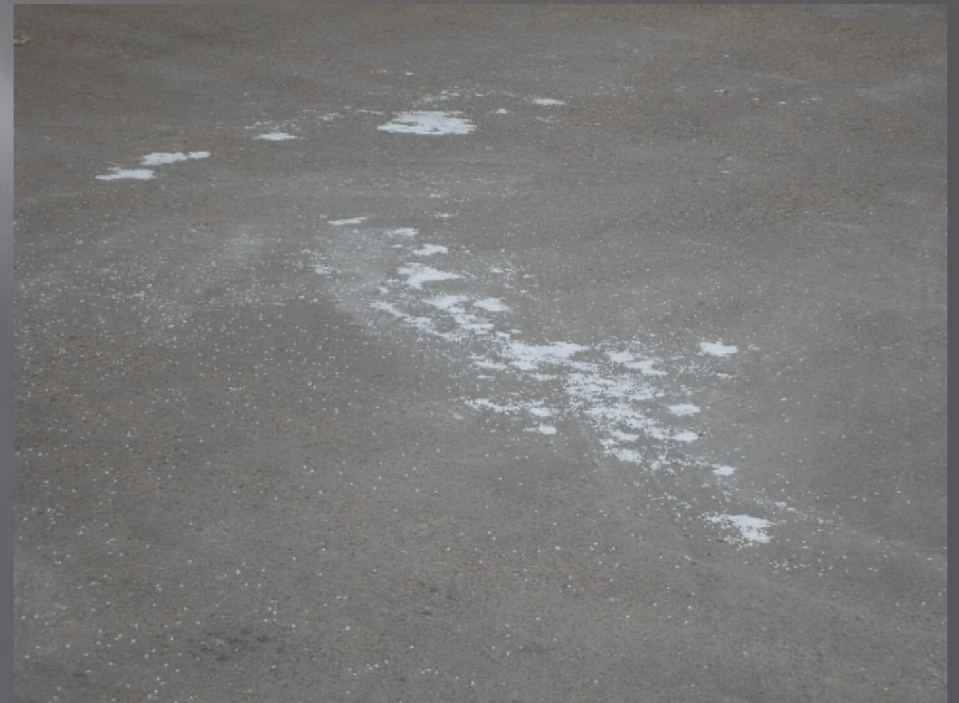
# PE1/PP1 Bagging/Shipping

AT THE TRUCK LOADING AREA FROM THE FIRST PHOTO BELOW PELLETS CAN BE SEEN ON THE PAVEMENT.

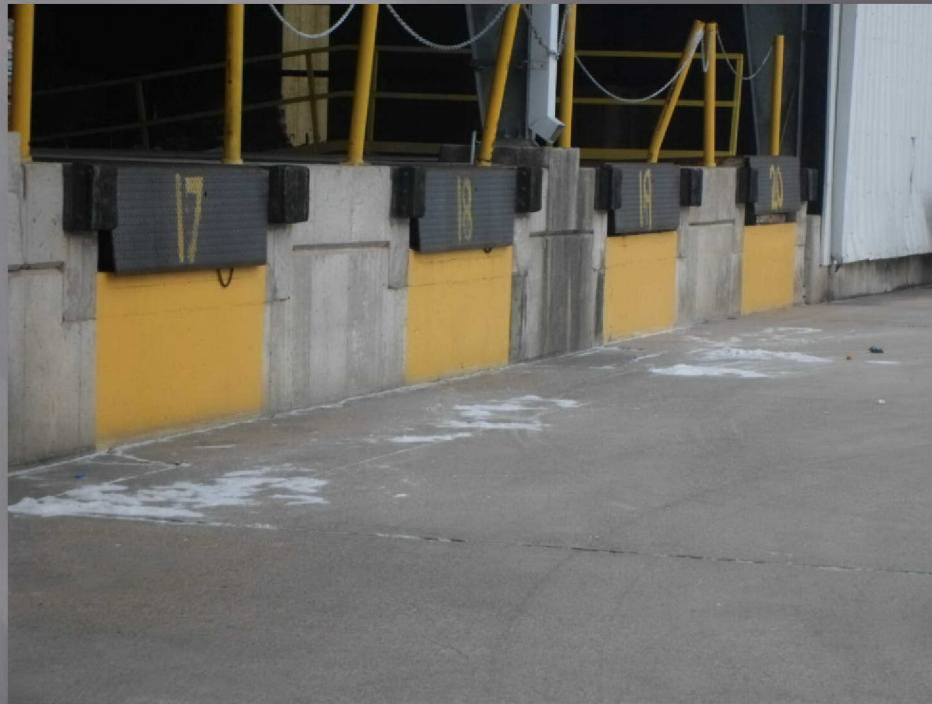
# PE1/PP1 Bagging/Shipping

ADDITIONAL PHOTO OF PELLETS ON PAVEMENT.

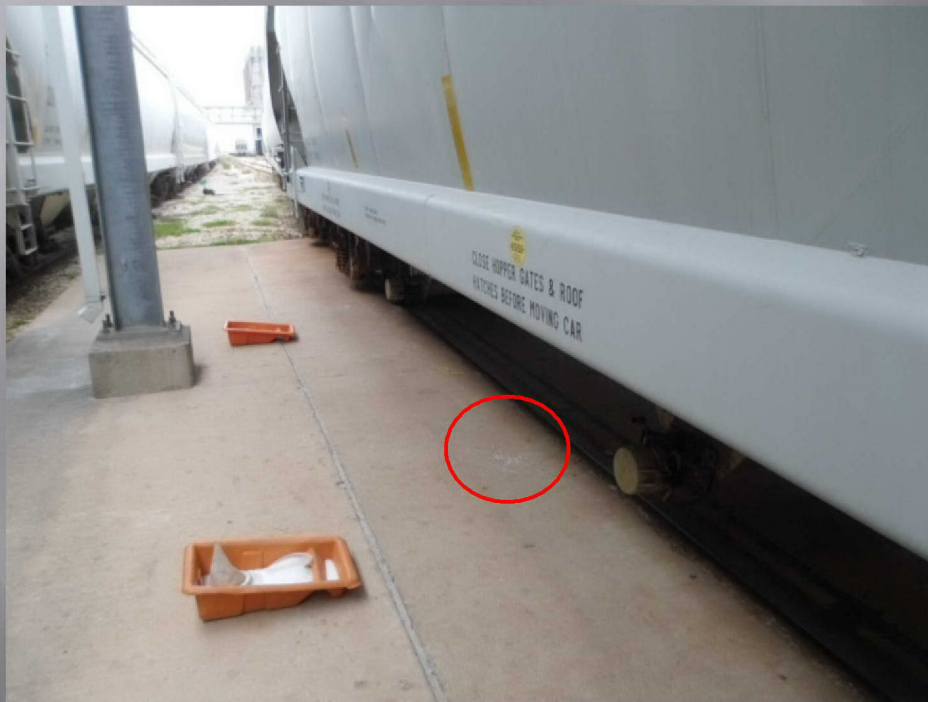
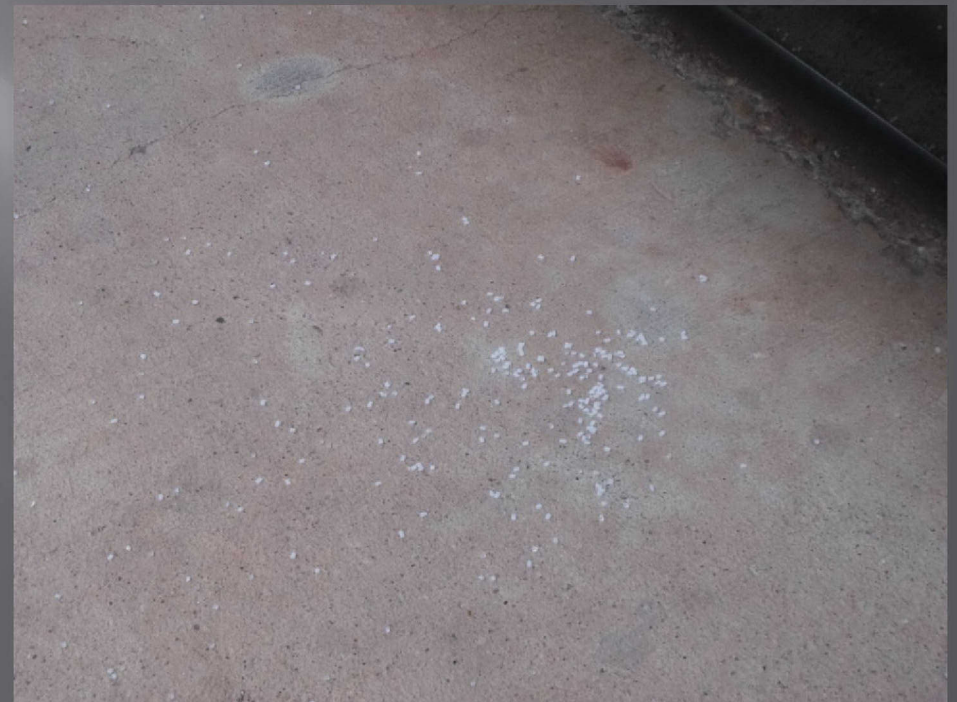
# PE1/PP1 Railcar Loading

IN THE HOPPER CAR CLEANING AREA, ONLY A SMALL SPILL OF PELLETS WAS OBSERVED.
