FORMOSA PLASTICS CORPORATION, TEXAS

Traffic Pellet/Powder & Misc.
Observations

Gate 2 Road

Conducted: January 26, 2017

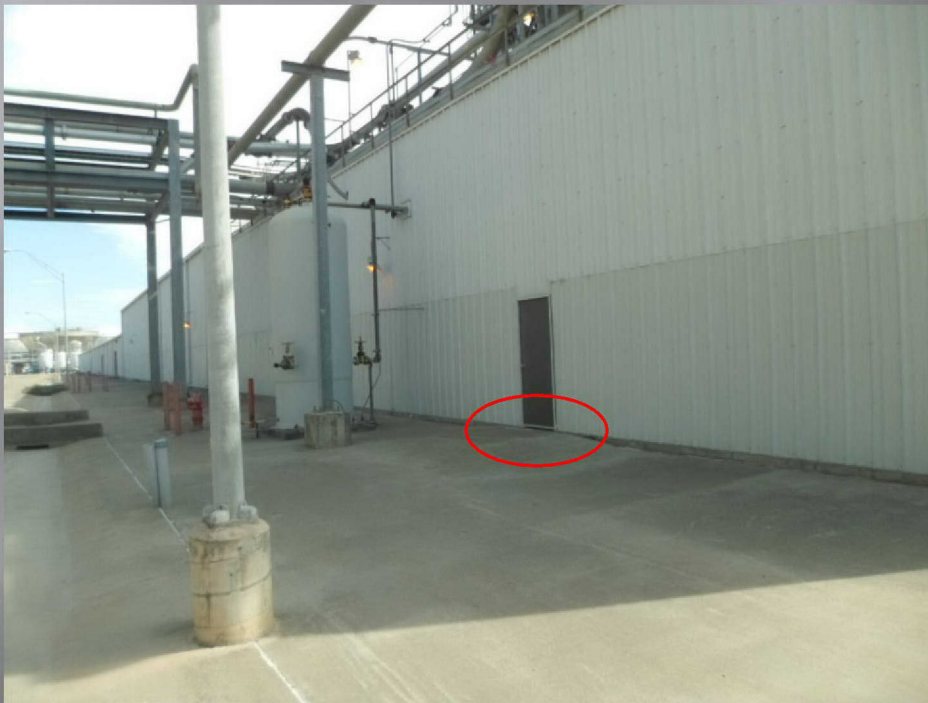
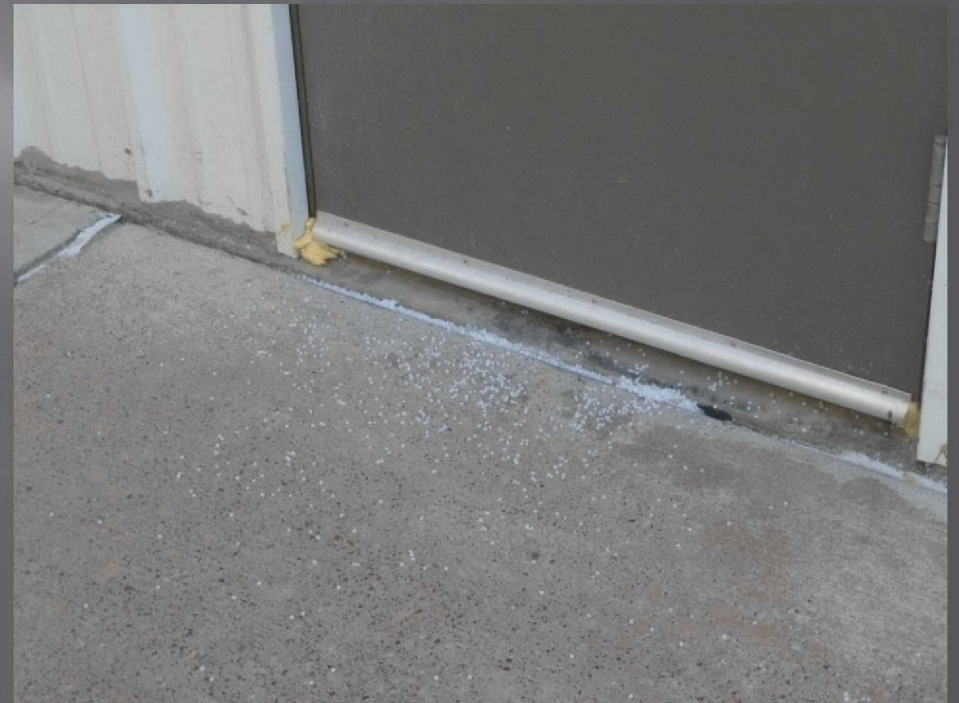
PE1/PP1 Bagging/Shipping Area

ON THE NORTH SIDE OF THE BUILDING JUST ACROSS THE STREET FROM THE PP1 SILOS, PELLETS WERE OBSERVED AT THE BASE OF THE DOOR. FROM INSIDE THE BUILDING A COVER IS IN PLACE TO KEEP PELLETS CONTAINED INSIDE, HOWEVER THERE IS A SMALL GAP WHICH IS ALLOWING PELLETS TO TRAVEL THROUGH.

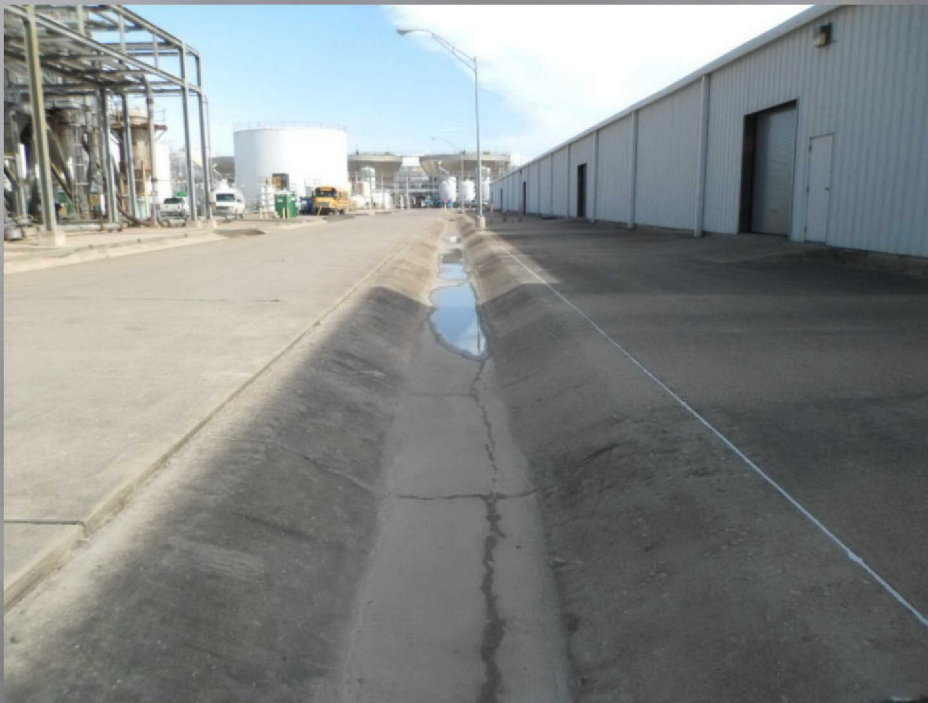
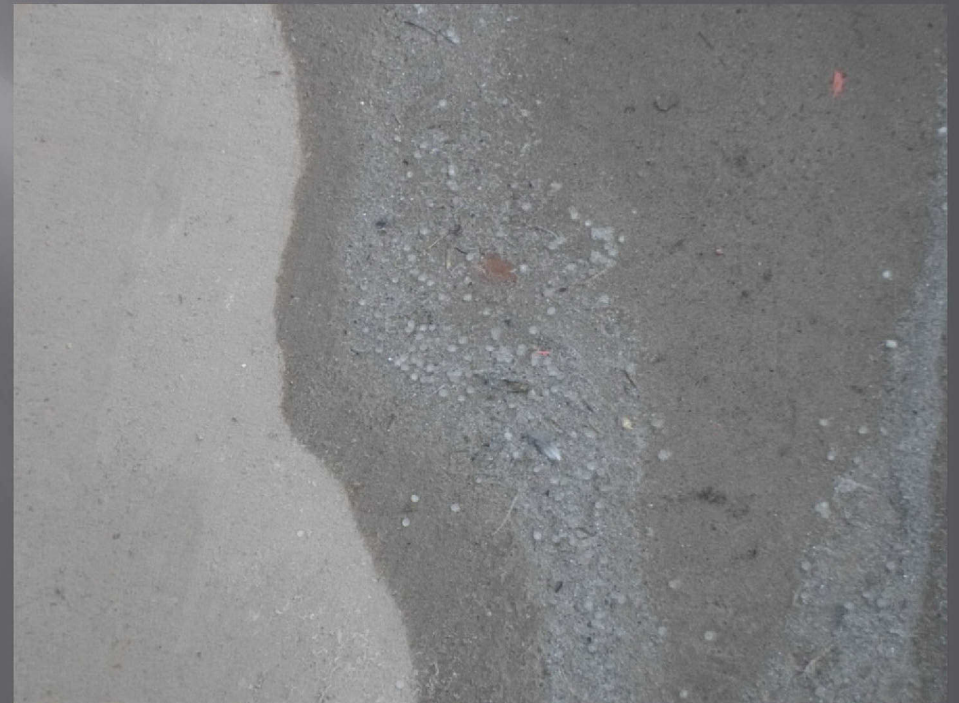
PE1/PP1 Bagging/Shipping Area

IN THE DITCH NORTH OF THE BUILDING, PELLETS AND DEBRIS ARE VISIBLE IN SEVERAL AREAS.

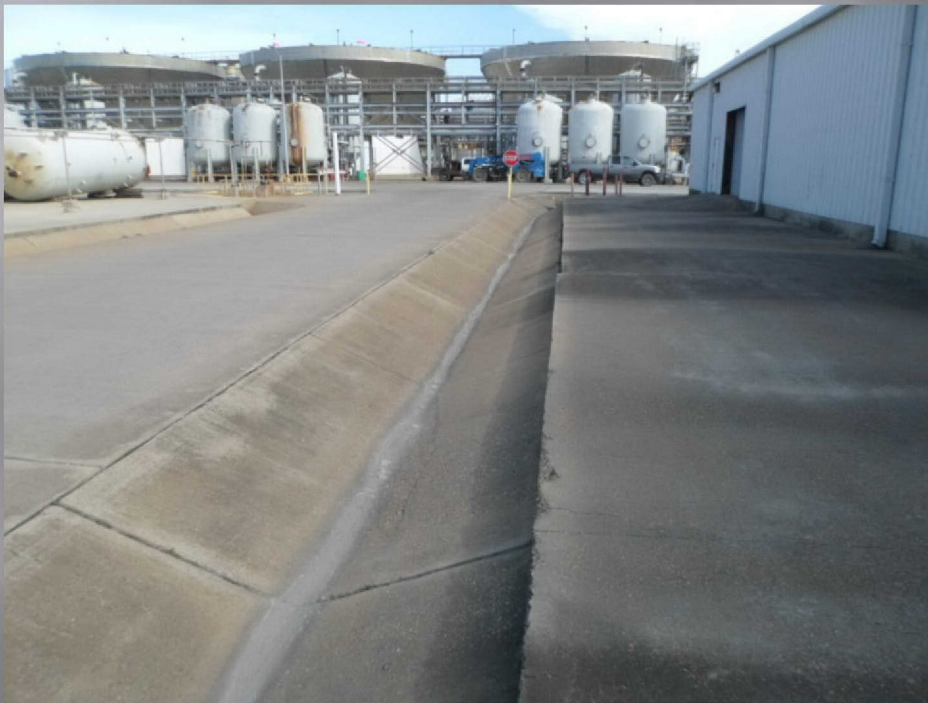
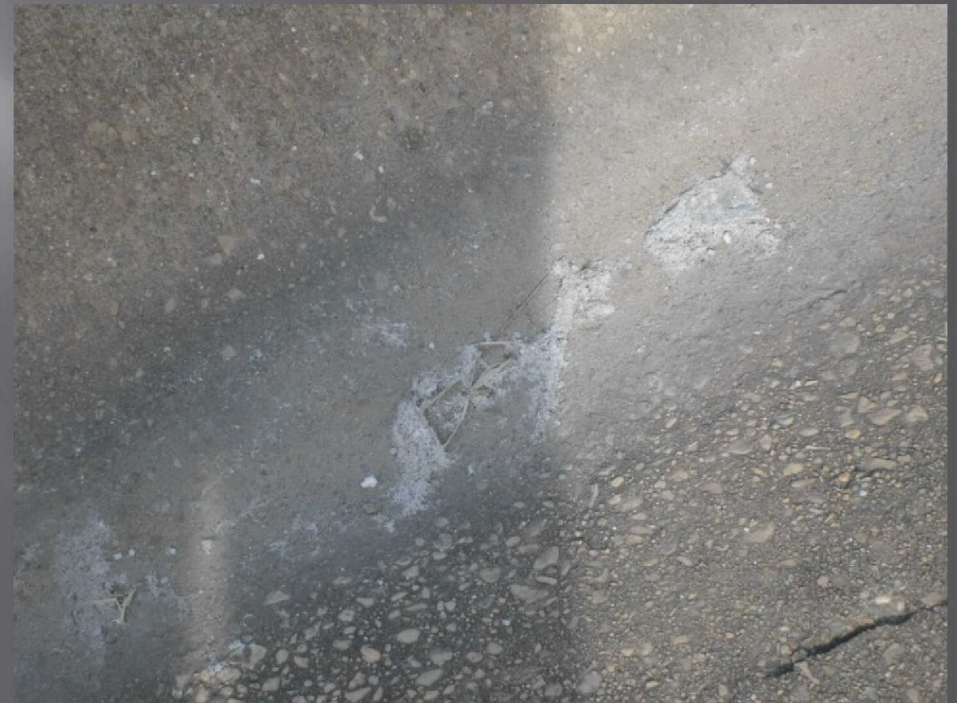
PE1/PP1 Bagging/Shipping Area

FURTHER EAST FROM PHOTOS OF PREVIOUS SLIDE, POWDER IS VISIBLE IN THE DITCH. PILES OF POWDER HAVE ACCUMULATED IN DIFFERENT AREAS OF THE DITCH.

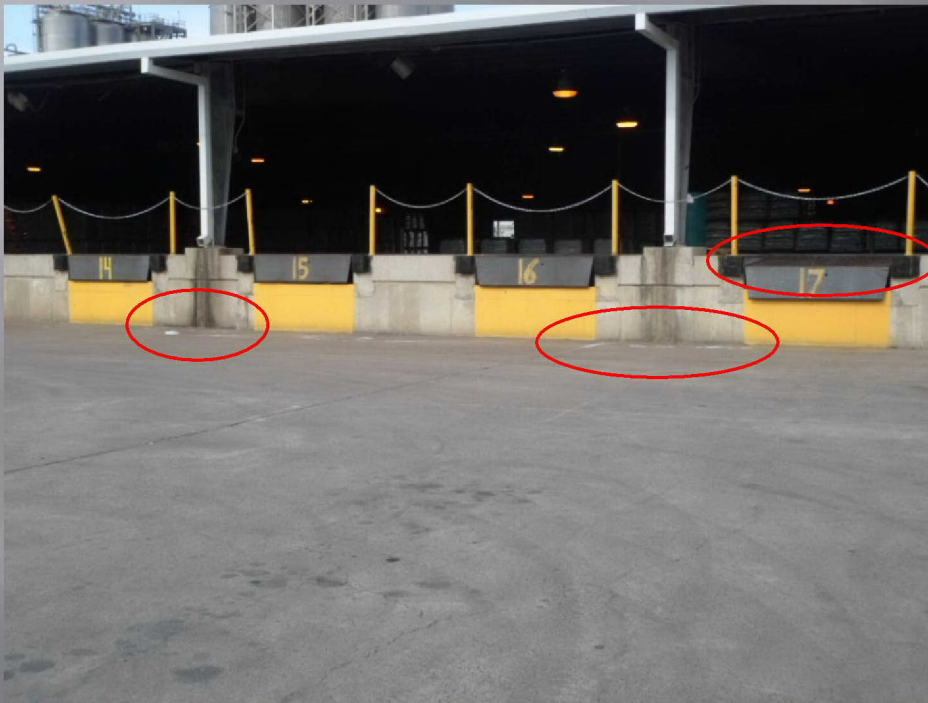
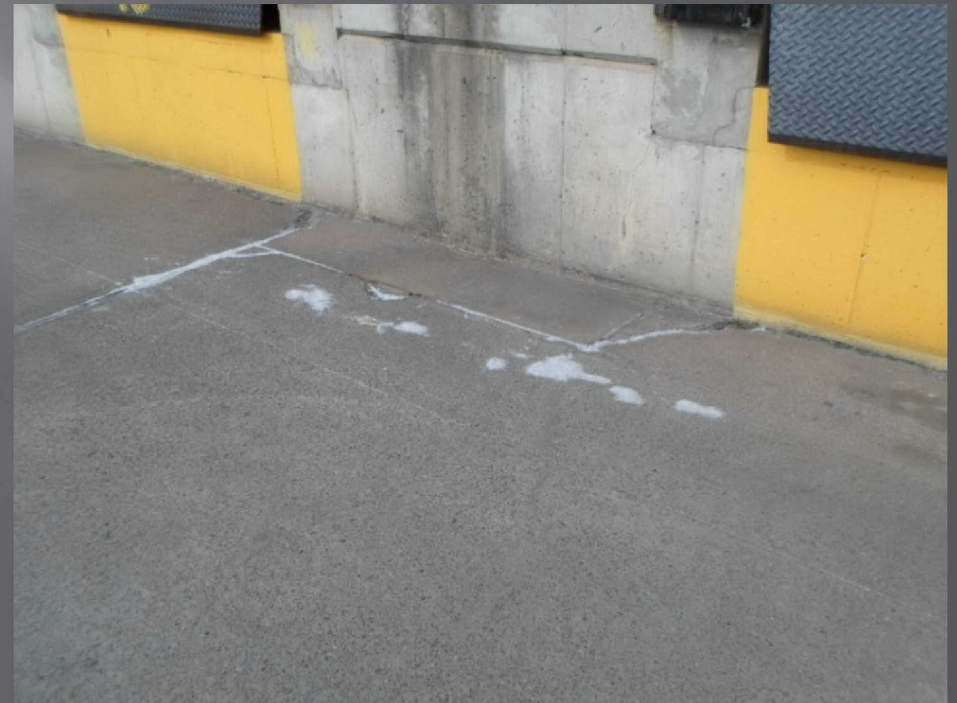
PE1/PP1 Bagging/Shipping Area

AT THE TRUCK LOADING AREA, PELLETS AND POWDER WERE OBSERVED ON THE PAVEMENT. ADDITIONALLY PELLETS WERE ALSO OBSERVED AT LOADING RAMP 17 (SEE NEXT PHOTO).

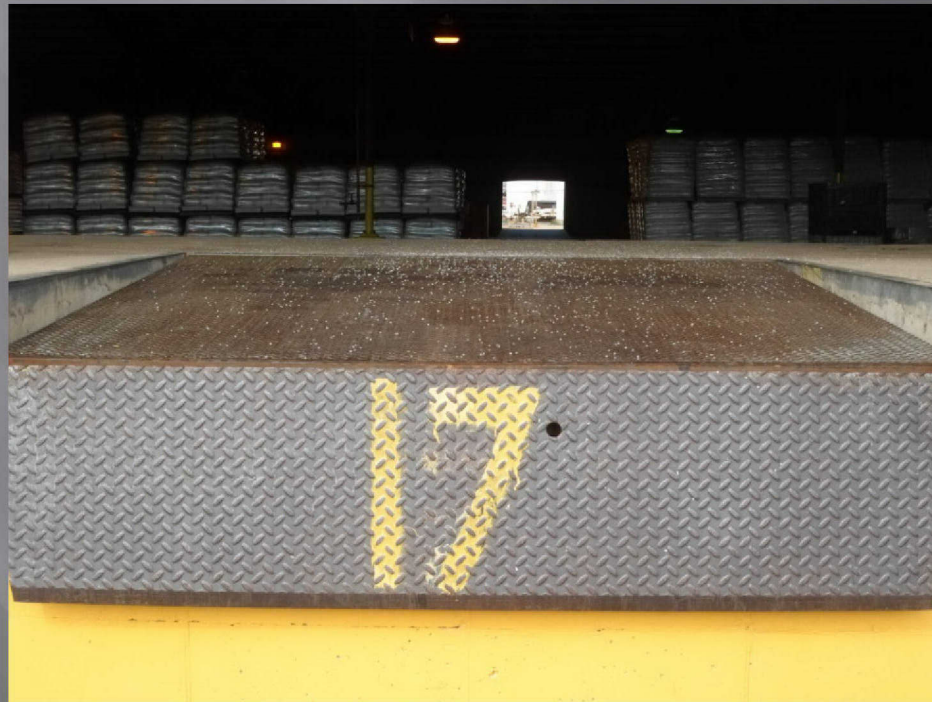
PE1/PP1 Bagging/Shipping Area

PHOTO OF PELLETS OBSERVED ON RAMP.

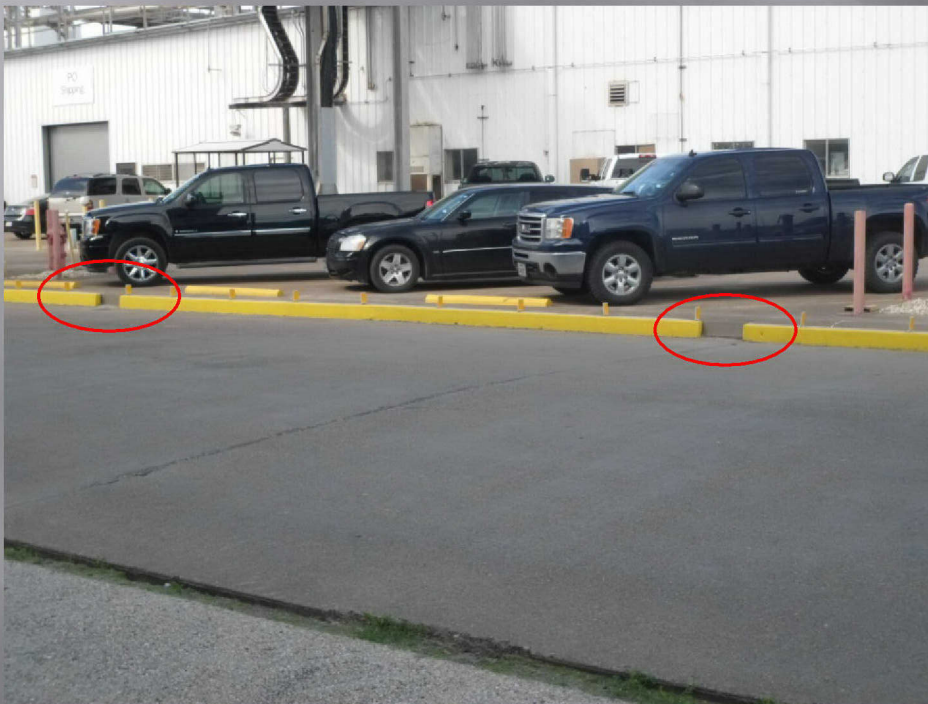
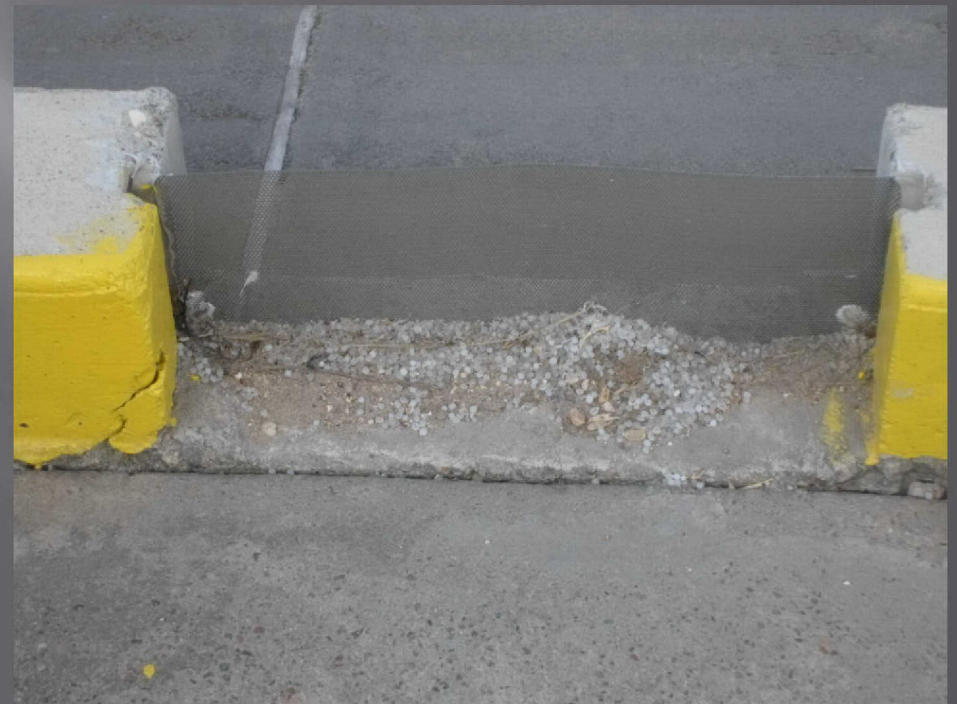
PE1/PP1 Bagging/Shipping Area

JUST OFF GATE 2 ROAD IN FRONT OF THE BAGGING/SHIPPING AREA, PELLETS WERE OBSERVED UP ALONG THE SCREENS WHICH ARE IN PLACE TO KEEP PELLETS FROM ENTERING THE DITCH.
