FORMOSA PLASTICS CORPORATION, TEXAS

Traffic Pellet/Powder & Misc.
Observations

Gate 2 Road

Conducted: March 10, 2017

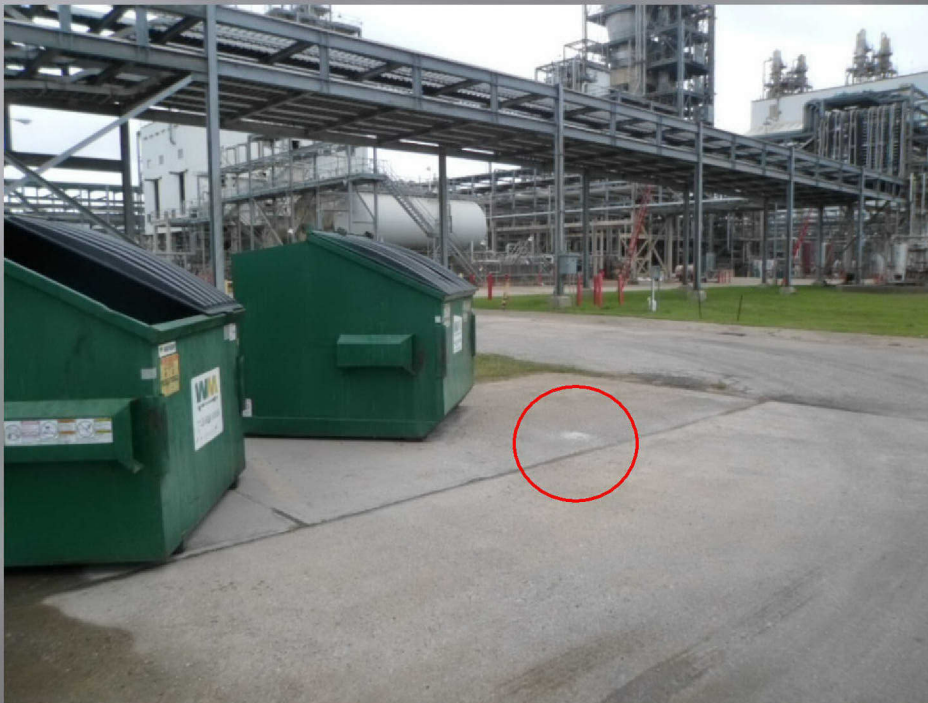
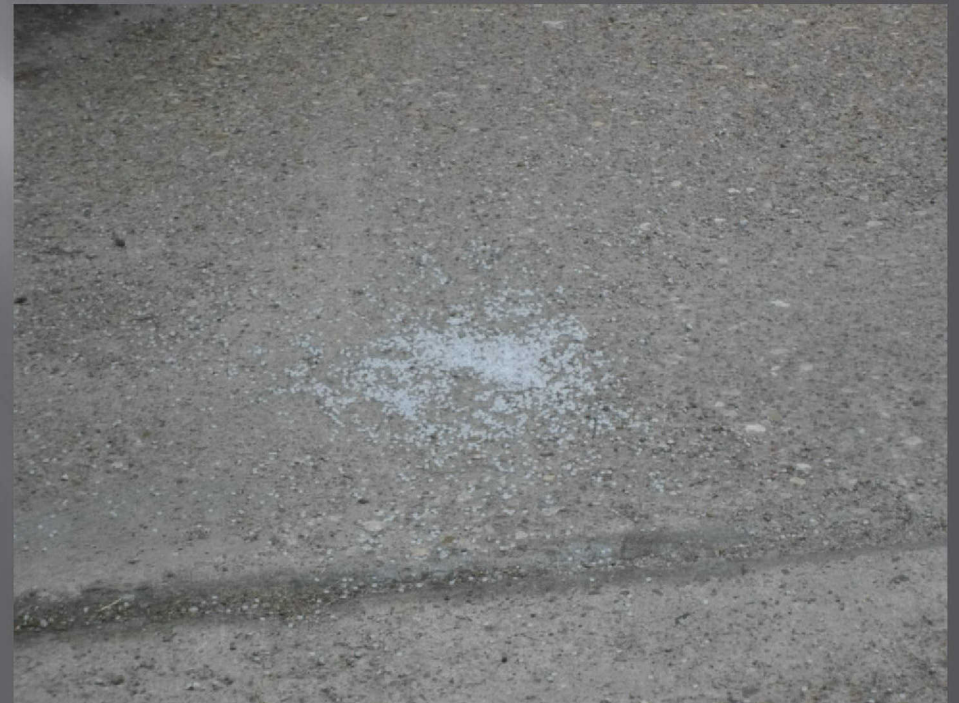
ON THE SOUTHEAST CORNER OF THE TECHNICAL LAB BY THE DUMPSTERS, A PILE OF PELLETS WAS OBSERVED ON THE PAVEMENT.

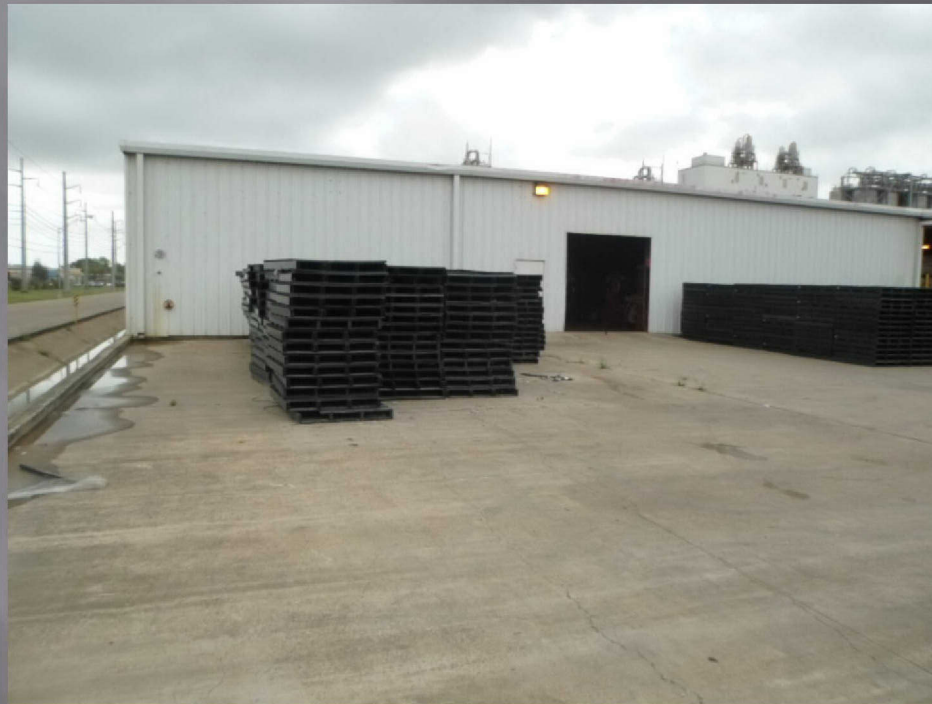
LLDPE WAREHOUSE

JUST OUTSIDE THE WAREHOUSE, PELLETS WERE OBSERVED UNDERNEATH AND AROUND THE STACKS OF PLASTIC PALLETS.

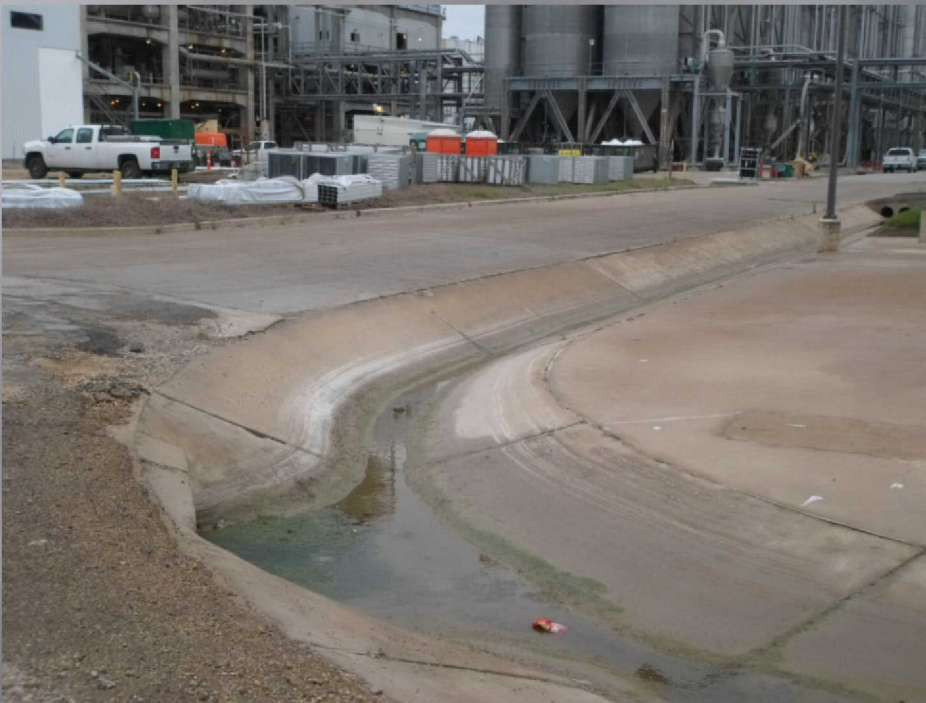
PP-1

NORTHWEST OF THE COOLING TOWER, POWDER DEBRIS LINE IS VISIBLE ALONG CONCRETE PAVEMENT.

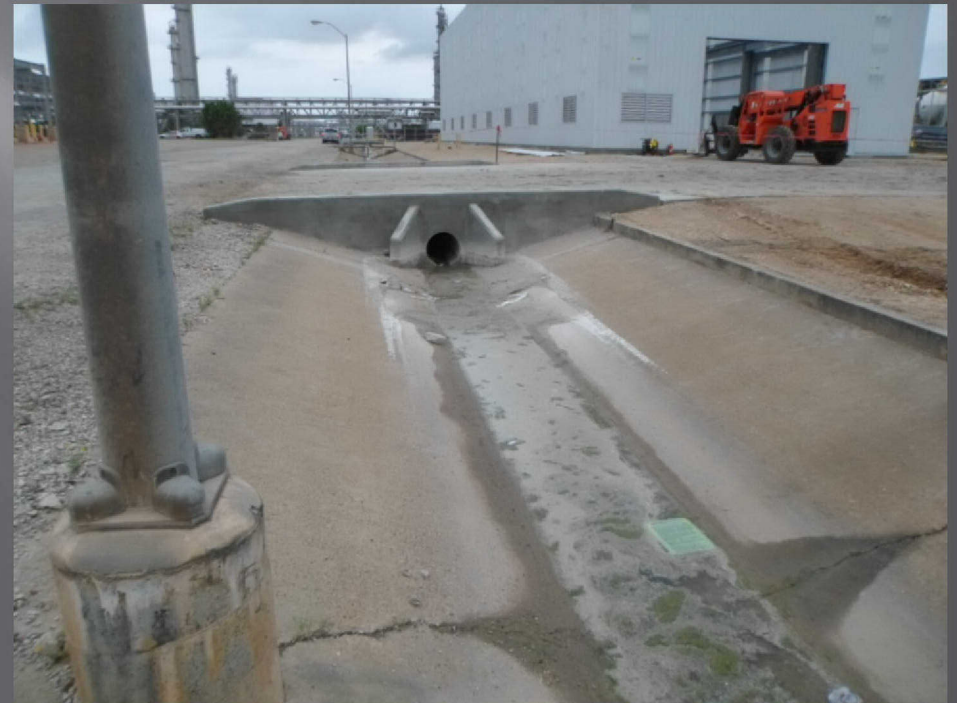
WEST SIDE OF THE PROCESS AREA, POWDER AND PELLETS WERE OBSERVED ON PAVEMENT AROUND CULVERT.

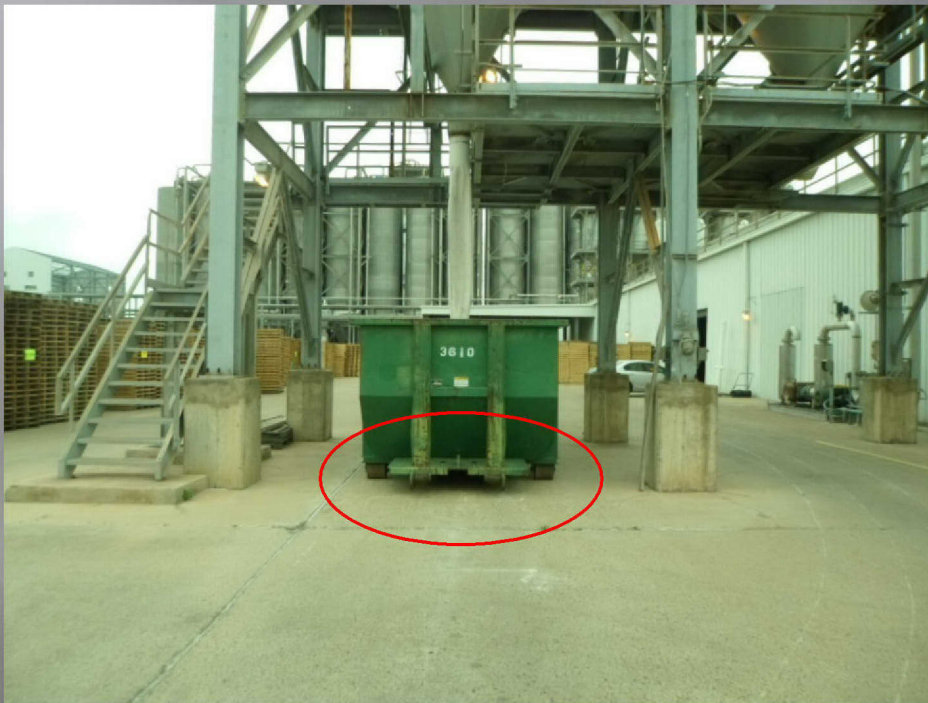
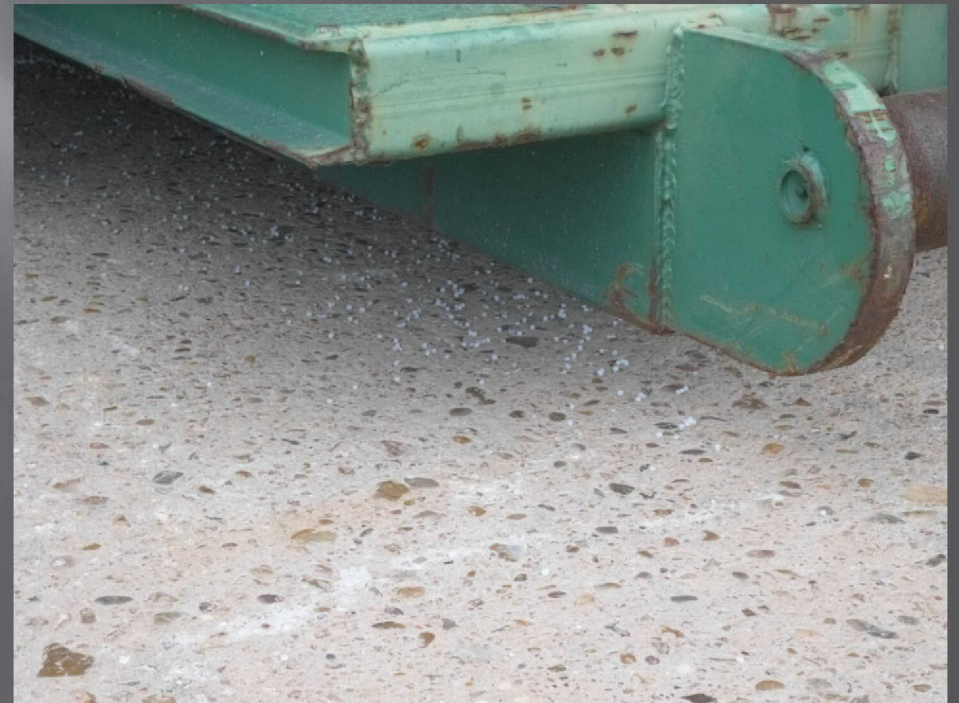
PE1/PP1 BAGGING SHIPPING

PELLETS WERE VISIBLE UNDER THE MOUSER CONTAINER WHICH IS STAGED UNDER THE SILOS AT THE BAGGING/SHIPPING AREA.

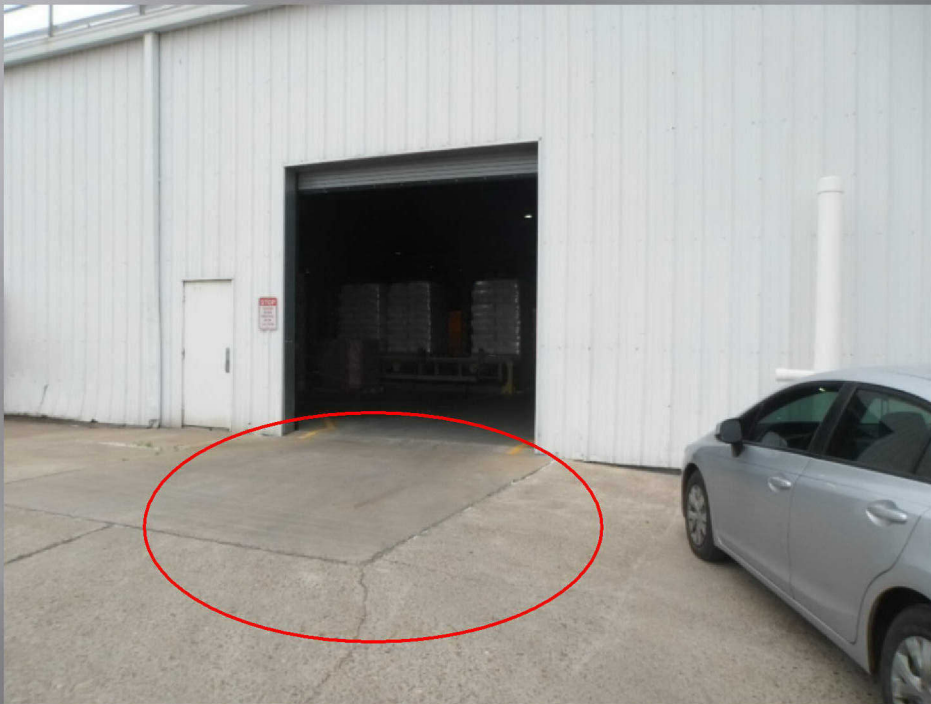
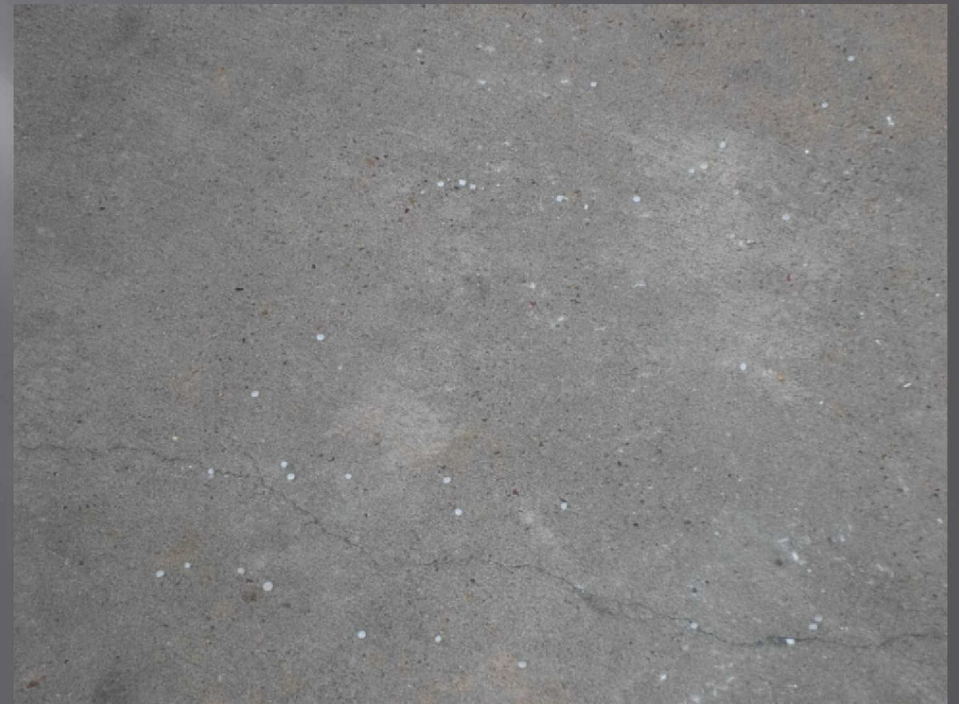
PE1/PP1 BAGGING SHIPPING

ON THE WEST SIDE OF THE BUILDING, PELLETS WERE OBSERVED ON THE PAVEMENT PRIOR TO ENTERING THE BUILDING.

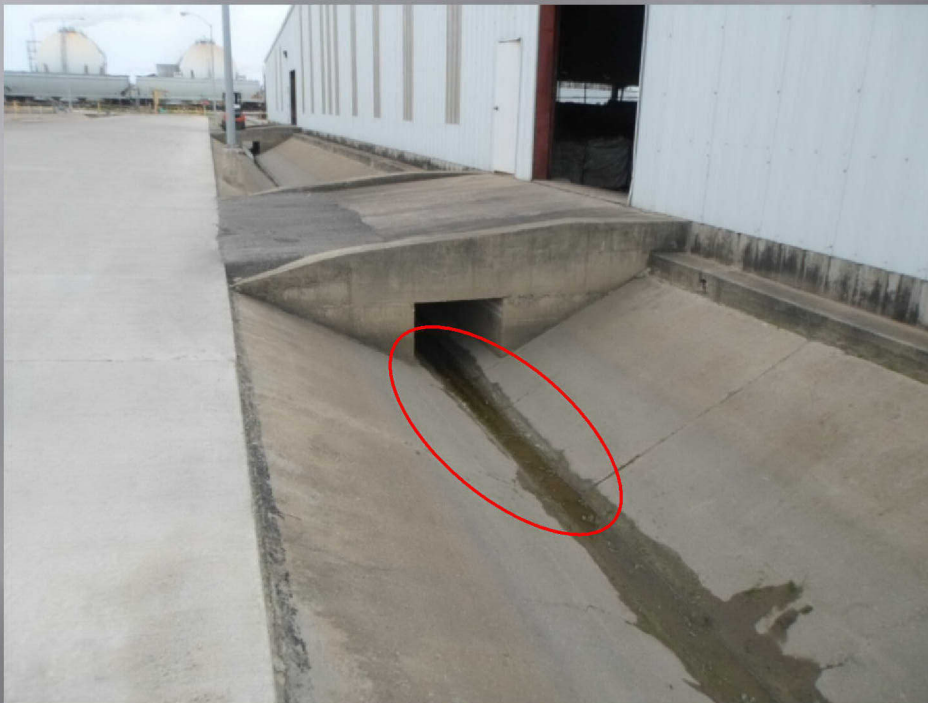
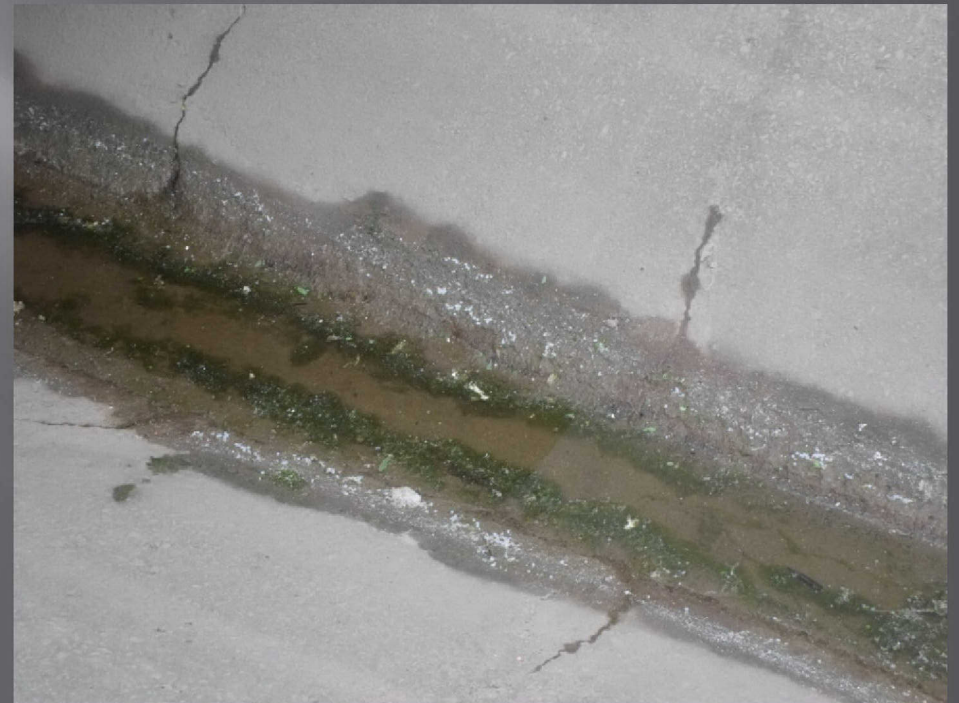
PE1/PP1 BAGGING SHIPPING

ON THE EAST SIDE OF THE BUILDING, POWDER & PELLETS ARE VISIBLE IN A SECTION OF THE DITCH.

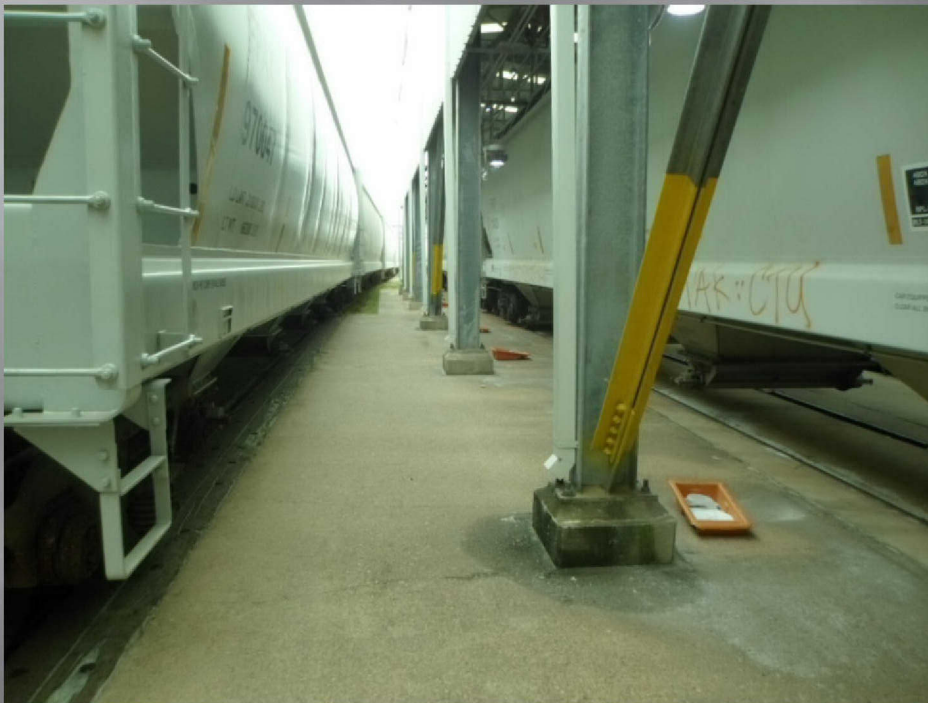
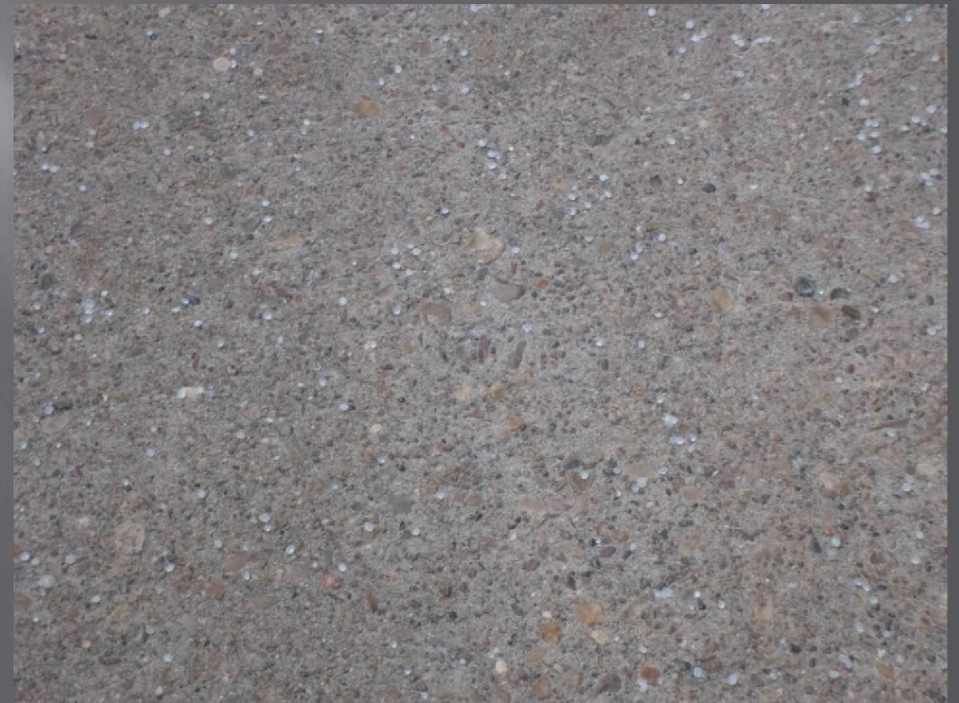
PE1/PP1 RAILCAR LOADING

IN THE HOPPER CAR CLEANING AREA, PELLETS WERE VISIBLE ON THE PAVEMENT.

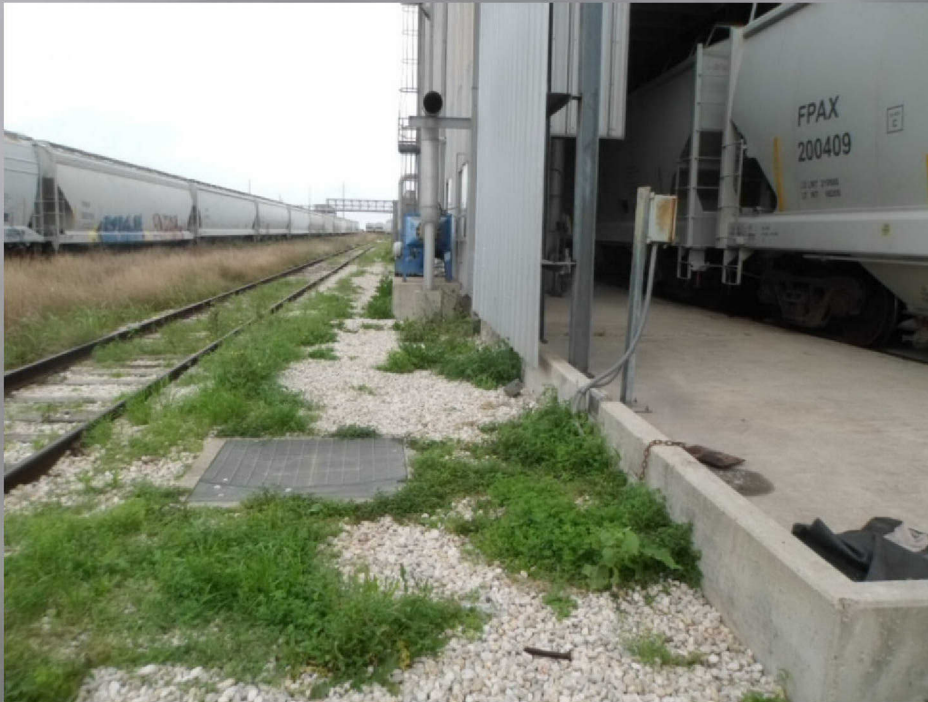
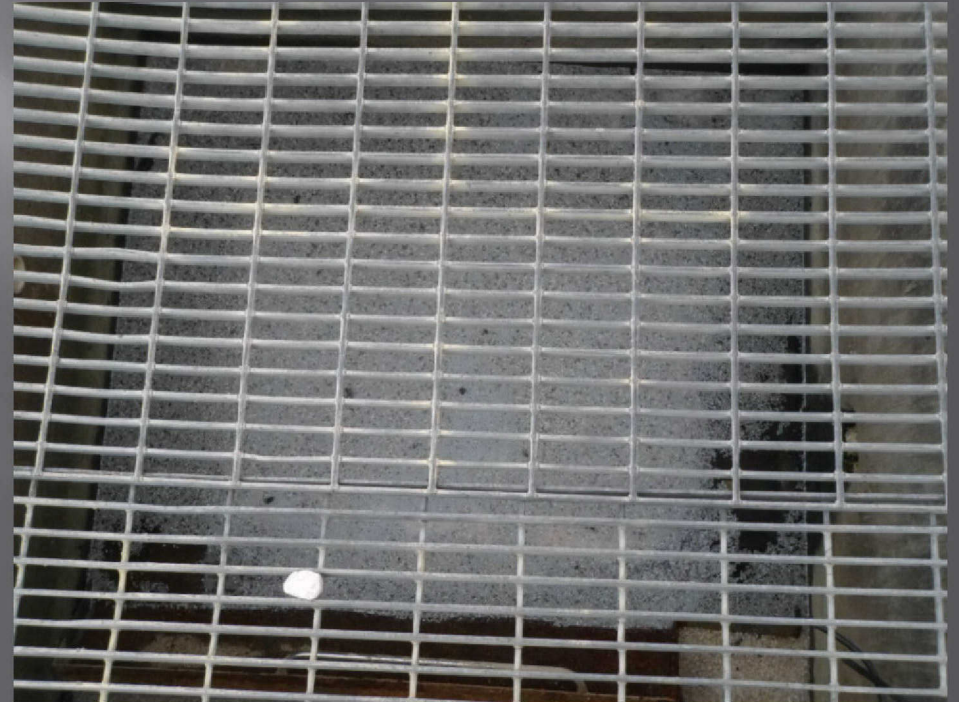
PE1/PP1 RAILCAR LOADING

ON THE SOUTH SIDE OF THE LOADING AREA, PELLETS ARE VISIBLE IN THE SUMP.
