# Exhibit Y

# LLDPE

August 10, 2017 Audit

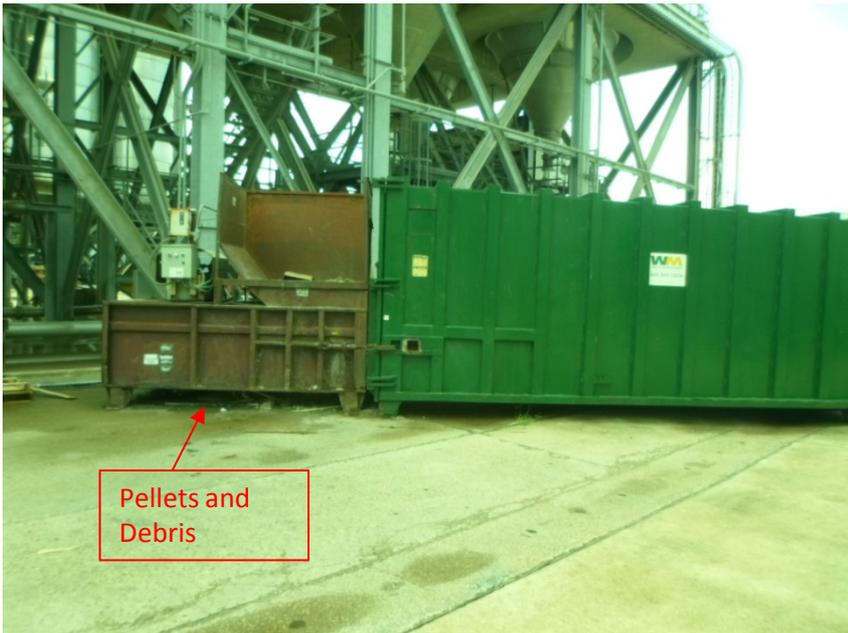
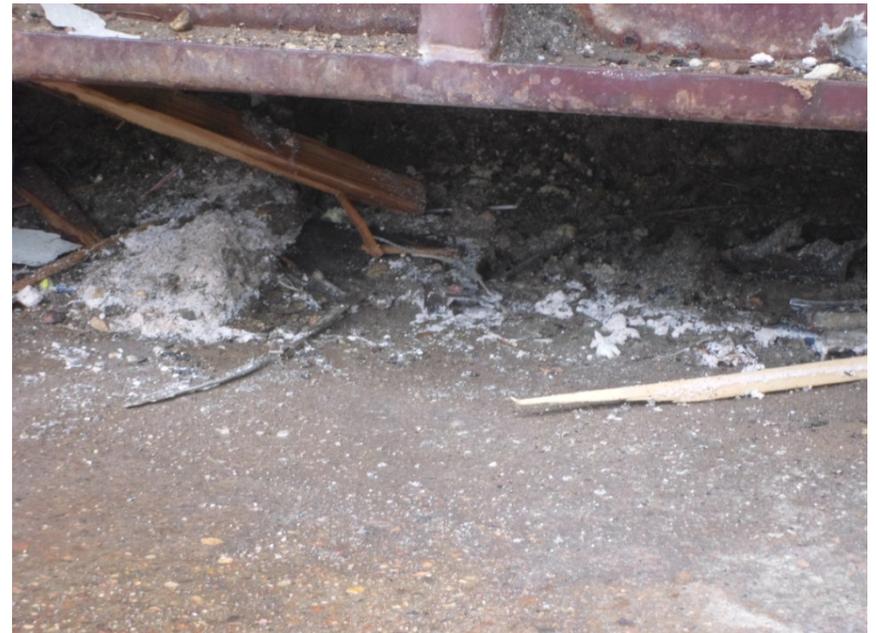
Under the compactor, pellets and powder were observed along with other debris.

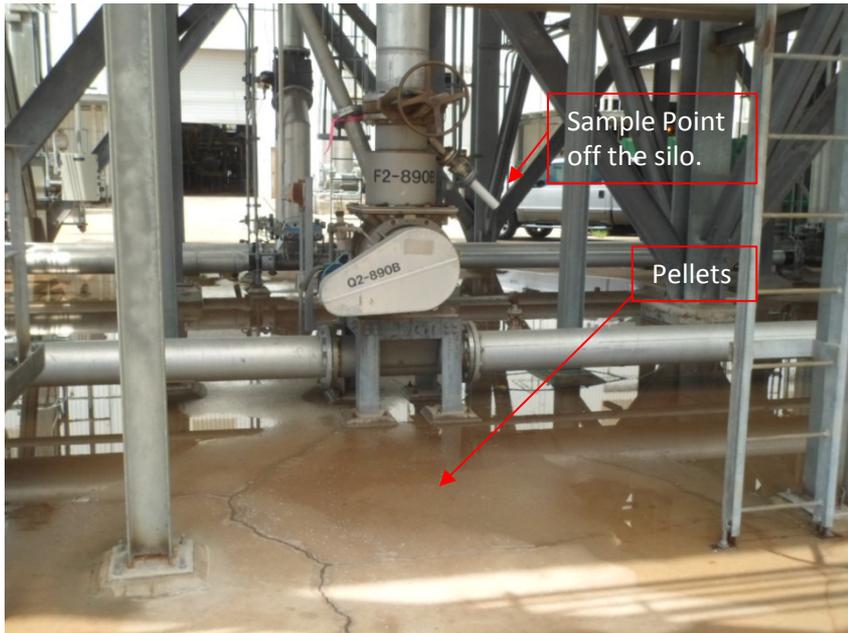
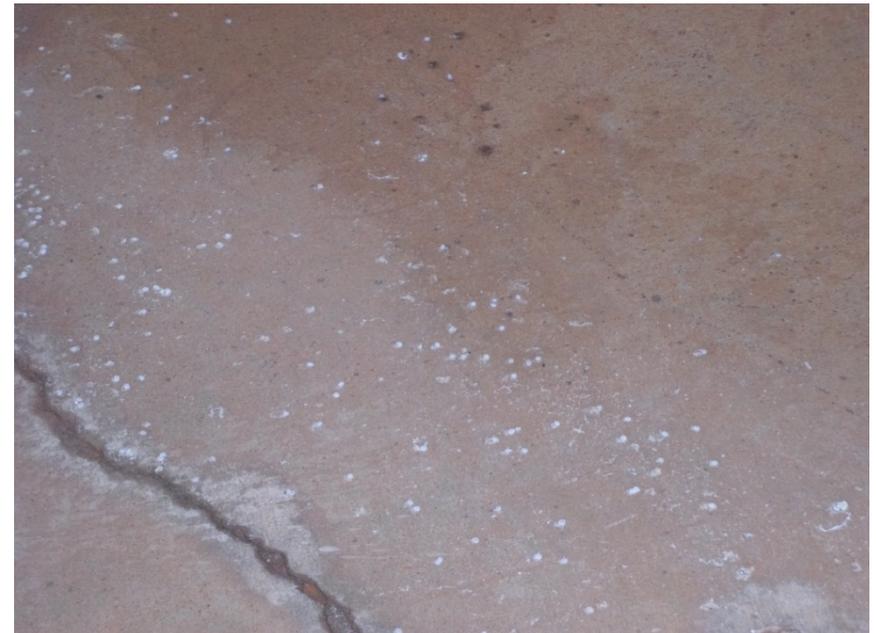
Under the silos, pellets were observed around the sample point. Note that before audit a heavy rain event occurred allowing pellets to float around inside the diked area.

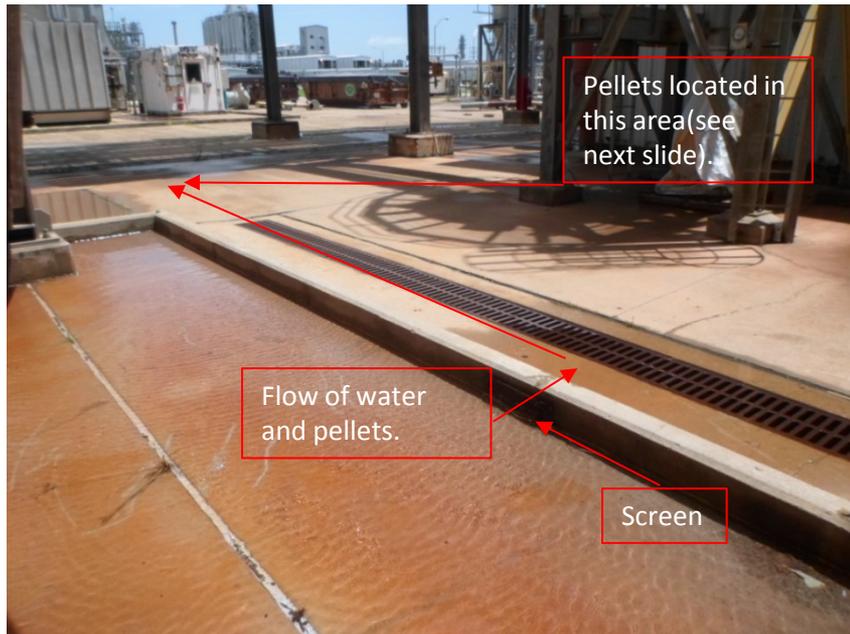
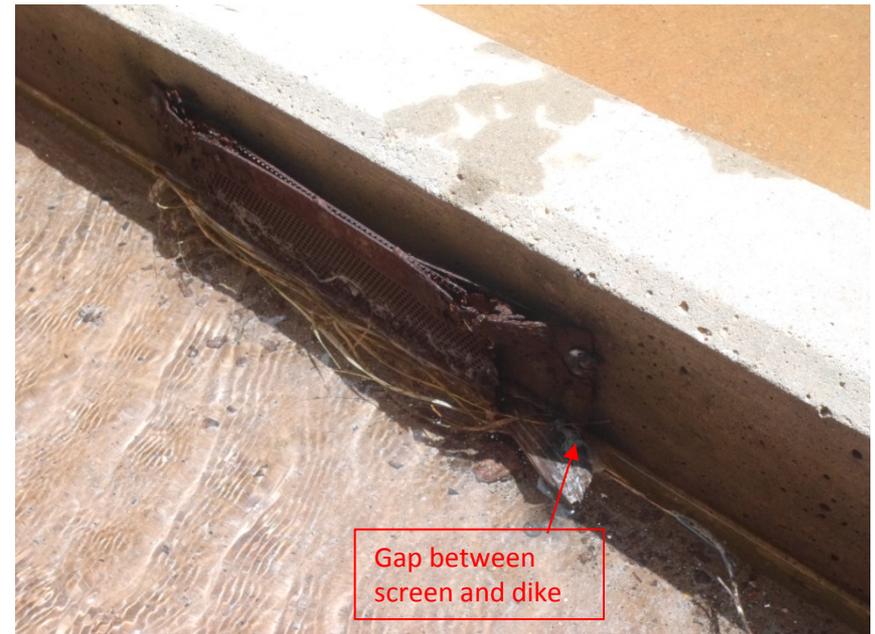
In silo area (F1), at the southwest corner of the curbing a section of screen has rusted and has a small gap allowing water and pellets to exit thru outside of the diked area

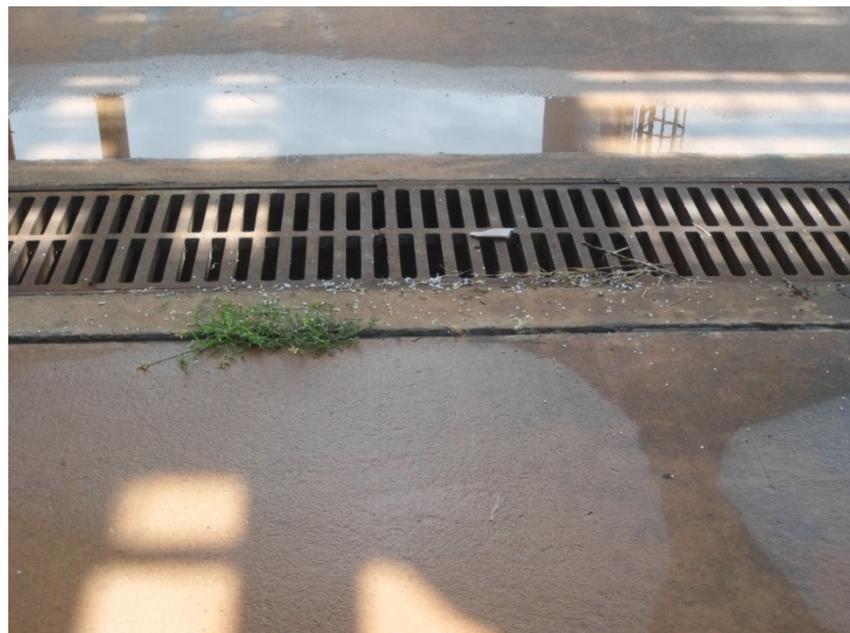
Pellets observed by trench from previous slide.

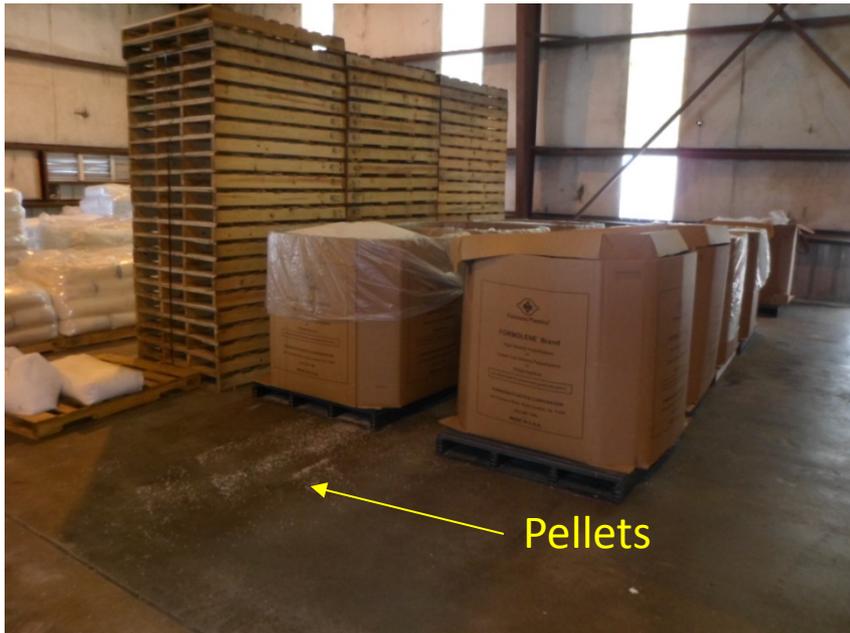
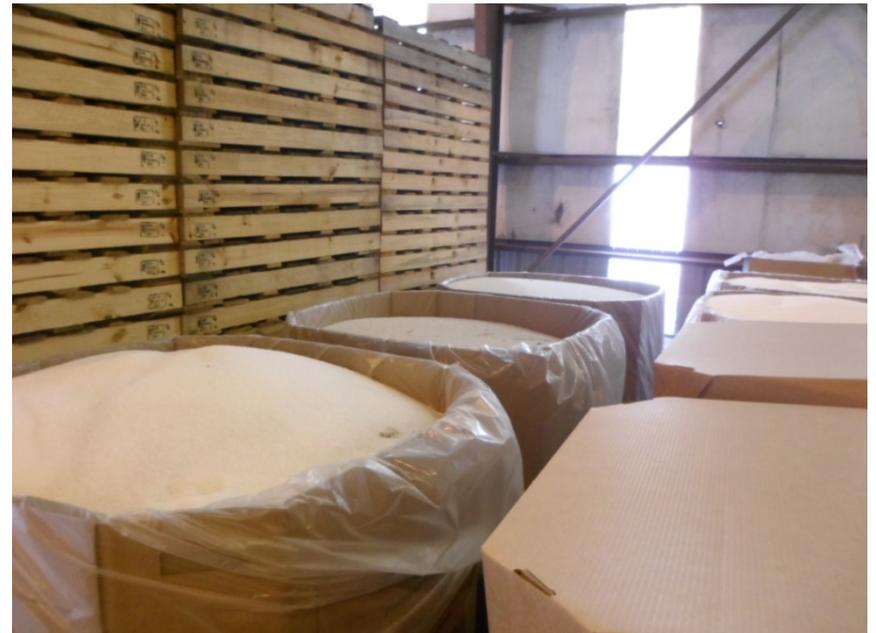
**Super sacks are not properly sealed. Pellets were observed on pavement around the pallets.**

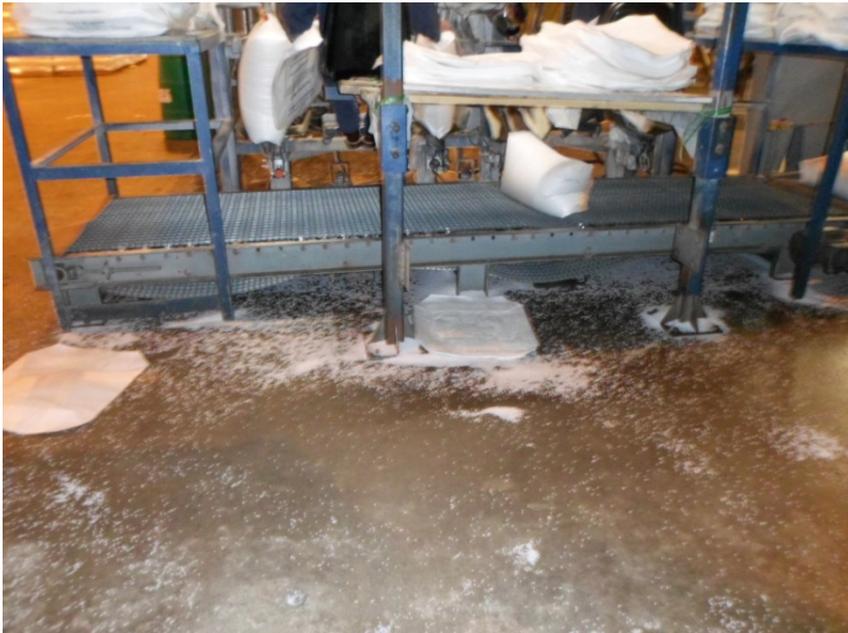
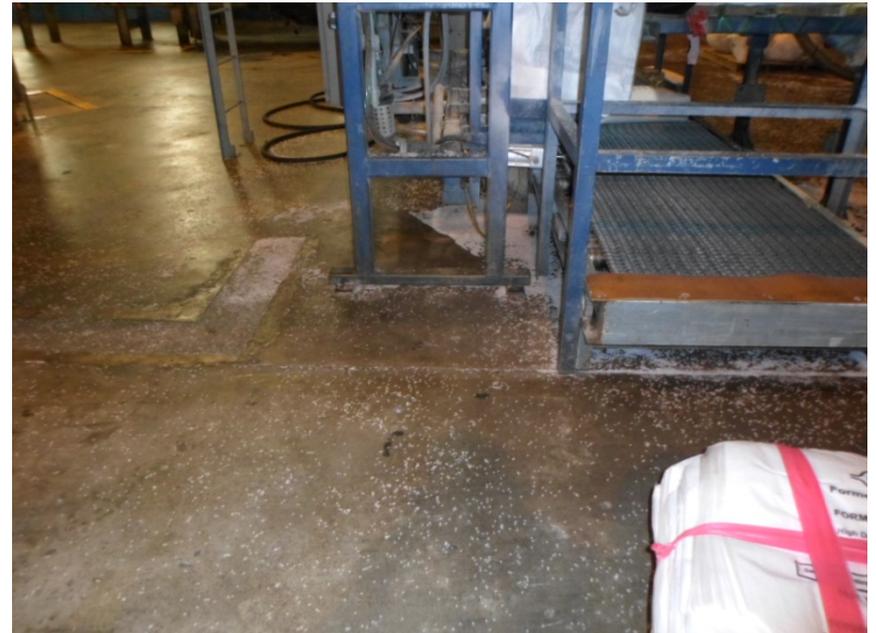
**Under the bagging machine, pellets were observed, further observation indicates that the spouts that bags are loaded into blow pellets out of the bags as the bags are released to land on the conveyor belt.**

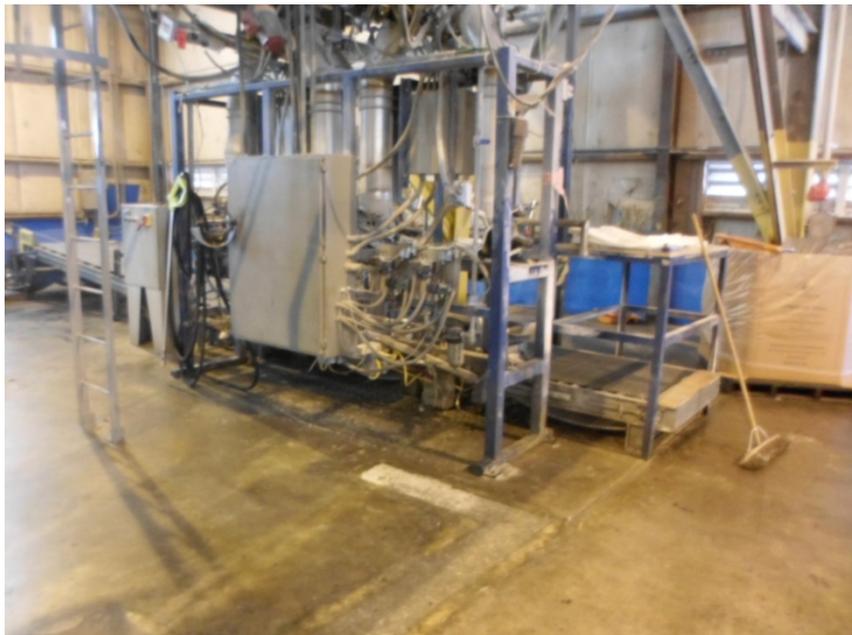
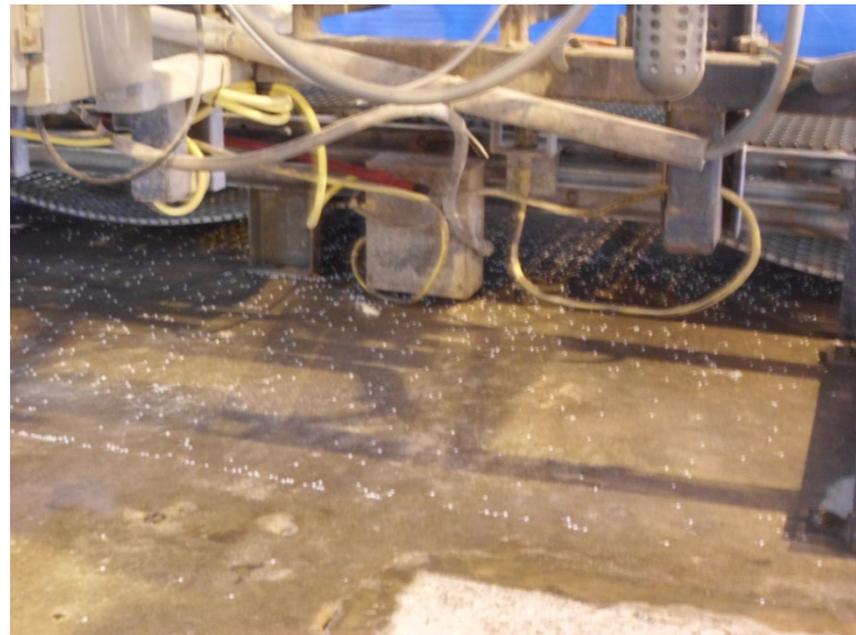
Under the bagging machine, an accumulation of pellets was observed.

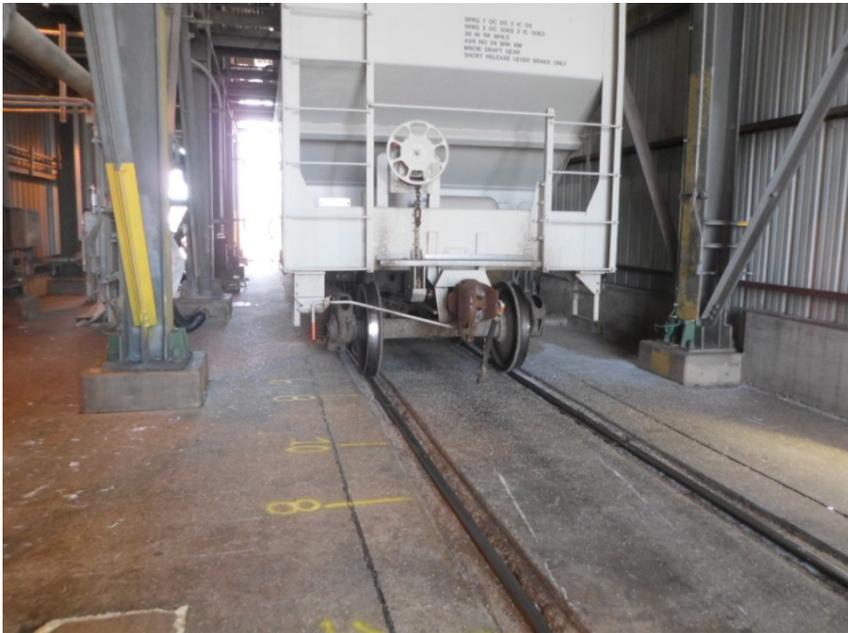
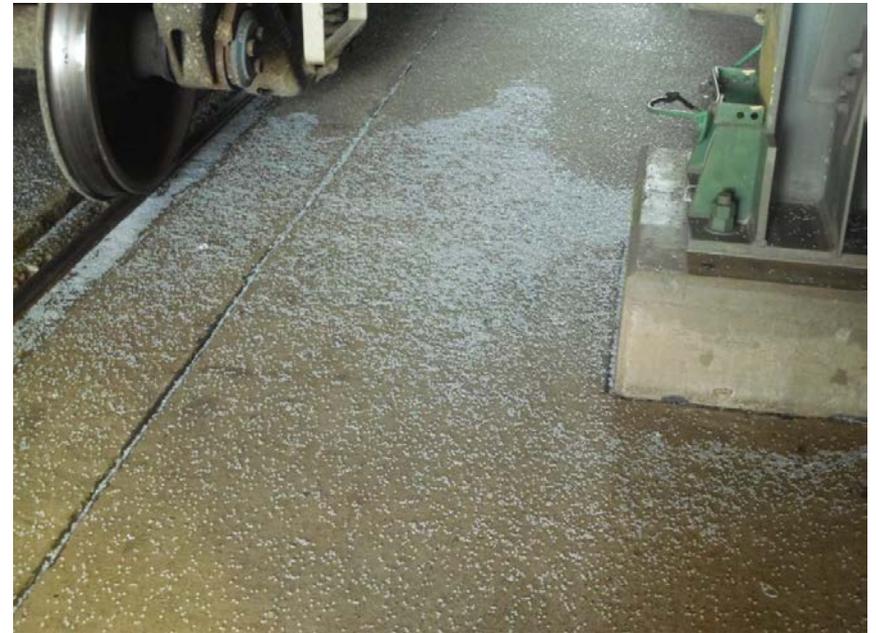
Inside the railcar loading area, pellets are observed on the ground around the rail car.

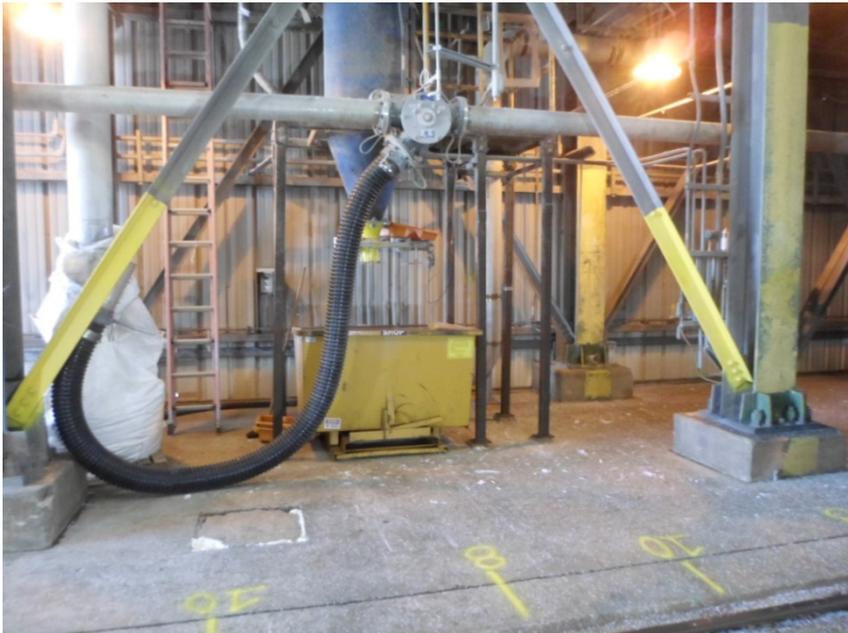
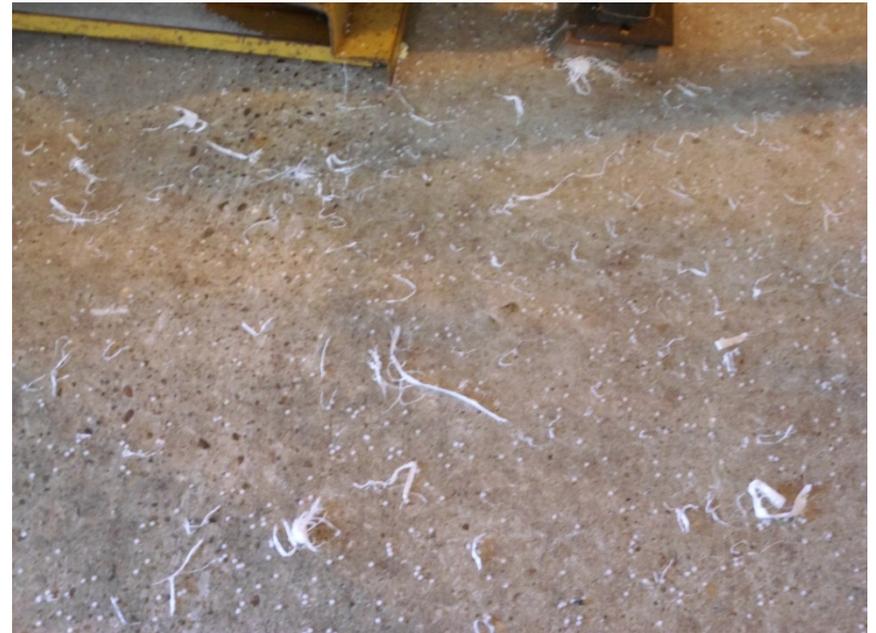
Over by the hopper, angel hair and pellets were observed on the ground. At time of audit, hopper was full and needed to be removed and emptied.

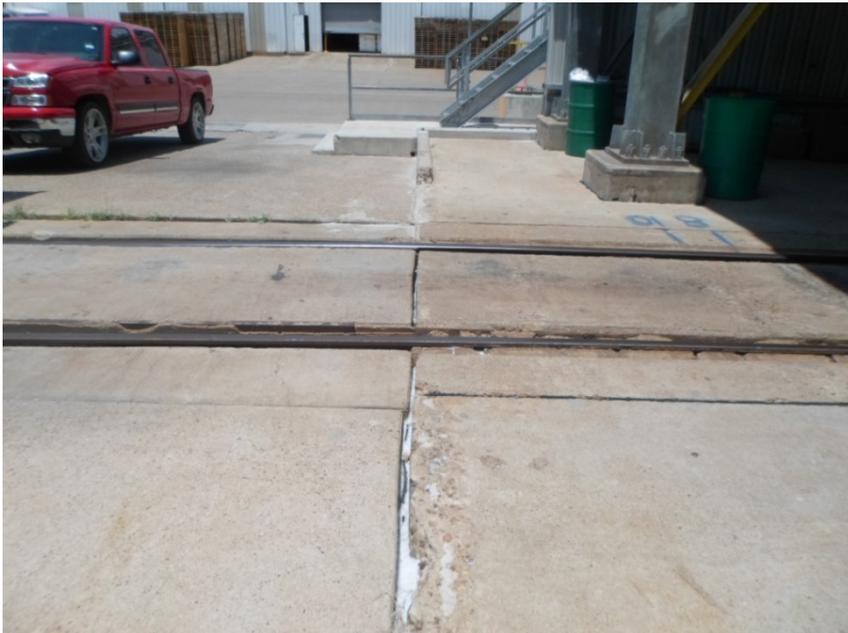
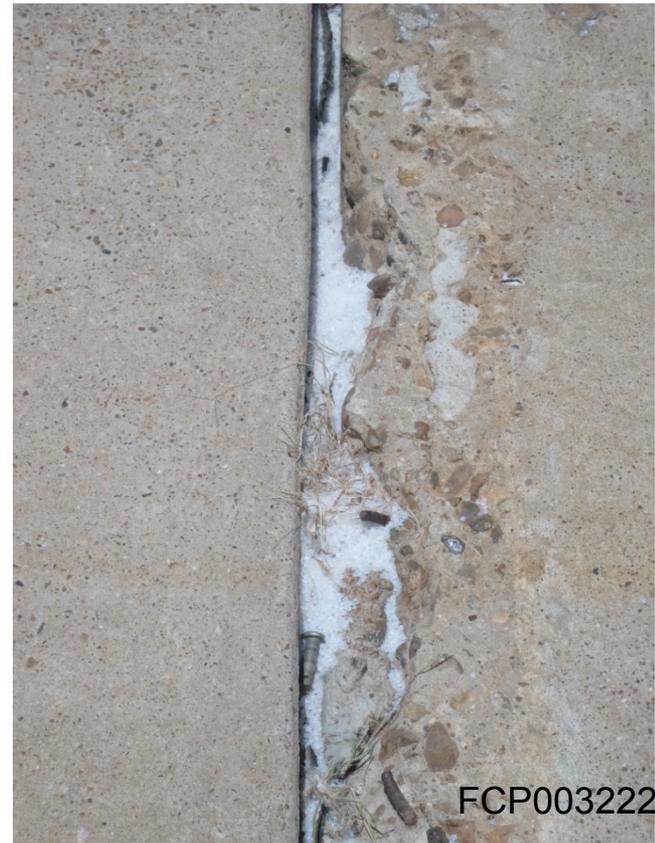
In between the cracks of the pavement, an accumulation of pellets was observed. Note that this was seen throughout the entire loading area.

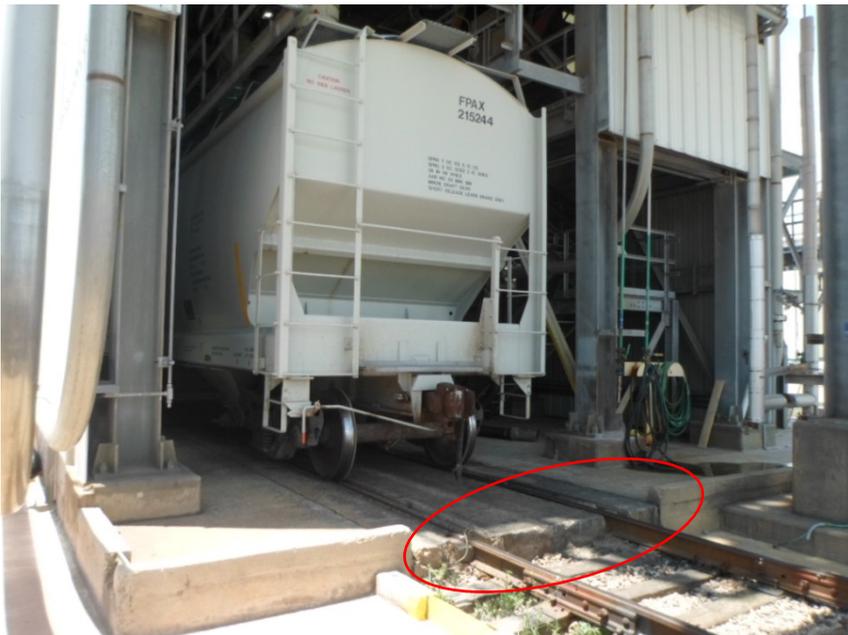
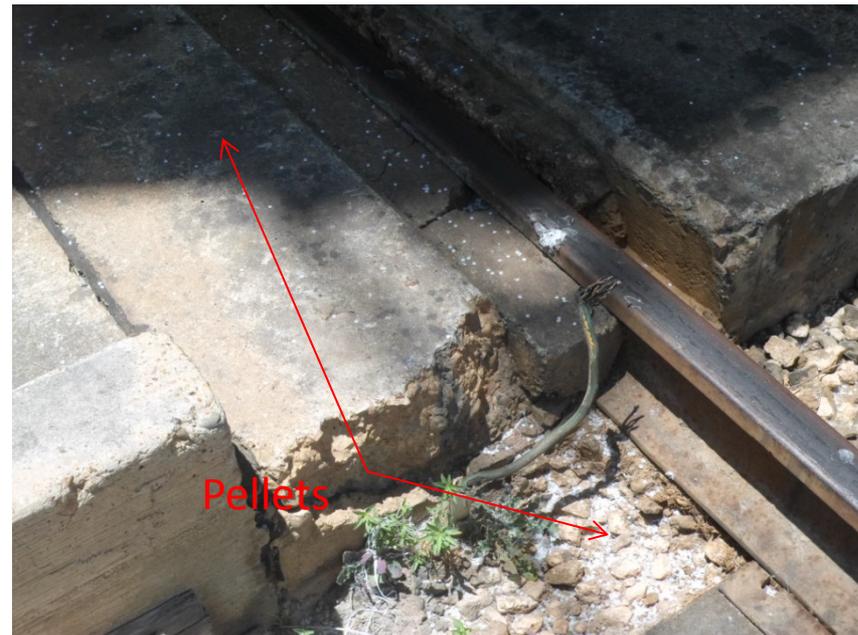
Pellets in this area were observed on the tracks coming from the loading area.

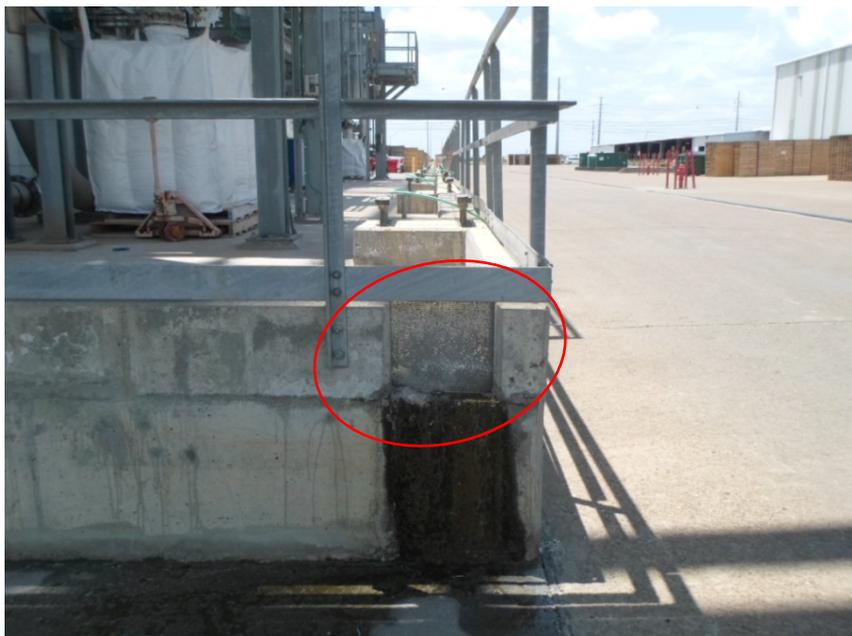
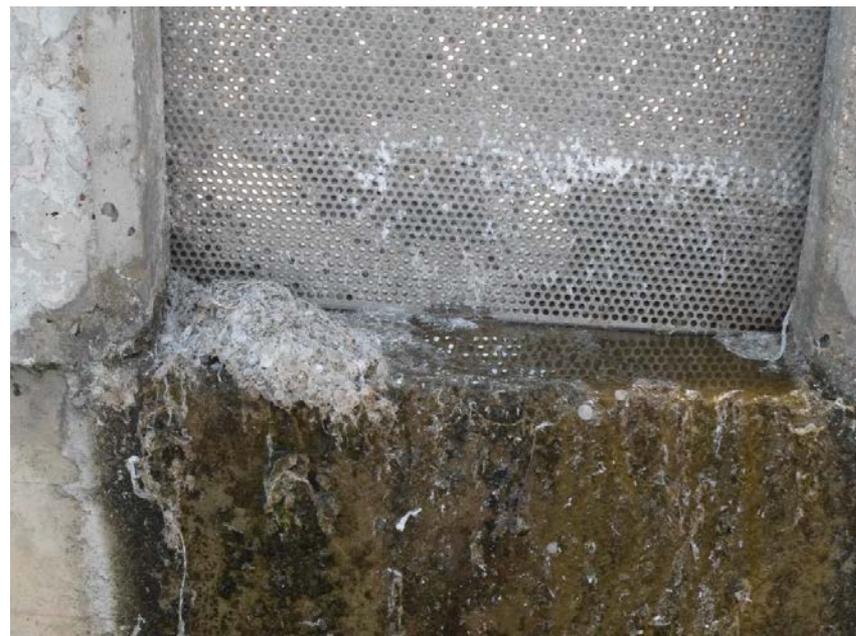
Powder and pellets were observed on the screens throughout the loading area.

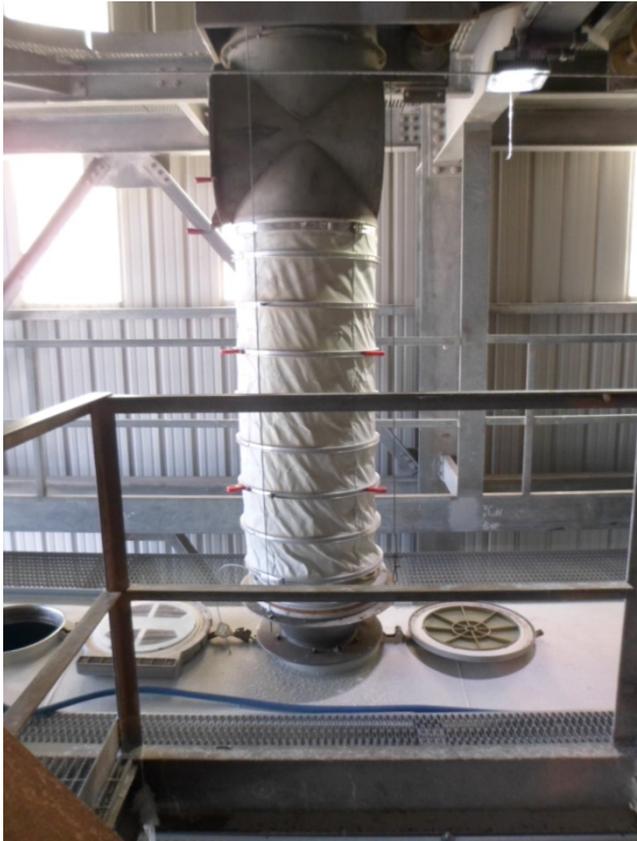
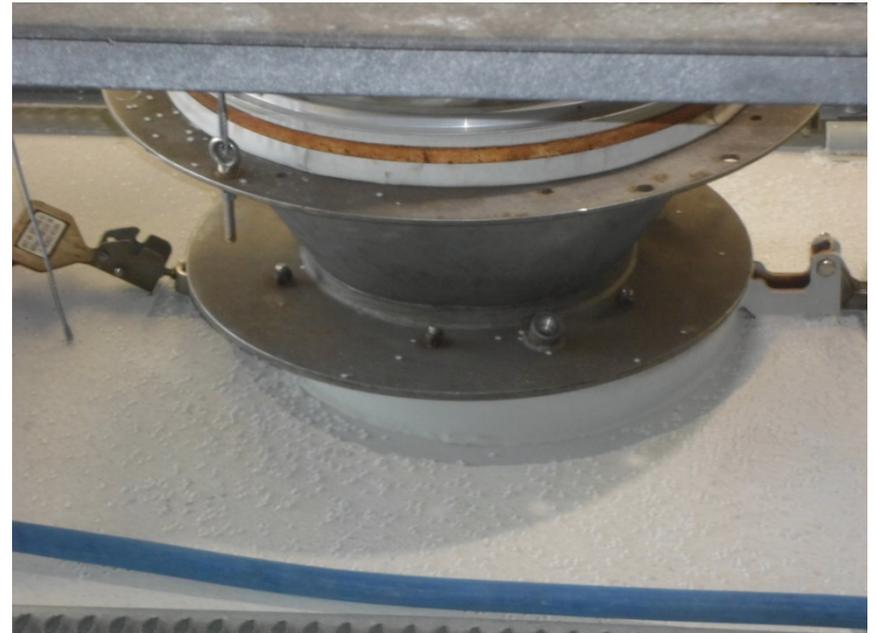
**Observation of the loading arms indicate that there is no proper seal. Pellets were observed on the actual railcar. Per personnel, pellets that spill out during loading either accumulate on the top of the car or fall onto the ground.**

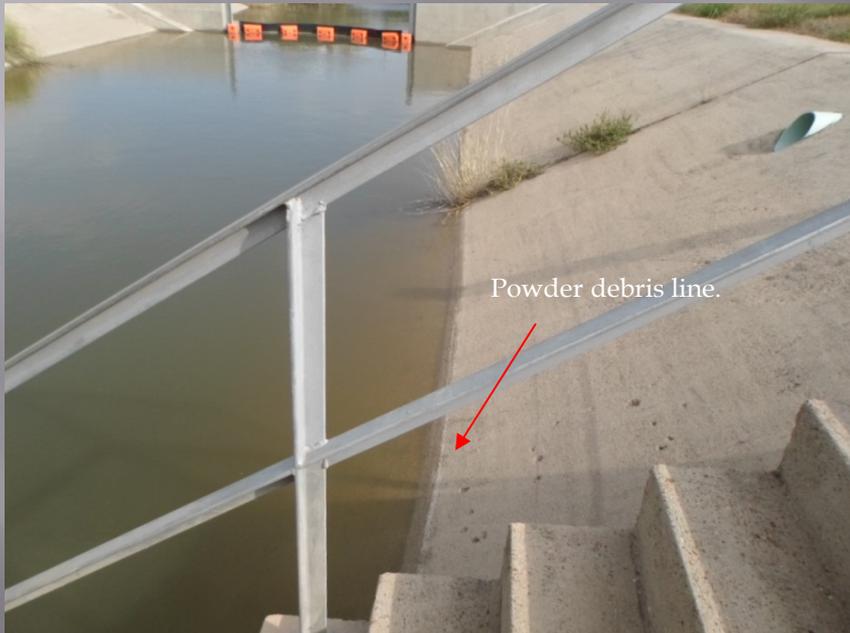
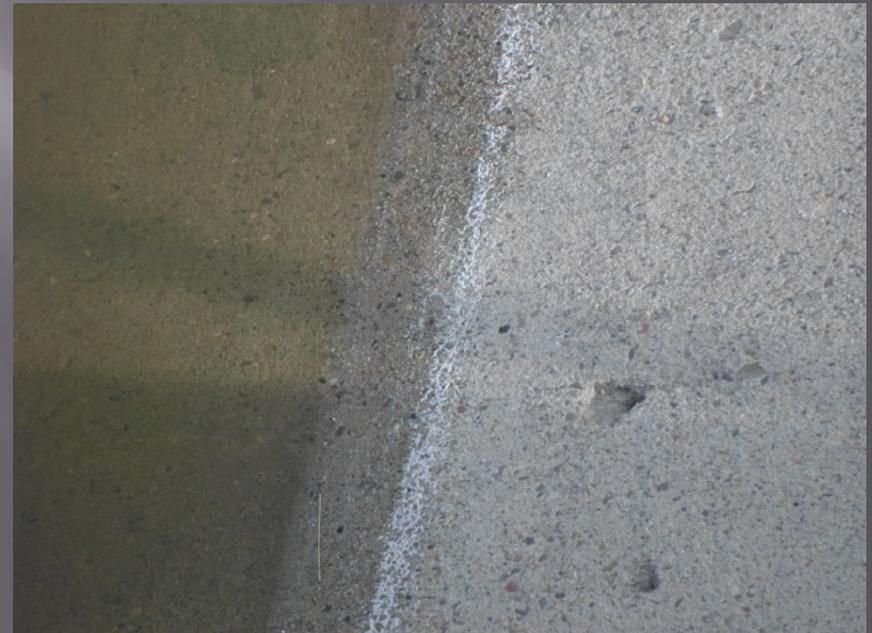
JUST SOUTH OF THE STEPS, A POWDER DEBRIS LINE IS VISIBLE ALONG THE PAVEMENT.

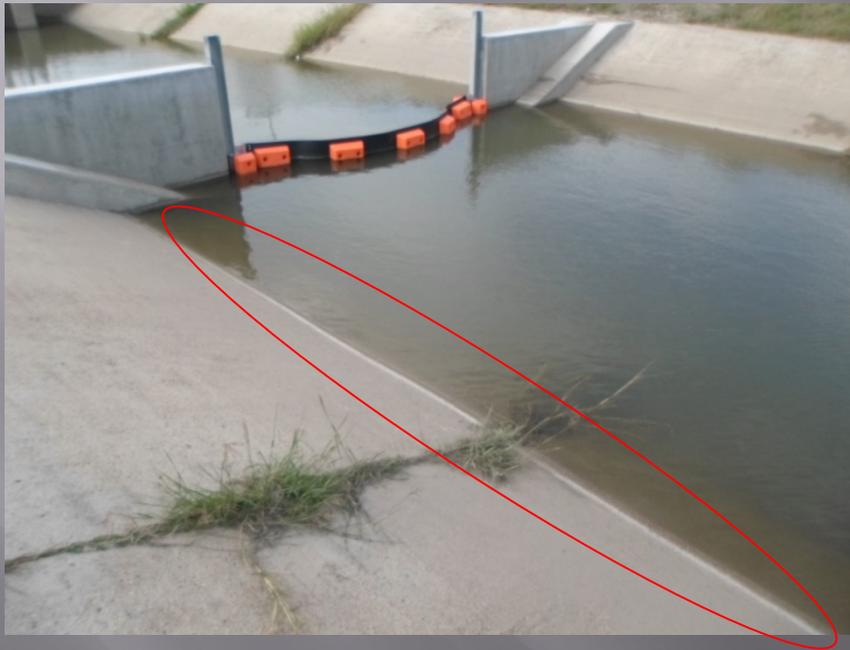
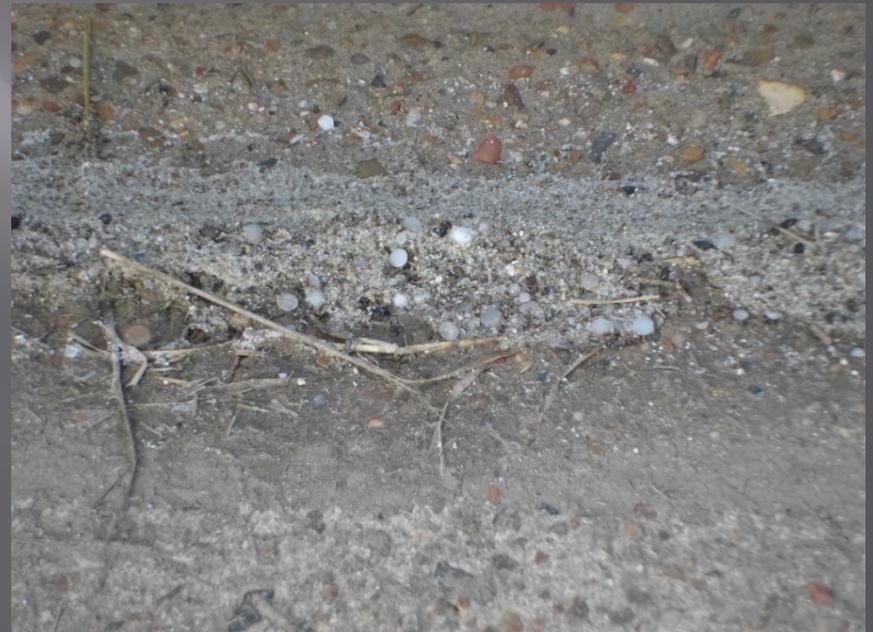
DOWNSTREAM OF THE FLOATING BOOM, PELLET AND POWDER DEBRIS LINE IS VISIBLE AT THE WATER LINE.
